BIN: 5512790 **MP:** 262.01
Region: 2 **County:** 4 MADISON
Feature Carried: NORTH MAIN ST
Feature Crossed: 90IX
General Recommendation: 4
Condition Rating: 4.11
Inspect Date: 7/29/2015

New York State Thruway Authority - Bridge Inspection Report

2015 INSPECTION

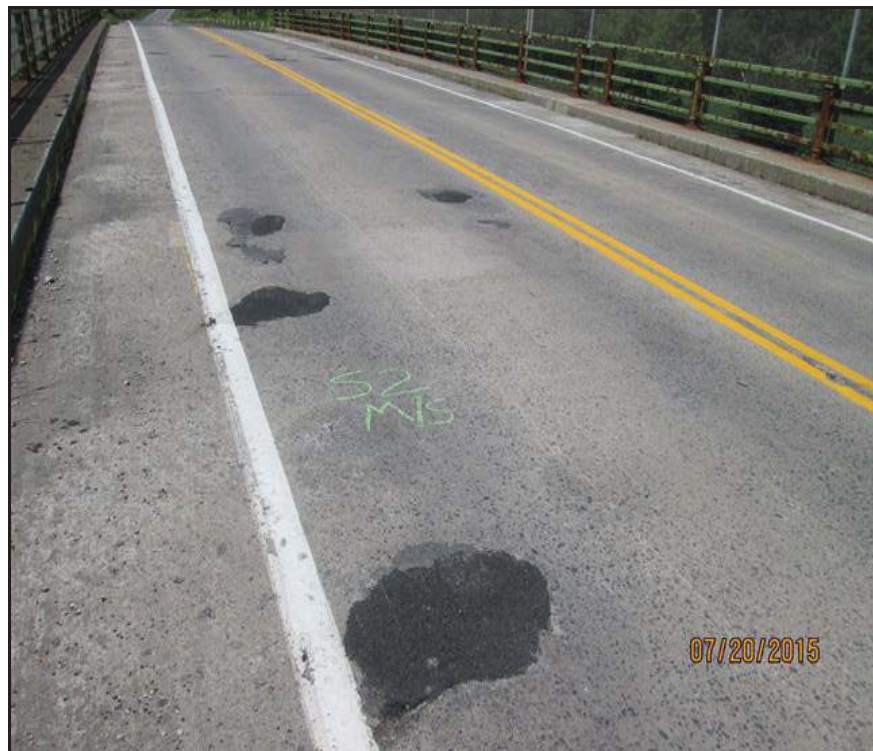
Location:	Photo Name:	Photo #:
Span 2, Wearing Surface in Left Travel Lane at Midspan	262.01-350-19-02-15WSsp2L.JPG	3

In Span 2, the Wearing Surface in the Left travel lane has several 2 SF areas of uneven asphalt patchwork near Midspan. The affected area represents 1% of the total surface in the span. Ride quality is slightly diminished.

The deck has several spalls with exposed rebar scattered throughout, and a few areas of dampness along the fascia girders, suggesting moderate leakage through the wearing surface.

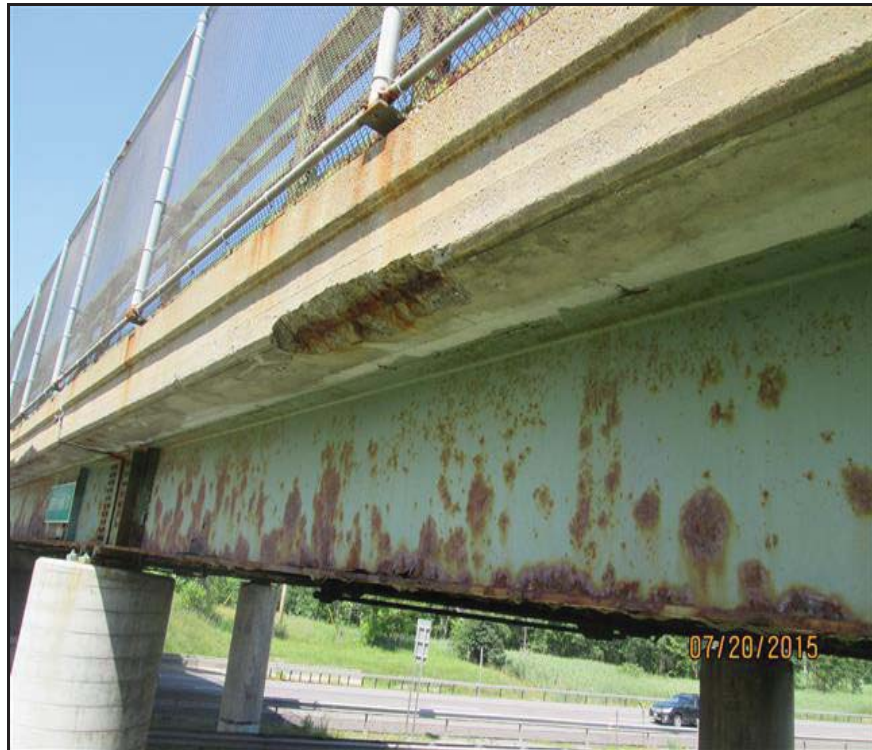
In Span 1, the Left Fascia has a 3' L x 3" H x 3" D bottom corner spall with exposed rebar near Midspan. The bridge railing anchorages are not affected. The remainder of the Left fascia is in good condition. Rating is lowered from '6' to '5' due to the isolated spall.

Description(s):
- 3' Long x 3" High x 3" Deep spall with exposed rebar.

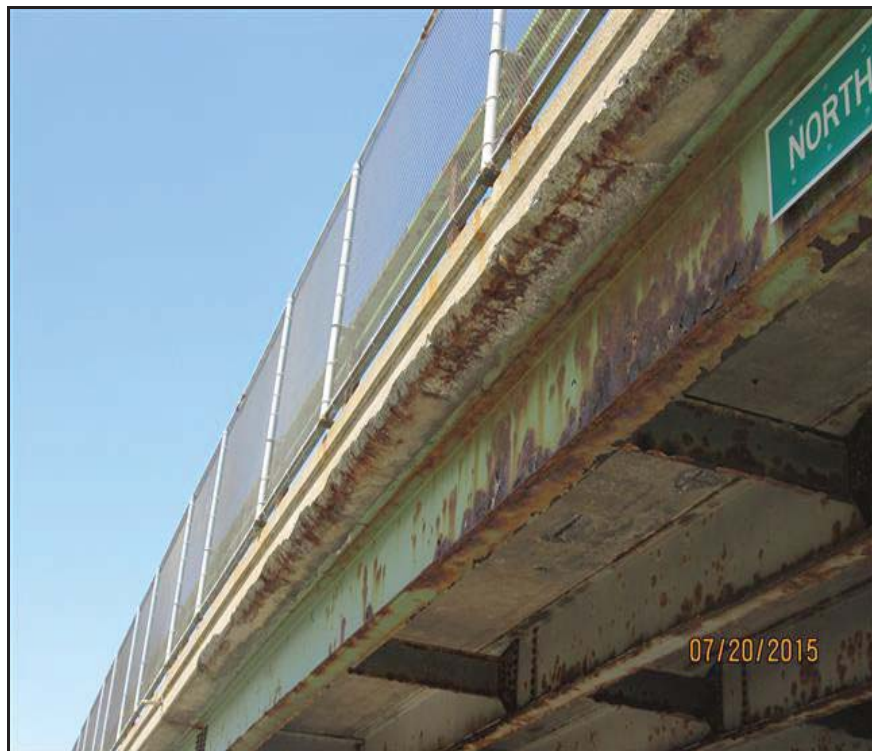
In Span 2, the Left Fascia has a 48' Long bottom corner spall with exposed and heavily corroded rebar directly over the entire width of the I-90 EB travel lanes and shoulders, affecting 80% of the total span length. Spalling is typically 3" to 6" High x 3" deep, and continues 6" to 18" along the underside of the overhang. The bridge railing anchorages are not affected. The remainder of the Left fascia is solid, with no loose or delaminated concrete.

Location:	Photo Name:	Photo #:
Span 2, Left Fascia	262.01-350-21-02-15FascLt.JPG	7

Description(s):
- 48' Long x up to 6" High x 3" Deep spall bottom corner spall, which affects 80% of the total span length.

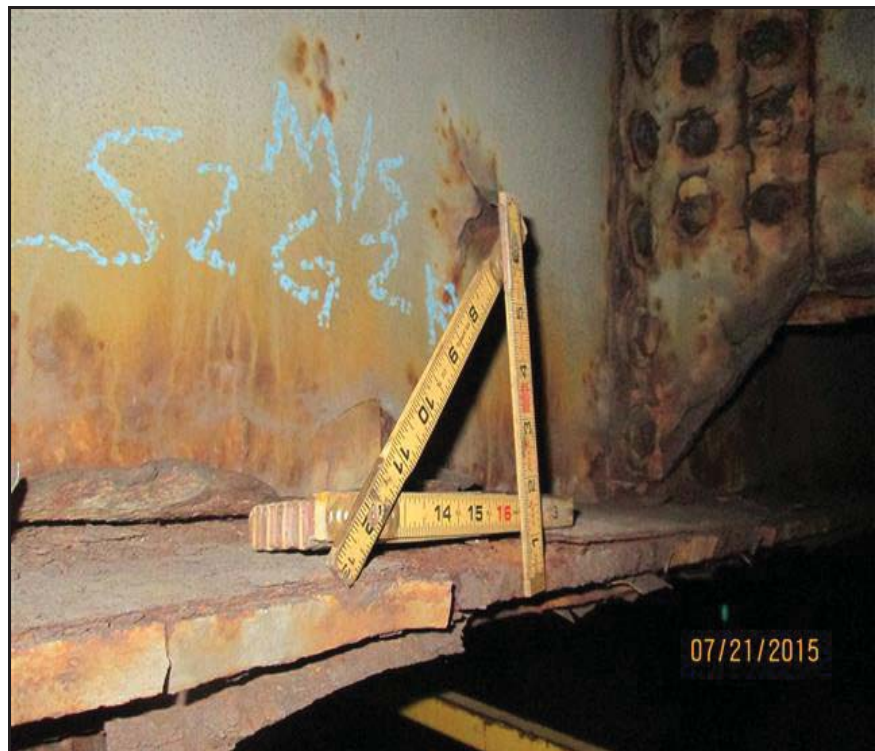
Location:	Photo Name:	Photo #:
Span 2, Girder G2 from Right at Midspan (Typical for All 5 Girders)	262.01-350-28-03-15S2G2MS.JPG	17

Description(s):
- 13% section loss on the Bottom Flange.

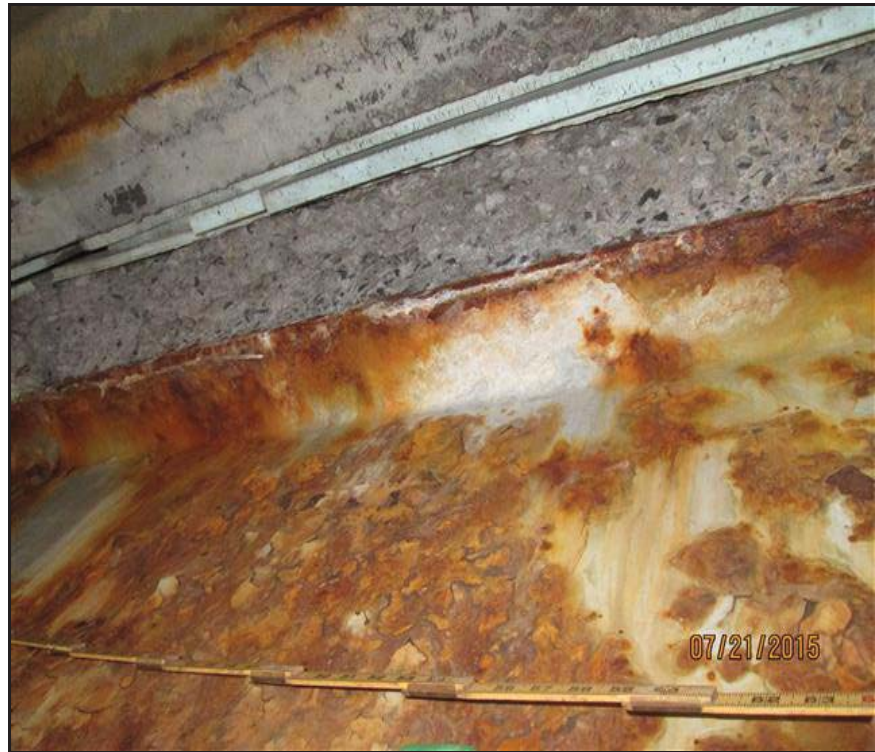
Below deck, conditions were dry during the inspection, but paint failure and corrosion on the underlying elements suggests moderate joint leakage. In girder Bay 3, the Span 2 header has a 6' Long x Full Width x 2" Deep spall.

Description(s):
- Span 2 header has a 6' Long x Full Width x 2" Deep spall

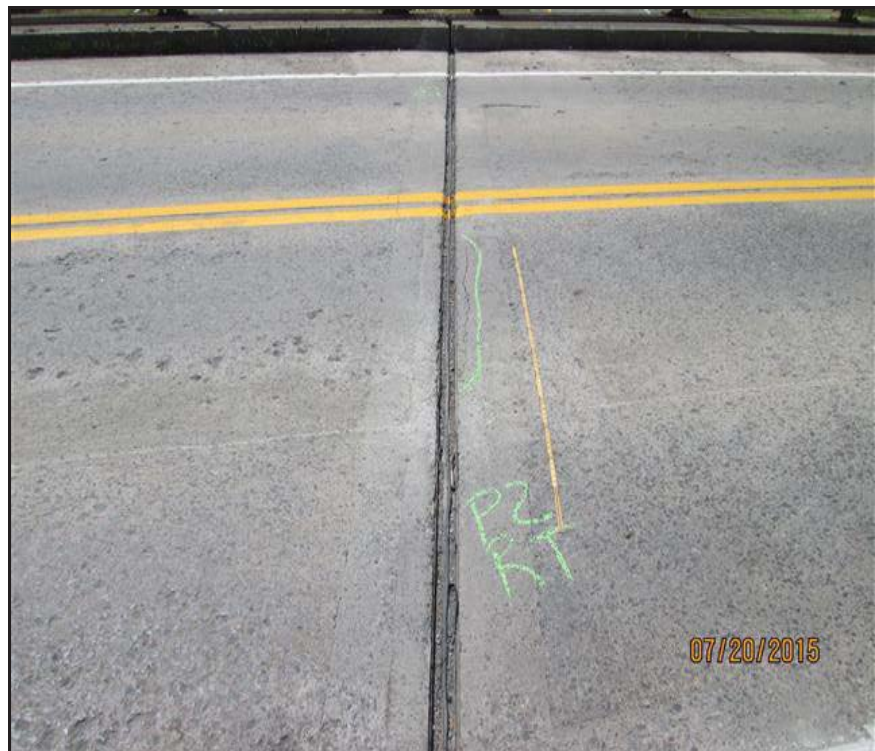
The Pier 2 Joint seal exhibits intermittent detachment throughout the width of the bridge, with minor fraying in the Right travel lane. The Span 2 header has a 4' Long x 1/8" Wide transverse crack near the centerline, in the Right travel lane.

Location:	Photo Name:	Photo #:
Pier 2 Joint from Right	262.01-350-31-02-15JointR.JPG	23

Description(s):
- Joint seal exhibits minor fraying. The Span 2 header has a 4' Long x 1/8" Wide transverse crack near the centerline.

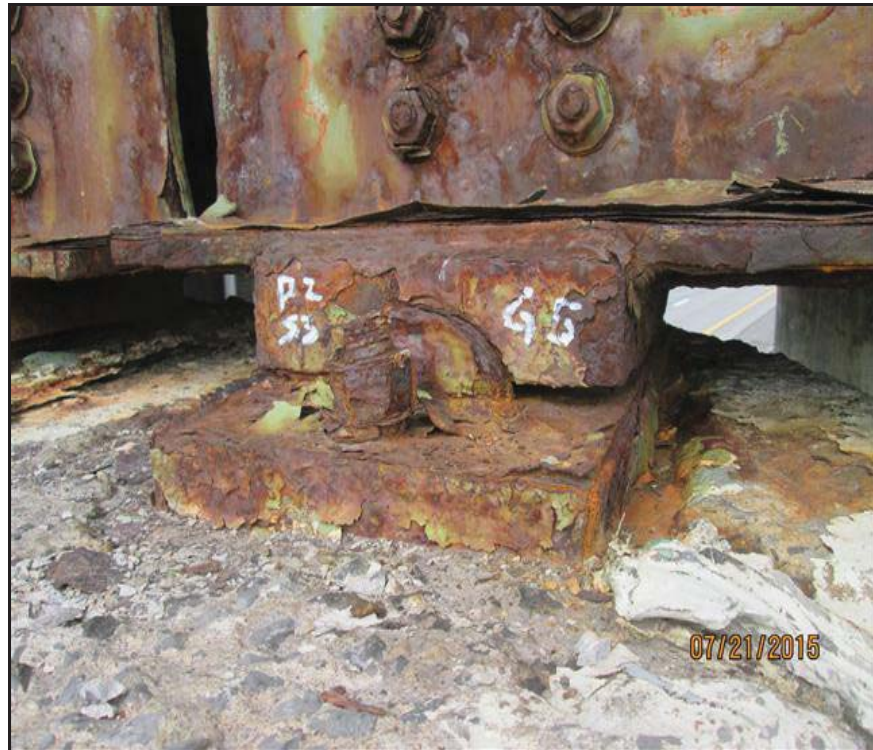
Description(s):
- Heavy corrosion affects all bearing components. Outer anchor bolt nut has 75% section loss. Corrosion impedes, but does not appear to restrict girder end rotation.

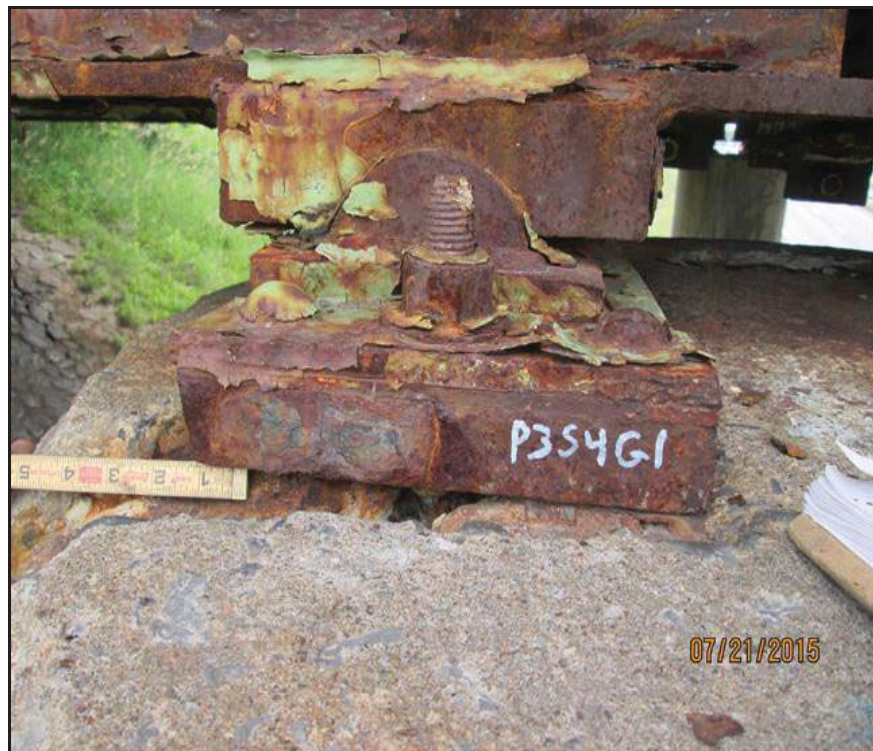
Location:	Photo Name:	Photo #:
Pier 3, Span 4 Bearing under Girder G1	262.01-350-33-03-15P3S4G1.JPG	29

Description(s):
- Moderate corrosion affecting all bearing surfaces. Spalling pedestal undermines the masonry plate by up to 1", which represents a 5% loss of contact area.

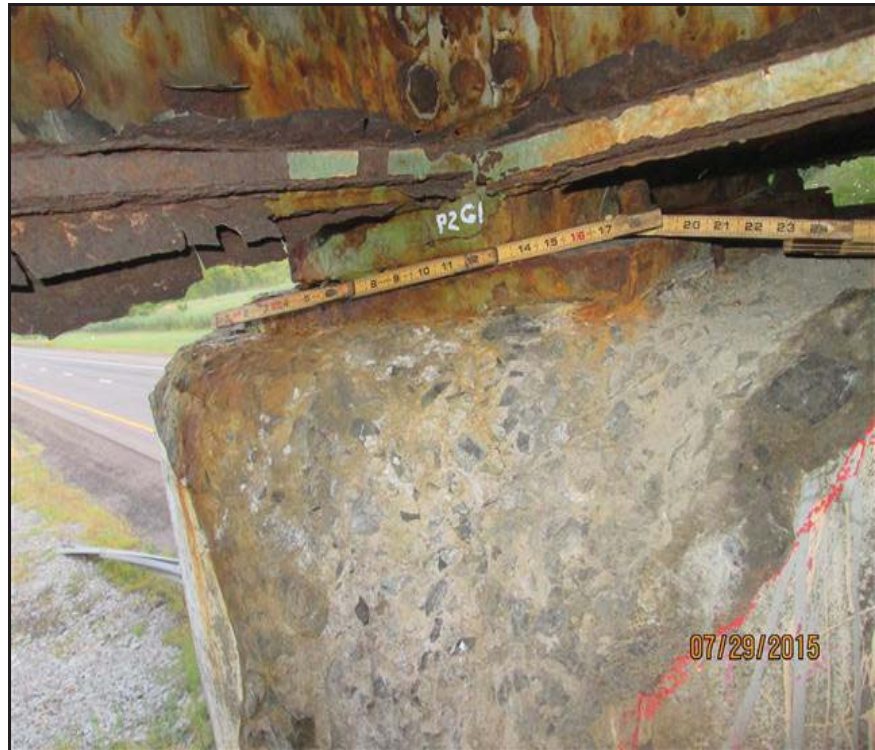
Description(s):
- 2" Wide x 18" High x up to 5" Deep spalling which continues along the top surface. Top surface spalling is 2" deep, and extends up to, but not under the bearing masonry plate.

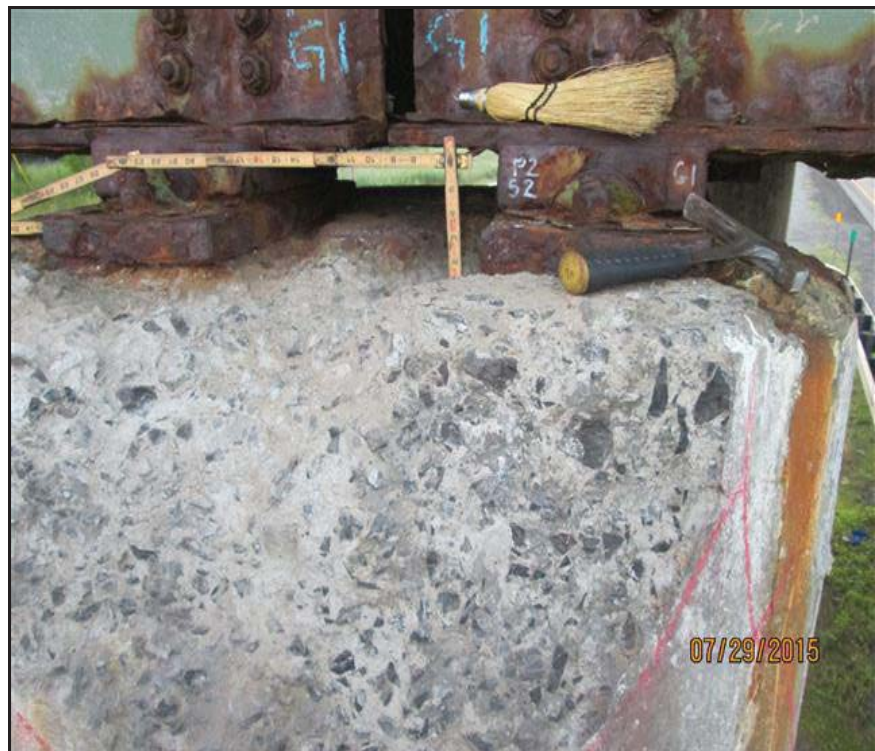
Location:	Photo Name:	Photo #:
Pier 2, Pedestal beneath Girders G1	262.01-350-34-02-15P2Pd1L.JPG	33

Description(s):
- 2" Wide x 18" High x up to 5" Deep top corner spall which extends up to, but not under the masonry plates.

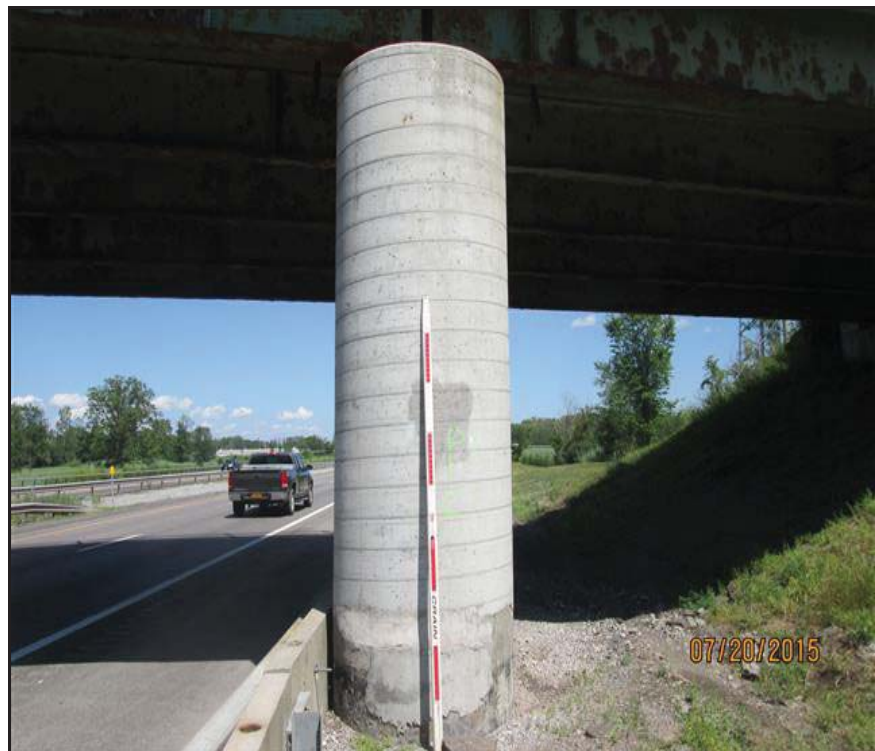
Location:	Photo Name:	Photo #:
Pier 1, Left Column	262.01-350-38-00-15P1Col1.JPG	35

The previously severely deteriorated portion of the Pier 1 Left Column has been completely replaced.
