## FINAL DESIGN REPORT

Bridge Project  
NYSTA D214386  
PIN S52886 B690.1  
MP 240.48 BIN: 5512980  
Judd Rd. (C.R. 840) over I-90  
Oneida County  
Town of Whitestown

This project proposes to replace the existing bridge carrying Judd Rd. over I-90 (I-90) EB & WB (BIN 5512980) located at MP 240.48 in the Town of Whitestown, Oneida County, New York.

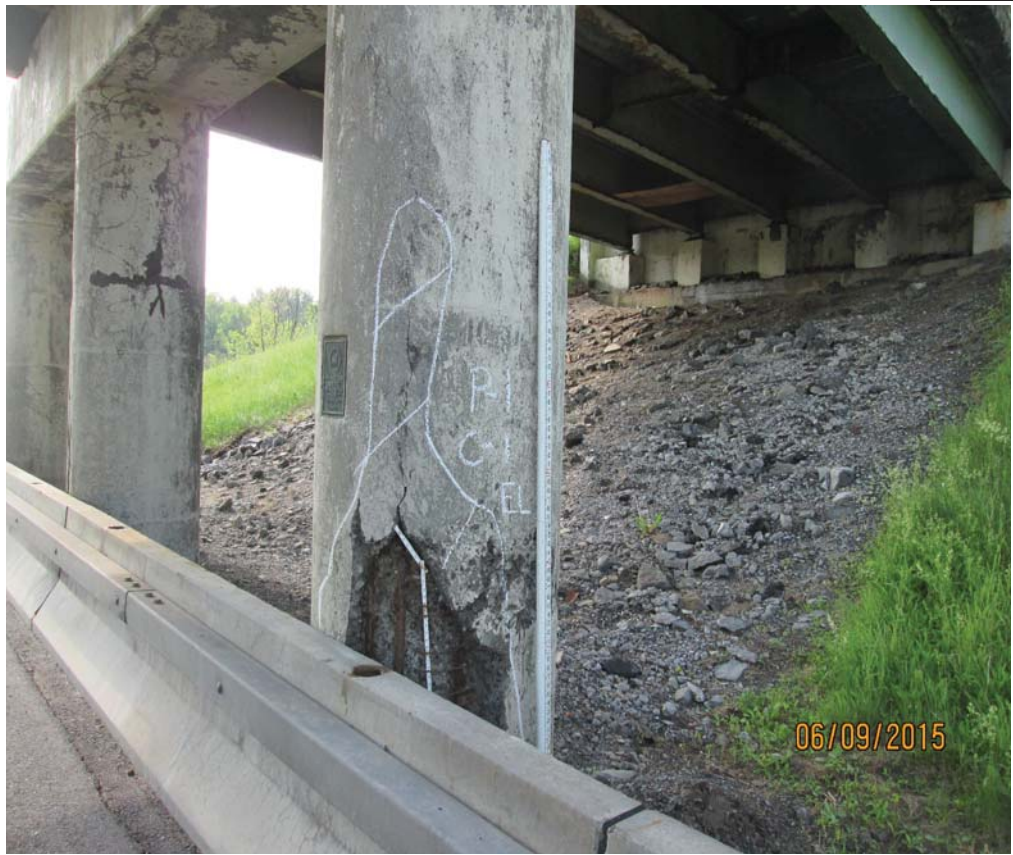
<b>Location:</b>	240.48-FLG-99-00-15P1C1EL.JPG	1
Pier 1, Column 1 from End Left

A safety flag (15-041) was issued for severe spalling with exposed, corroded and debonded reinforcement in the Pier 1 and Pier 3 columns.

Piers 1 and 3 are have a rating of 3 and 4 out of 7 respectively due to severe spalling with exposed, corroded and debonded rebar in the pier columns, cap beam and pedestals.

<b>Description:</b>		
The End Left face of the Column has spalling is up to 5.0' high x 2.8' wide x 4" deep, with debonded reinforcement.		
<b>Reference:</b>		
FLAG #: 15-041

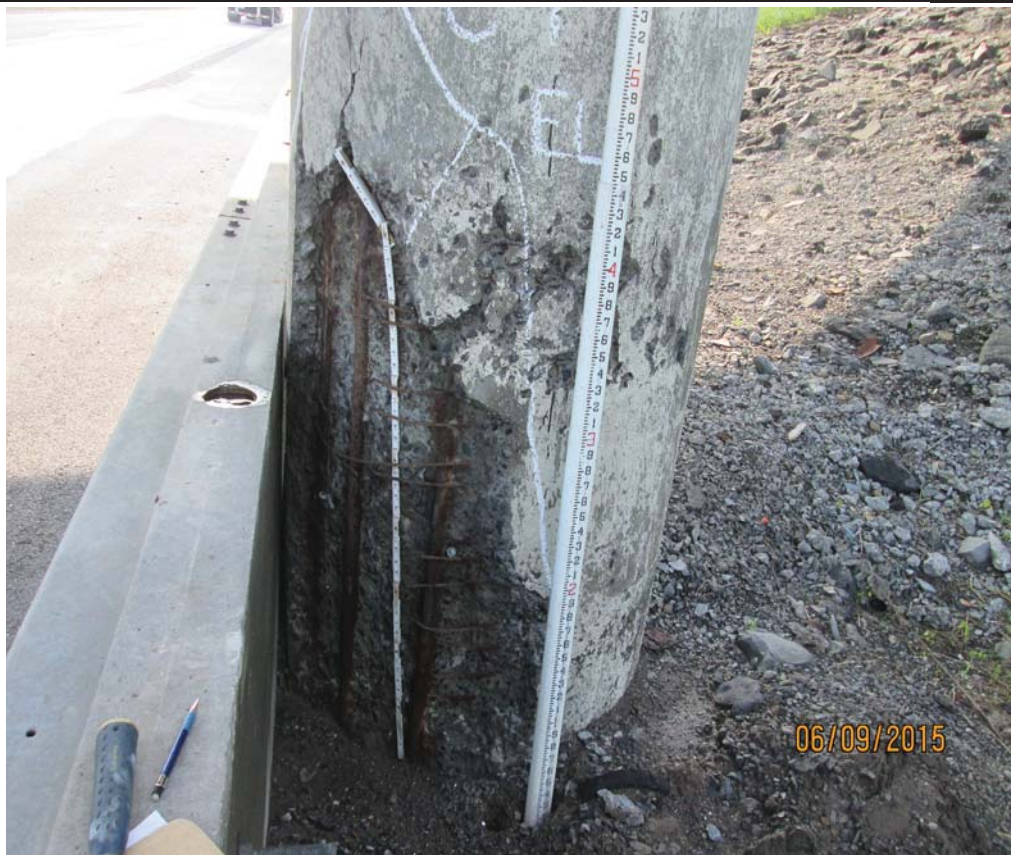
<b>Location:</b>	240.48-FLG-99-01-15P1C1EL.JPG	2
Pier 1, Column 1 from Left

<b>Description:</b>		
Two vertical bars are debonded over a height of 3.5', and the 18 exposed spiral ties are broken.		
<b>Reference:</b>		
FLAG #: 15-041

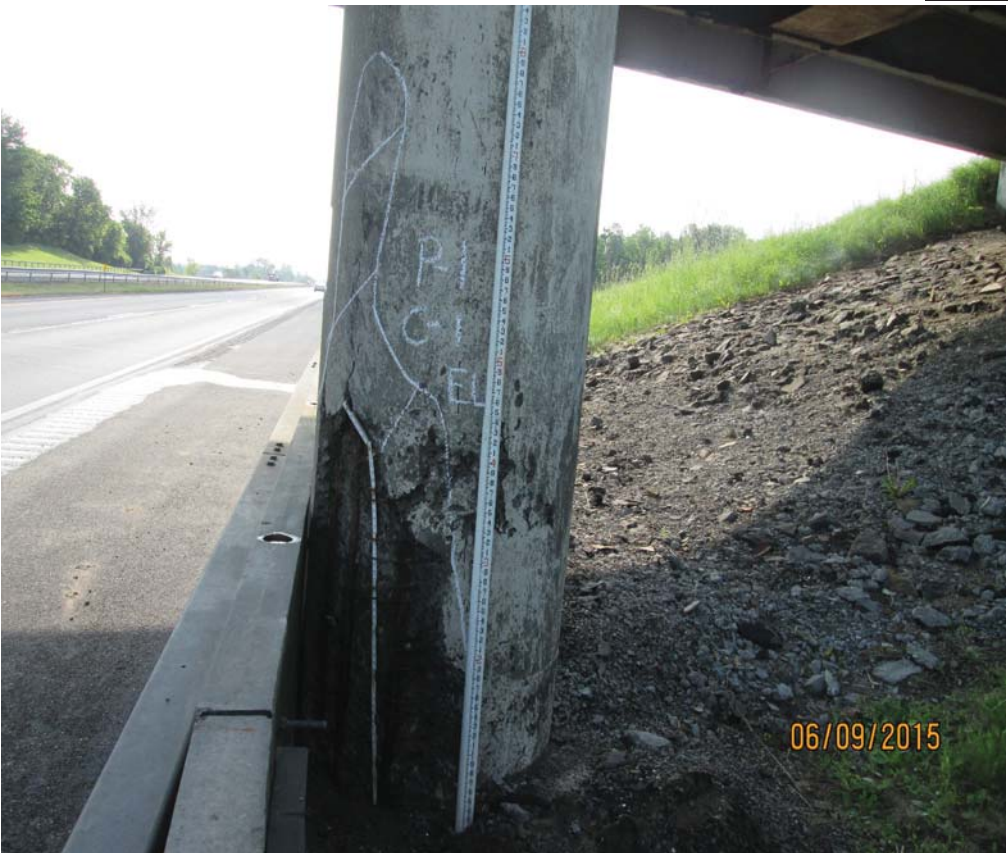
<b>Location:</b>	240.48-FLG-99-02-15P1C1EL.JPG	3
Pier 1, Column 1 from Left

<b>Description:</b>		
The 5.0' high spall extends 1' below the surrounding ground line.		
<b>Reference:</b>		
FLAG #: 15-041

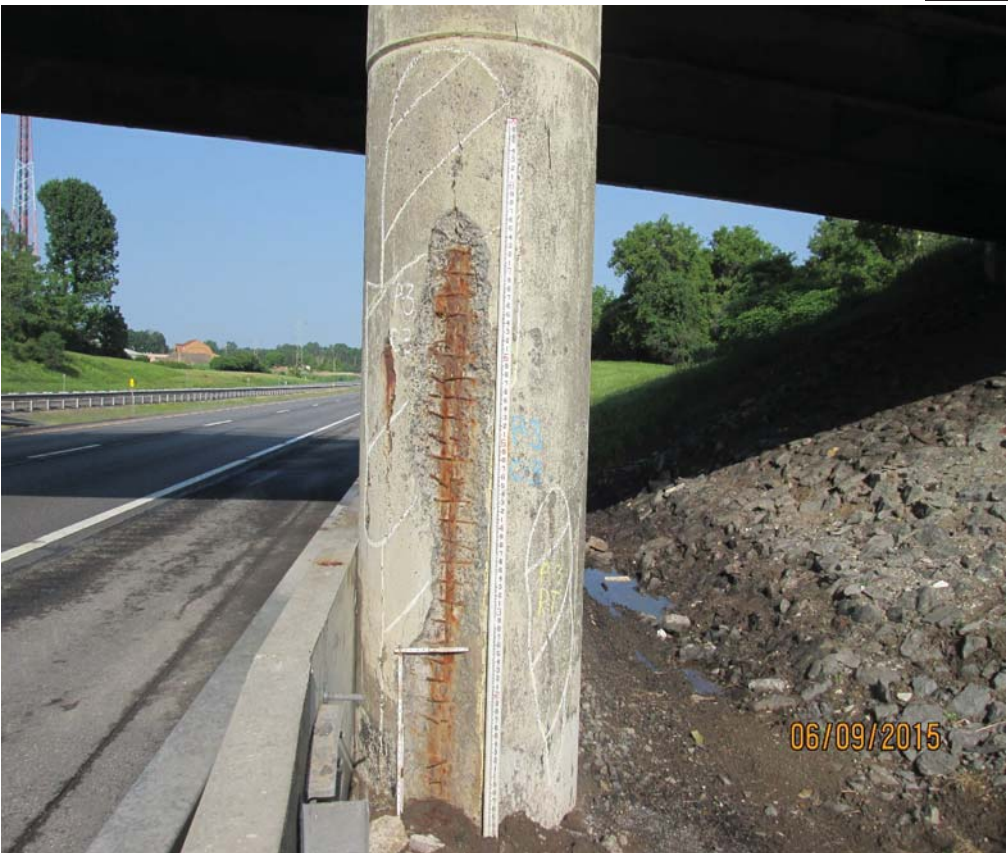
<b>Location:</b>	240.48-FLG-99-03-15P3C3Rt.JPG	4
Pier 3, Column 3 from Right

<b>Description:</b>		
The Right face of the Column has a 7.5' H x up to 1' W x 2" D spall with one exposed vertical bar and 30 exposed spiral ties, 13 of which are broken.		
<b>Reference:</b>		
FLAG #: 15-041

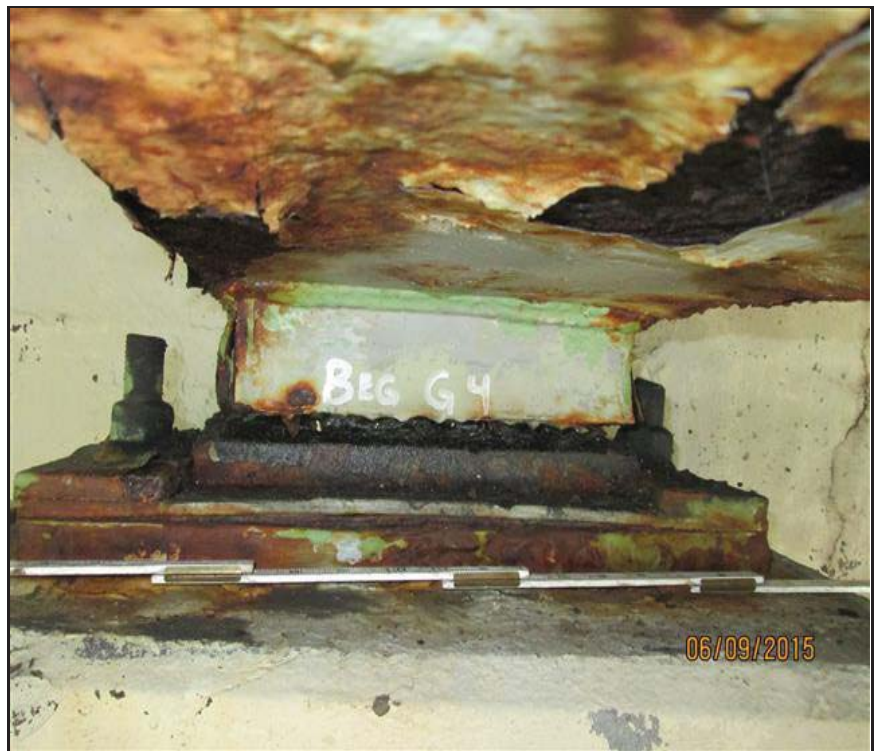
Location:	Photo Name:	Photo #:
Begin Abutment Bearing under Girder G4	240.48-349-24-00-15BrgG4B.JPG	3

Description(s):
<ul style="list-style-type: none"> <li>- The bronze sheet is bowed upward in the middle due to 1/4" thick pack rust. Thermal movement may be restricted.</li> </ul>

Reference:			
Form:	Item:	Item Desc:	Rate:
349	24	Bearings, Anchor Bolts, Pads (Begin)	4

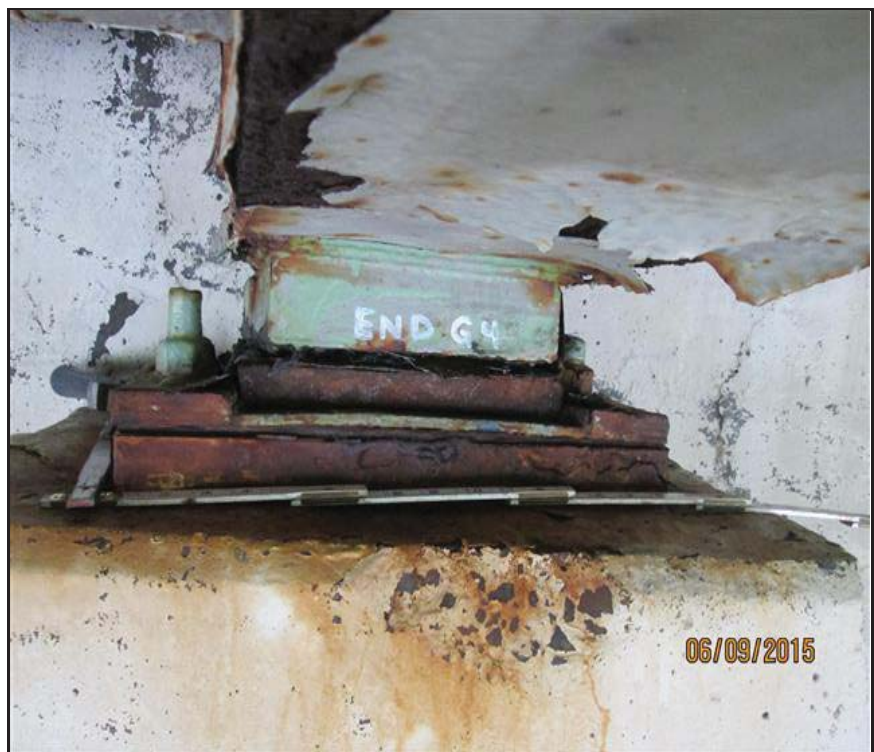
Location:	Photo Name:	Photo #:
End Abutment Bearing under Girder G4	240.48-349-25-01-15BrgG4E.JPG	4

Description(s):
<ul style="list-style-type: none"> <li>- The bronze sheet is bowed upward in the middle due to 3/8" thick pack rust. Thermal movement may be restricted.</li> </ul>

Reference:			
Form:	Item:	Item Desc:	Rate:
349	25	Bearings, Anchor Bolts, Pads (End)	4

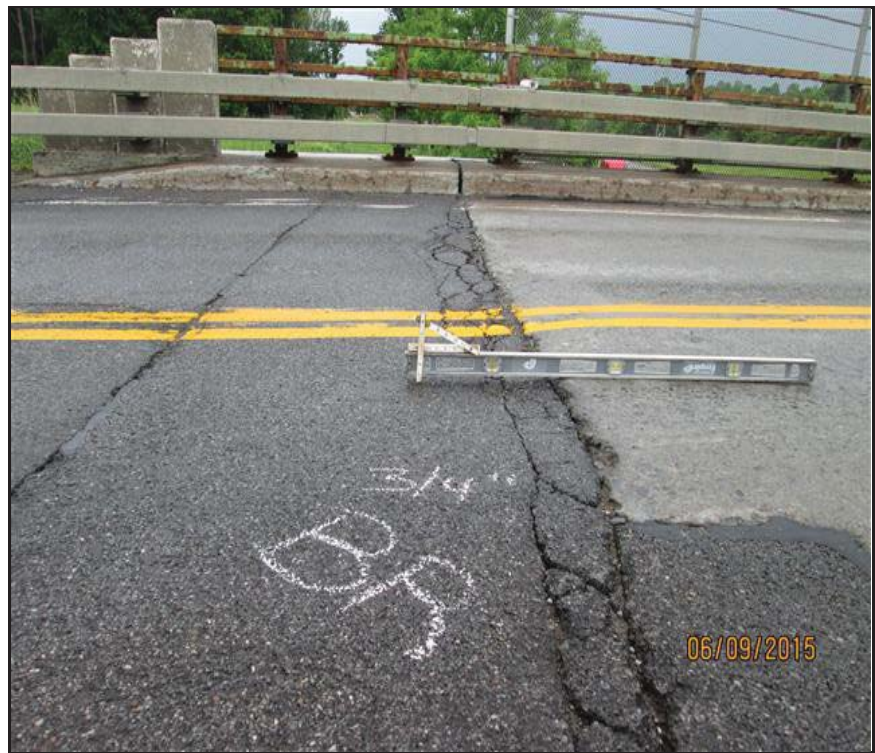
Location:	Photo Name:	Photo #:
Begin Approach from Right	240.48-349-55-00-15Set_BR.JPG	9

Description(s):
- Up to 3/4" settlement at the bridge, adversely affecting ride quality.
Reference:
Form: Item: Item Desc: Rate:
349 55 Settlement 4
349 57 Pavement 4

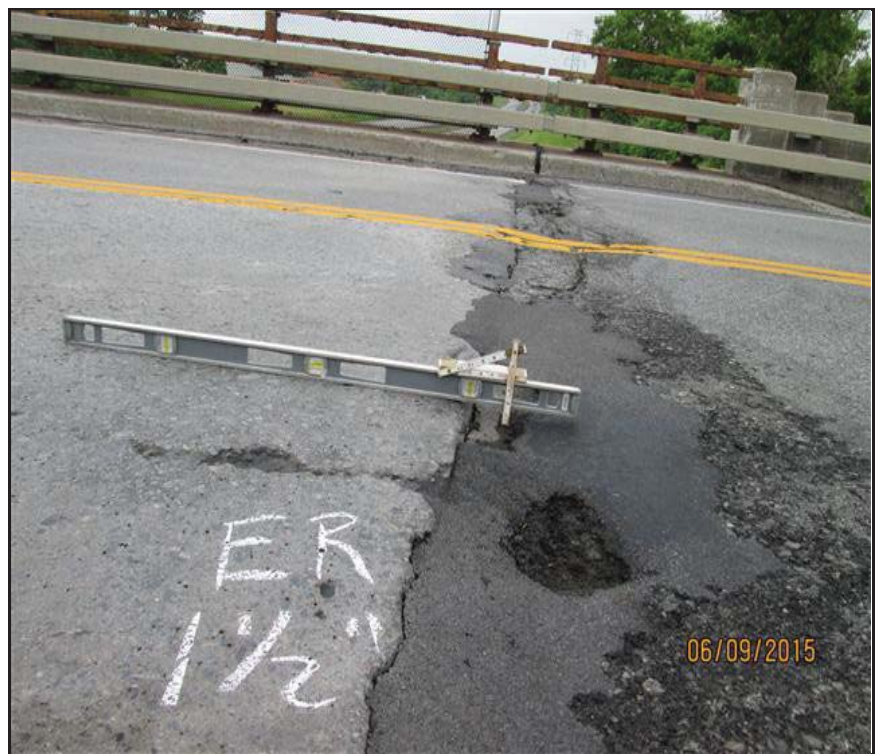
Location:	Photo Name:	Photo #:
End Approach from Right	240.48-349-55-00-15Set_ER.JPG	10

Description(s):
- Up to 1.5" settlement affecting the entire width of the roadway. Patchwork is uneven, ride quality is fairly rough over this joint transition.
Reference:
Form: Item: Item Desc: Rate:
349 55 Settlement 4
349 57 Pavement 4

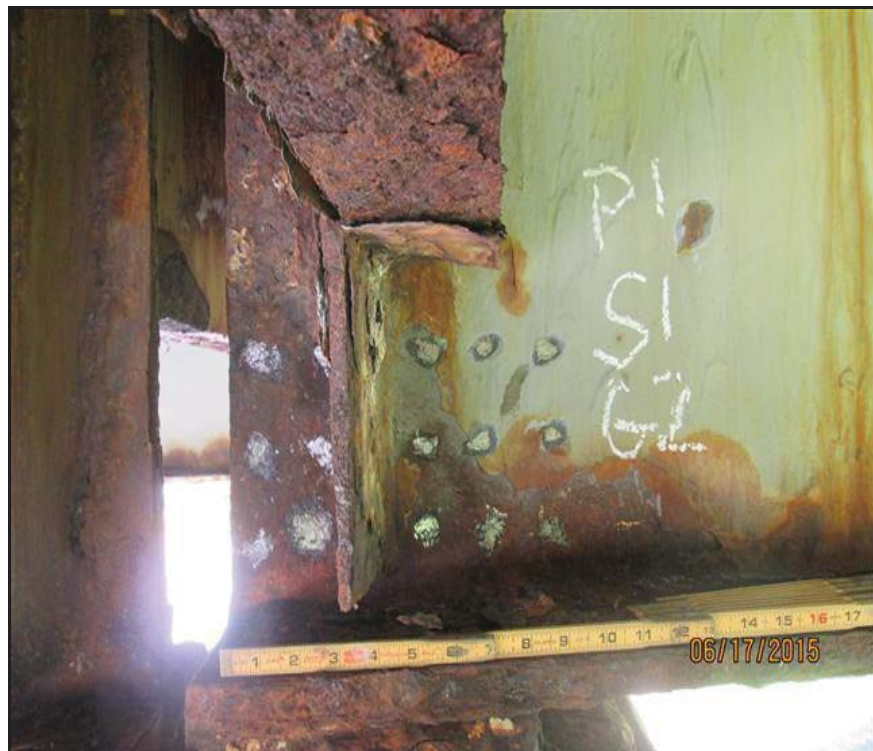
Location:	Photo Name:	Photo #:
Span 1, Girder G2 at Pier 1 from Left	240.48-350-28-02-15S1G2P1.JPG	22

Description(s):
- Complete paint failure has resulted in minor corrosion, with up to 14% section loss in the critical section over the bearing.

Reference:				
Form:	Item:	Item Desc:	Span:	Rate:
350	28	Primary Members	1	5
350	30	Paint	1	3

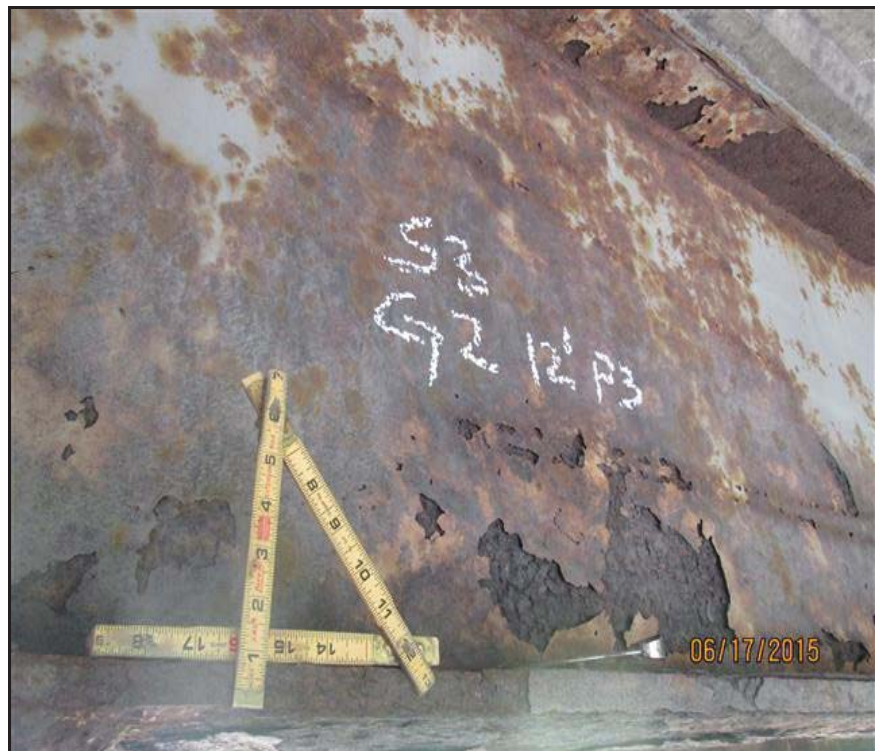
Location:	Photo Name:	Photo #:
Span 3, Girder G2 at 47' (Typical for Span 2 & 3 Interior Girders over the Shoulder)	240.48-350-28-06-15S3G2MS.JPG	24

Description(s):
- Complete paint failure has resulted in heavy corrosion, with 21% bottom flange section loss.

Form:	Item:	Item Desc:	Span:	Rate:
350	28	Primary Members	2-3	4
350	30	Paint	2-3	2

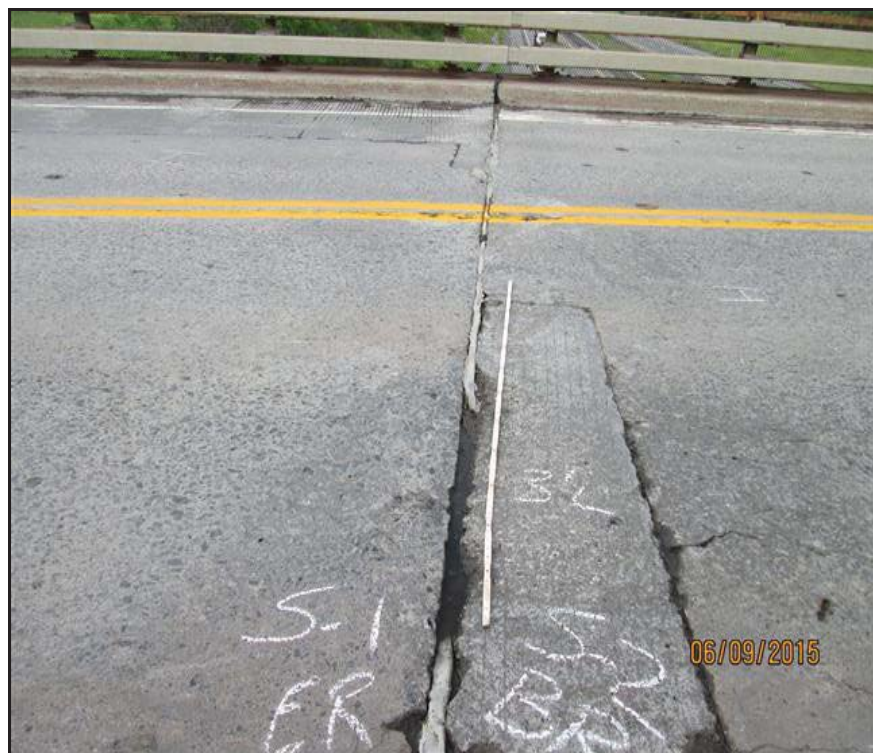
Location:	Photo Name:	Photo #:
Pier 1 Joint from Right	240.48-350-31-01-15Joint1.JPG	26

Description(s):
- Joint sealant material is missing over a 3' length.

Form:	Item:	Item Desc:	Span:	Rate:
350	31	Joints	1	3

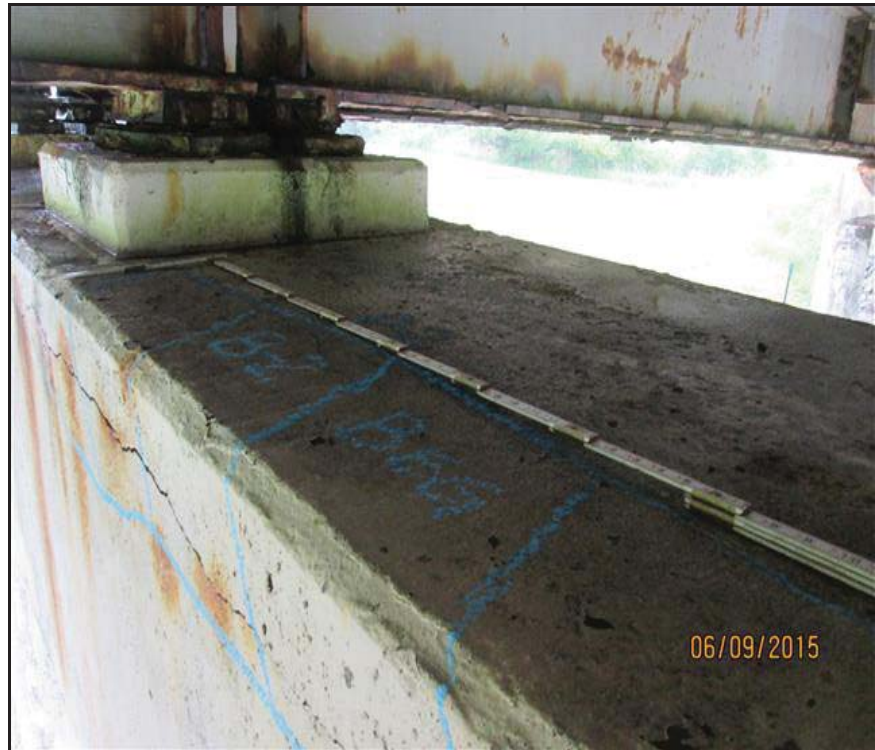
Location:	Photo Name:	Photo #:
Pier 3 Top of Cap in Bay 1 from Begin	240.48-350-35-03-15ToCB1B.JPG	36

Description(s):
- 6" deep top corner spall extending 10" into the top surface and up to 18" down the vertical face. The top corner longitudinal bar is exposed and debonded.
