BIN: 5516072 **MP:** 225.48

Feature Crossed: CR 53 MILLERS GROVE RD

New York State Thruway Authority - Bridge Inspection Report

2015 INSPECTION

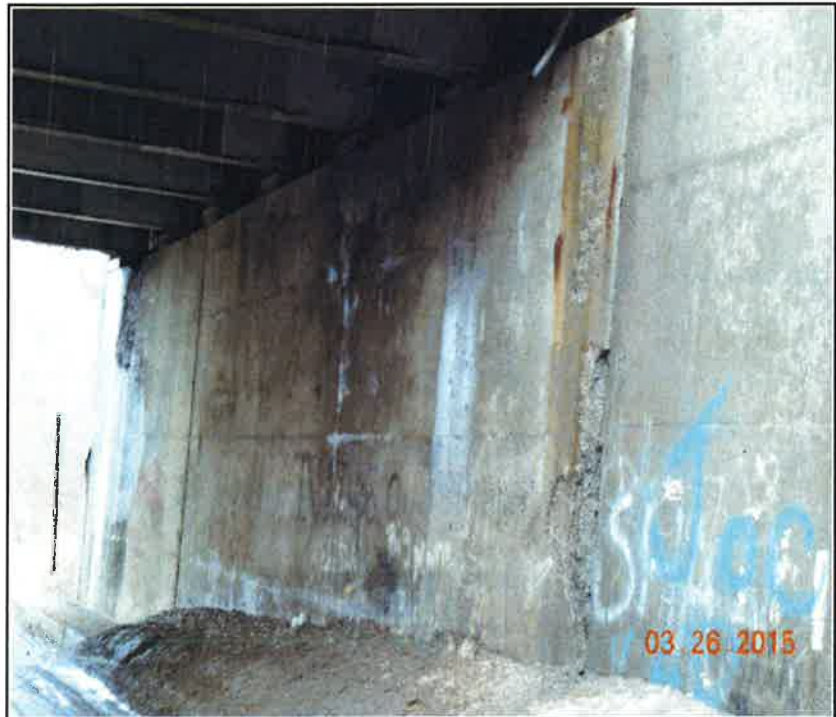
Saw & seal of asphalt over joint with deck was placed across only the passing lane at both joints; asphalt is transversely cracked atop the remainder of the joint area at both abutments. Both joints have leakage below causing deterioration; leakage is more extensive at begin in bays 1, 2, & 6 and at end in bays 1, 2, 3 & 6.

- Wet and stained due to joint leakage (typ of end joint).

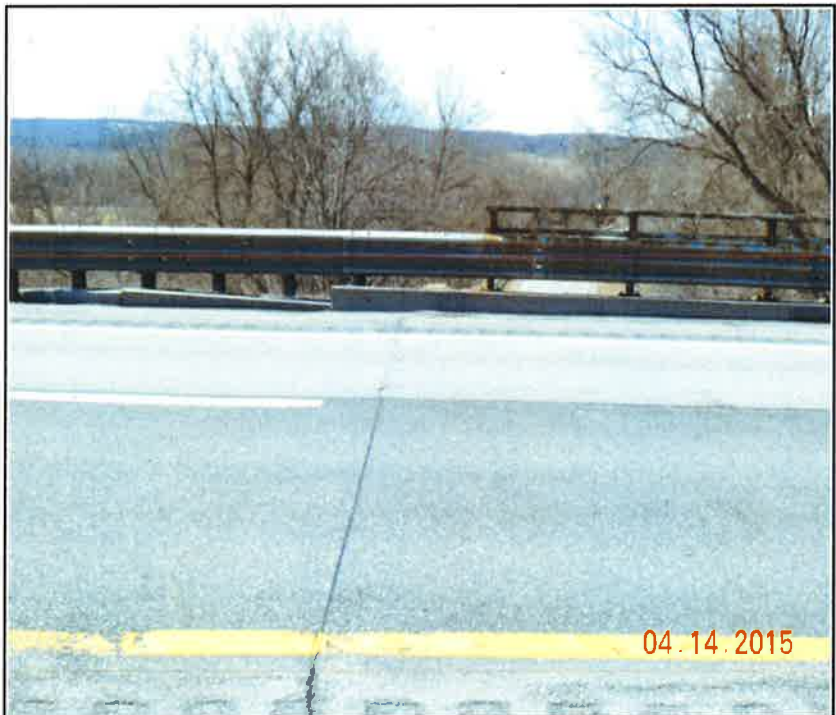
Location:	Photo Name:	Photo #:
Top of end joint.	225.48-349-23-00-15EnJtLt.JPG	2

Saw & seal of asphalt over joint with deck was placed across only the passing lane at both joints; asphalt is transversely cracked atop the remainder of the joint area at both abutments. Both joints have leakage below causing deterioration; leakage is more extensive at begin in bays 1, 2, & 6 and at end in bays 1, 2, 3 & 6.

- Saw cut placed only in passing lane, remainder of asphalt has transverse crack (typ of beg).

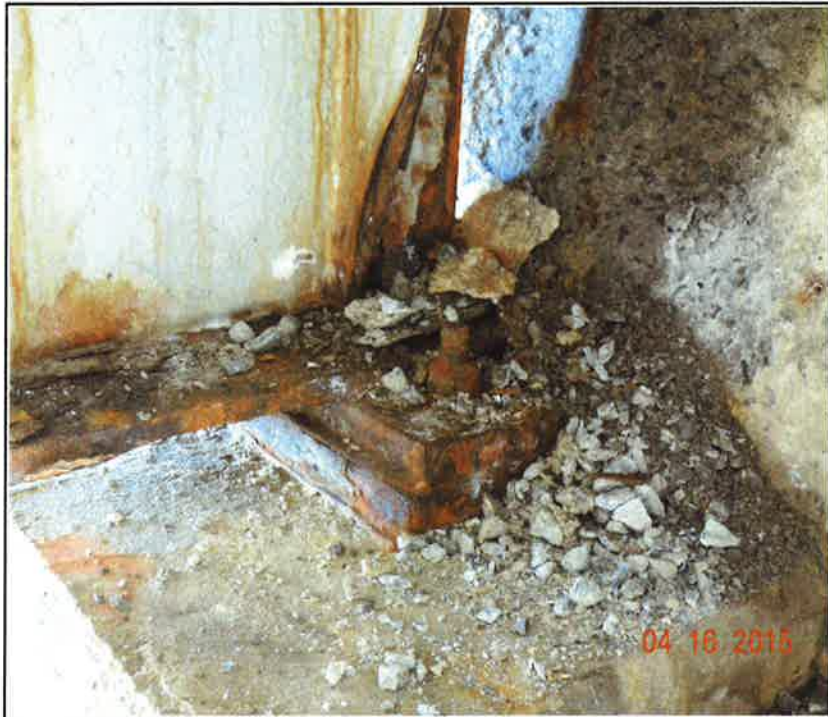
All begin fixed bearings have minor rusting, fascias are worst having minor delamination building. Begin right fascia bearing is buried with backwall spillings; bearing 1 has minor build up of spillings. Remainder of begin bearings are clear.

- Fixed bearing rusted and covered with backwall spallings.

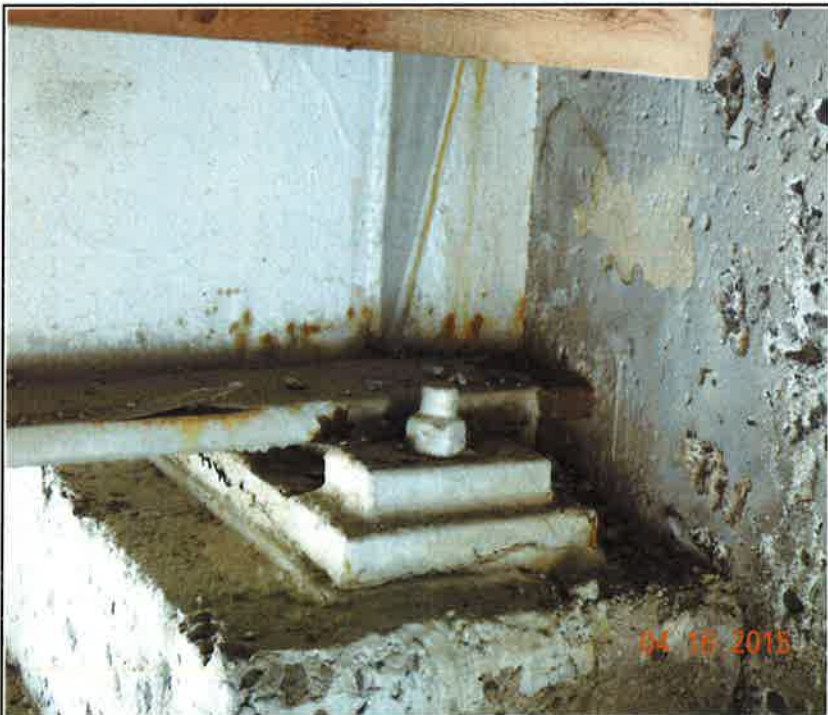
Location:	Photo Name:	Photo #:
End expansion bearing 3.	225.48-349-25-00-15EnBrg3.JPG	4

End expansion bearings 3 thru 7 are overextended and cantilevered off back of masonry plate by up to 1/2". End of girder 3 is in contact with backwall preventing further expansion of bearing.
End bearing 2 is even with back of masonry plate; end bearing 1 is in good position.
Bearing 7 is delaminated and appears frozen.

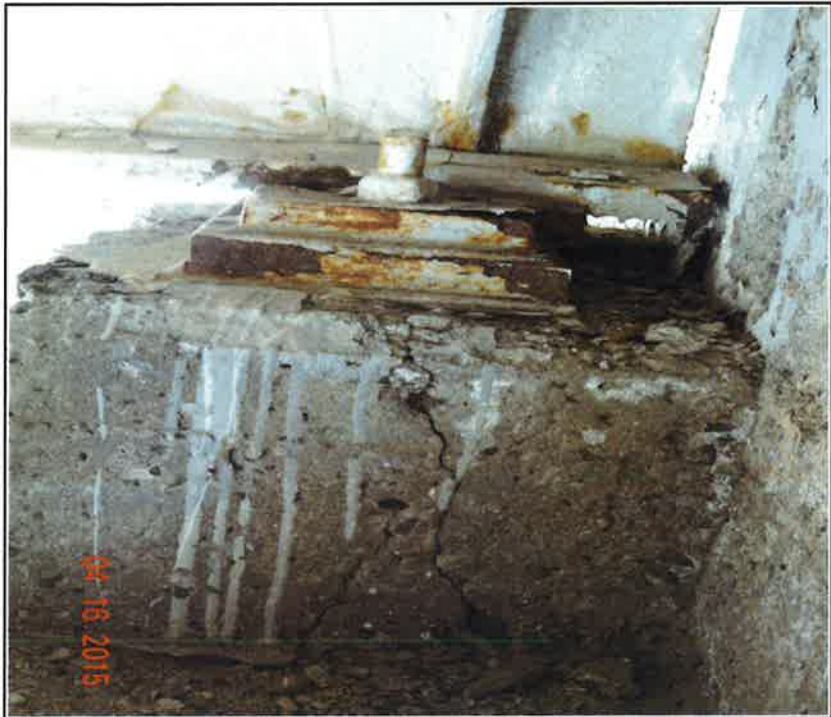
- Bearing overextended 1/2" beyond masonry plate.
- 1/16" open vertical crack at anchor bolt; concrete rings solid.

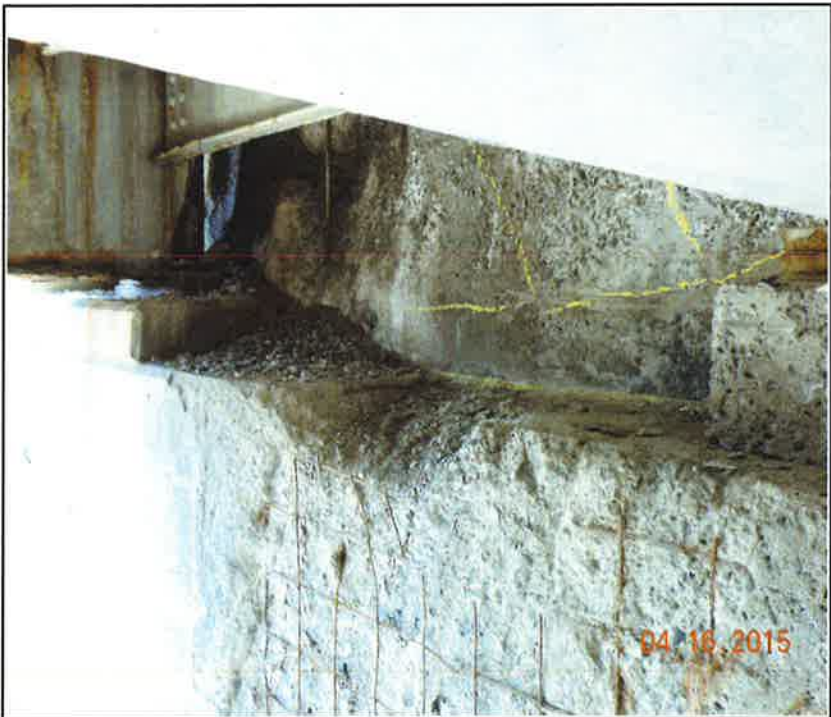
Location:	Photo Name:	Photo #:
Begin seat, bay 6.	225.48-349-26-00-15Bay6_.JPG	6

Begin seat area in bay 6 is partially covered with wet backwall spillings. Where exposed, top of seat is hollow, soft, and spalled 3" to 4" deep; spalling extends to 5" deep along front edge of seat in bay 6. Remainder of seat and all begin pedestals are solid having areas of minor surface scale.

- Seat area soft and spalled to 5" deep.

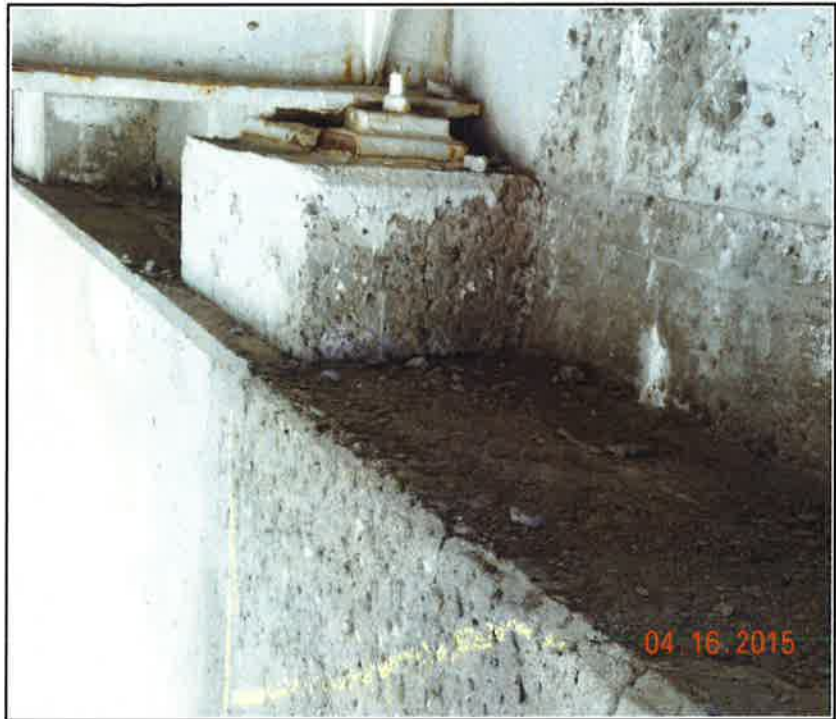
End seat between pedestals 3 & 4 is surface scaled, hollow and spalling 1 1/2" deep. Front edge of seat for a 4' length at pedestal 6 (incorrectly noted at ped 5 in 2013) is cracked with minor hollowness. End pedestal 4 on right side and end pedestal 6 on right side each have a hairline to 1/16" open vertical crack extending from anchor bolt, concrete remains solid. End pedestals 4 & 5 both have hairline vertical crack on left side at 1" +/- from backwall. Remainder of seat and end pedestals are good, having minor areas of surface scale/spall.

- Seat area cracked with minor delamination; vertical crack in pedestal.

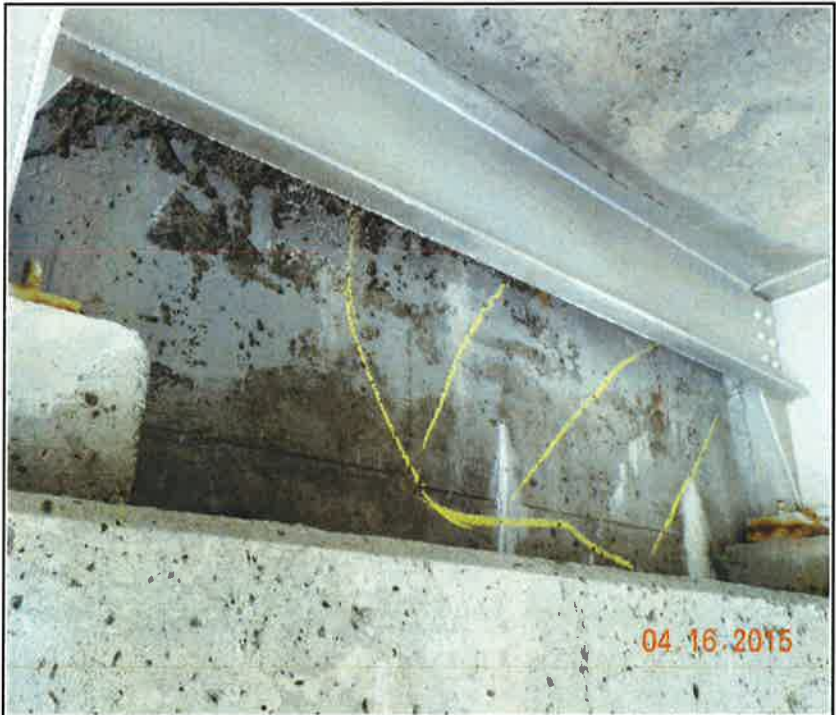
Location:	Photo Name:	Photo #:
Begin backwall, bay 2.	225.48-349-28-00-15Bay2_.JPG	8

Begin backwall has minor honeycombed concrete in upper 1/2 +/- of all bays with random vertical cracks and areas of hollowness as follows: bay 1, 10% hollow with minor 1" deep spalling behind G1; bay 2, 60% hollow with 1" deep spalling to 6" wide along top edge; bay 3, 40% hollow; bay 4, 15% hollow; bay 5, 0; bay 6 has honeycombed concrete with efflorescence and hollowness throughout, the upper 3/4 for a 4 1/2' length behind G7 is spalled 6" to 9" deep (total depth of backwall is 15") with reinforcing bars exposed; remaining concrete in spall area is wet and soft.

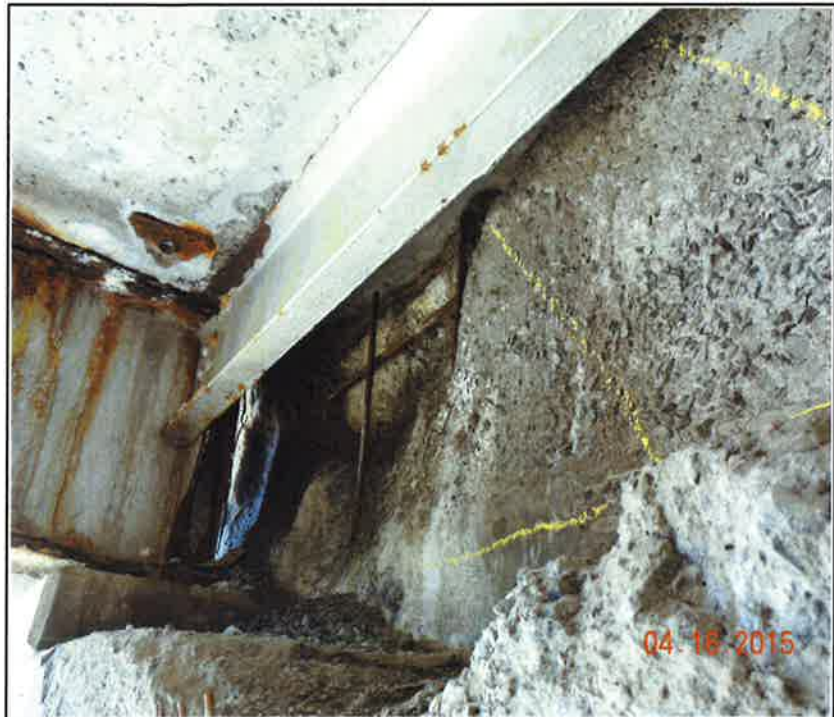
- Soft, severely spalled area of backwall.

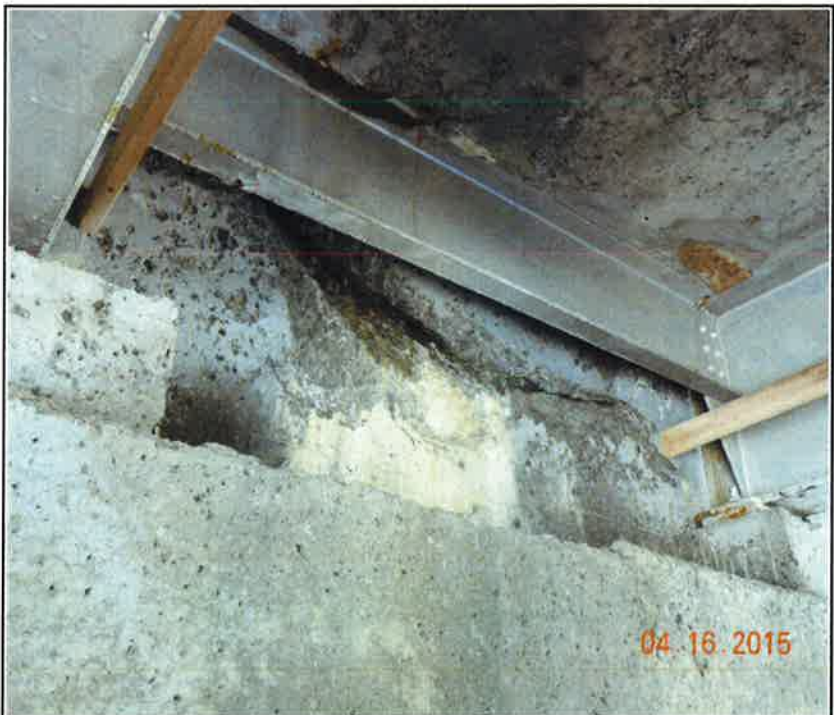
Location:	Photo Name:	Photo #:
End backwall, bay 3.	225.48-349-29-00-15Bay3_.JPG	10

End backwall, bay 3 has a horizontal/diagonal crack/fracture near mid-height with concrete spalled to 18" wide x 4" deep along crack; area above crack is hollow.
Remainder of end backwall has minor honeycombed concrete throughout bays 3, 4, 5 & 6 and random hairline vertical cracks.
Backwall has full height hairline to 1/8" open vertical crack above construction joint in stem just left of pedestal 5. Additionally, at 3" to 6" from each side, backwall has a vertical/diagonal crack open 1/4" to 1/2".

- Diagonal crack/fracture of backwall.

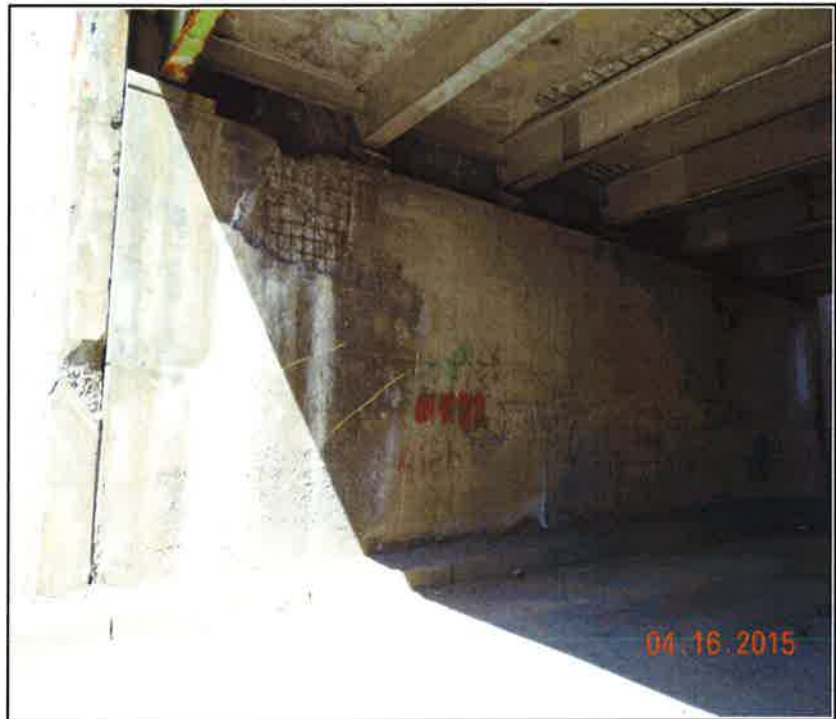
Begin stem has map cracked/hollow concrete leaching efflorescence full height for 5' to 9' wide at left side. 15' wide, full height at right side has honeycombed concrete with upper half leaching efflorescence, very hollow, soft and spalling to 5" deep. Remainder of begin stem is solid with random hairline vertical cracks.

Begin right wingwall has cracking with efflorescence and hollow concrete full height for 4' to 5' wide adjacent to stem; remainder has fine damp tight pattern cracking for 70% area. Begin left wingwall is okay.

Description(s):
<ul style="list-style-type: none"> - Delaminated, very soft/spalled area of concrete. - Begin right wingwall is cracked/delaminated adjacent to stem.

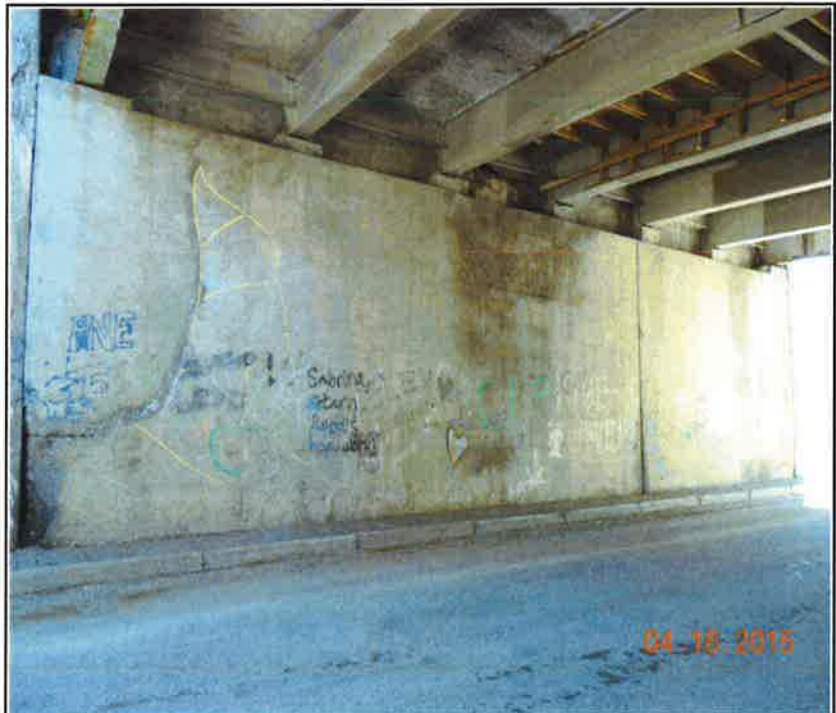
Location:	Photo Name:	Photo #:
End stem, left half.	225.48-349-31-00-15EnStem.JPG	12

Lower 6' of end stem is very hollow for 10' at left side with 3" to 4" deep spalling for 1' adjacent to end left wingwall. Delaminated concrete to 3' wide extends full height adjacent to previous repair at both sides. 6sf area of delaminated concrete is also present at base adjacent to construction joint at left of G5. Remainder of end stem is solid with minor areas of honeycombed concrete, worst area is upper 1/3 between pedestals 3 & 4.

Description(s):
<ul style="list-style-type: none"> - Delaminated concrete at base and full height adjacent to repair.

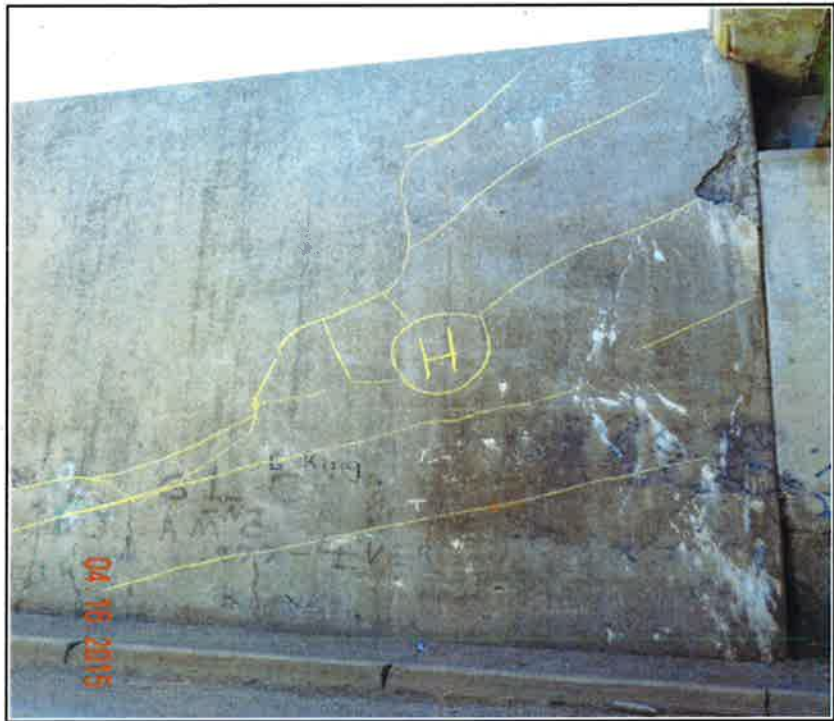
End left wingwall has cracking with hollow to very hollow concrete for 80% +/- of its area; 3' to 6' wide adjacent to stem is leaching efflorescence and starting to spall 2" to 3" deep.
End right wingwall has delaminated concrete for 60% +/- of its area. 4' to 6' wide full height adjacent to stem has cracking with efflorescence and very hollow concrete; upper 6' in this area is spalled to 4" deep with reinforcing exposed.

- Delaminated across 80% of face; spalling adjacent to stem.

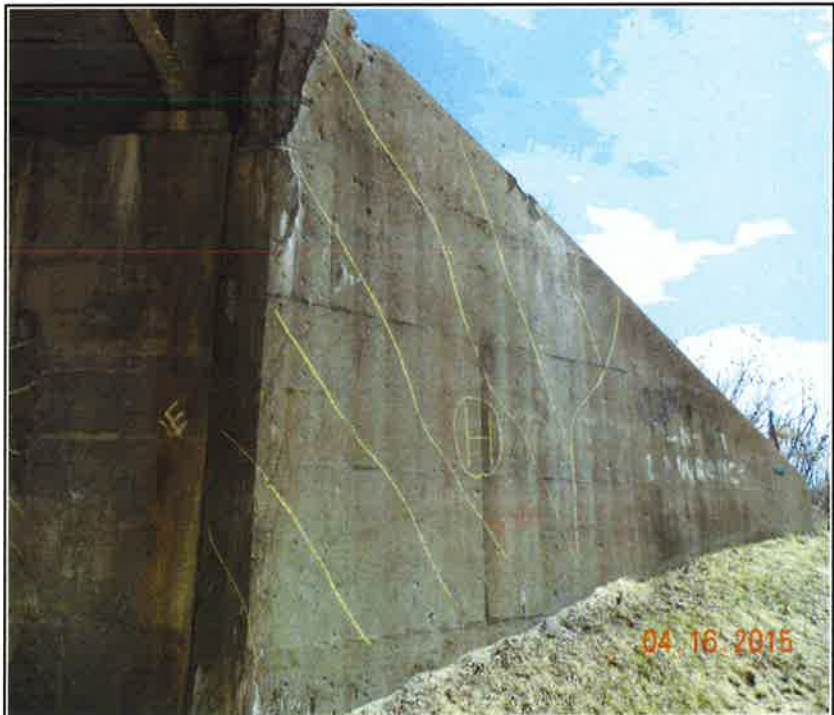
Location:	Photo Name:	Photo #:
End right wingwall.	225.48-349-41-00-15EnRtWW.JPG	14

- Delaminated across 60% of face; spalling at top adjacent to stem.

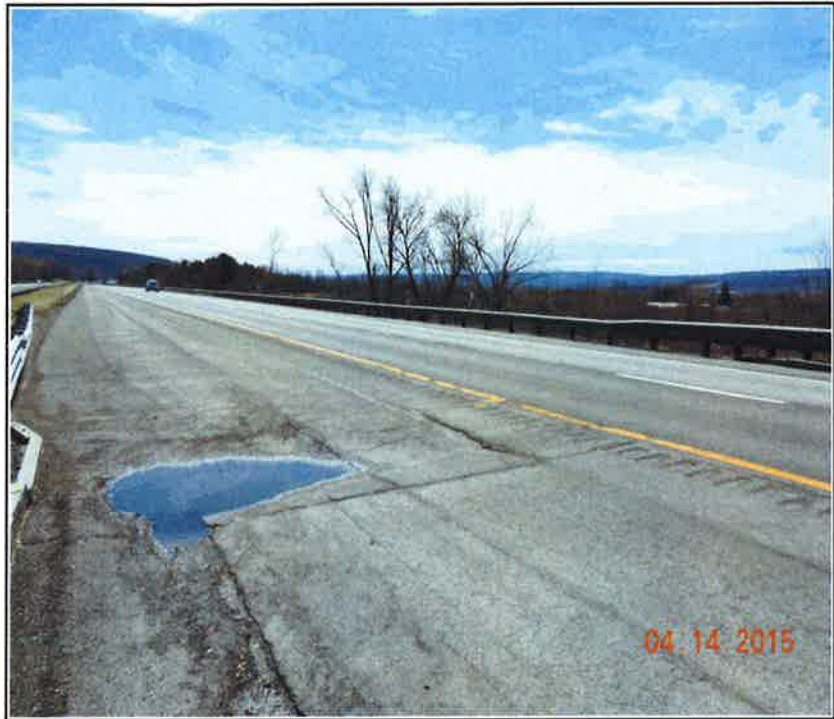
Median shoulder areas of both approaches are settled 3" to 4" adjacent to bridge allowing water to pond; end approach is slightly worse having a 10' diameter depressed area allowing water ponding to reach within 5' +/- from edge of passing lane. Very minimal settlement is evident in travel lanes. Per 2014 inspection manual, condition of approach curb is now included with the rating of curb element on the structure.

- Depressed area which ponds water.

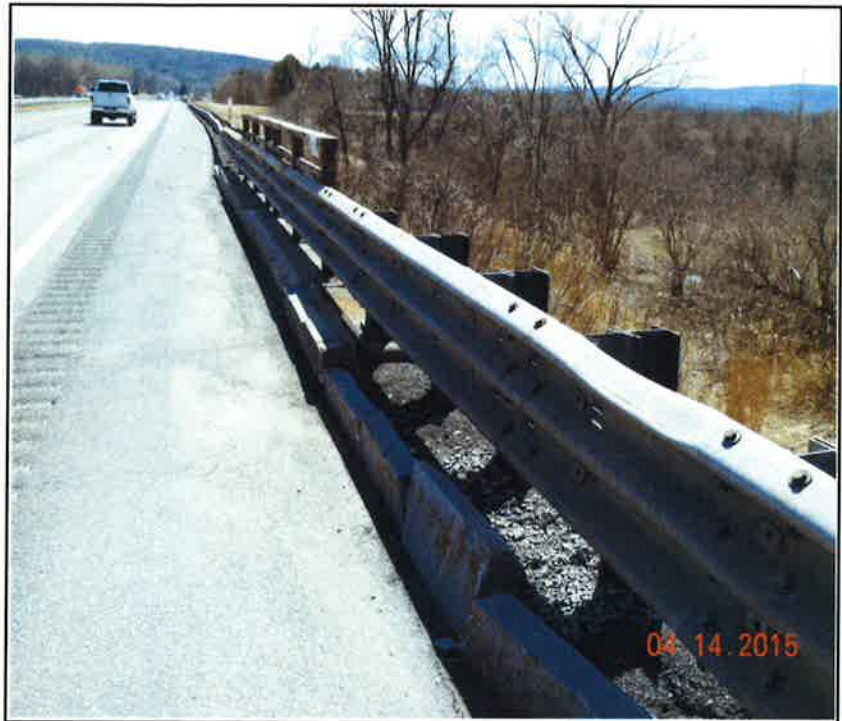
Approach curbs are settled, displaced, and uneven to varying degrees in all quads. Begin right is worst as first 6' section of curb adjacent to bridge is broken, separated 3", and very loose in place.
Granite curb on both sides of bridge remains solidly in place.

- Approach curbs settled, displaced, and loosely in place.

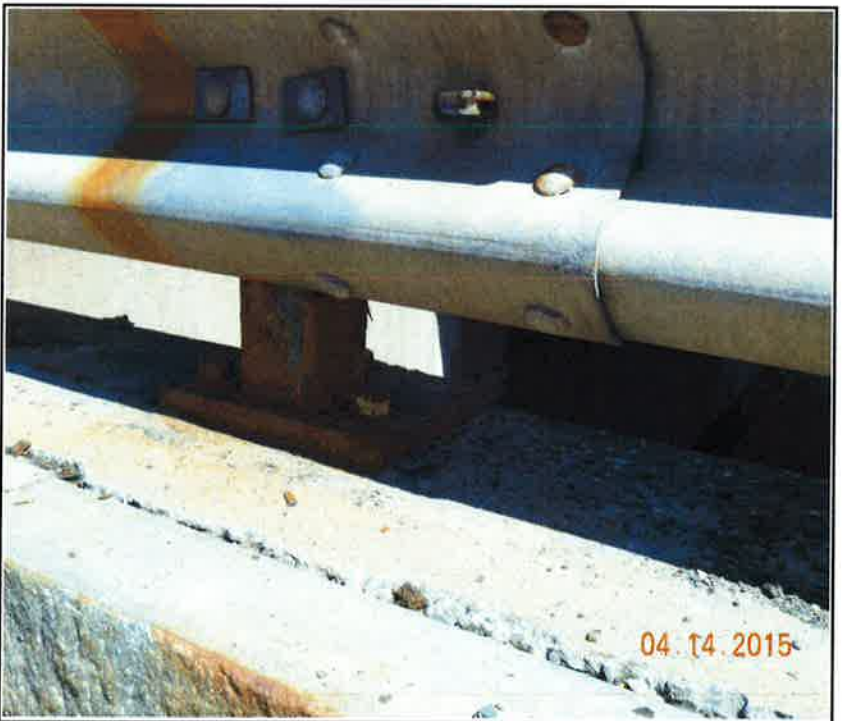
Location:	Photo Name:	Photo #:
Left railing, post 3.	225.48-350-22-00-15LtP3Rp.JPG	17

- Split corner of post repaired.

☒ Bridge Rail Split left railing post 3 repaired by
maintenance personnel.

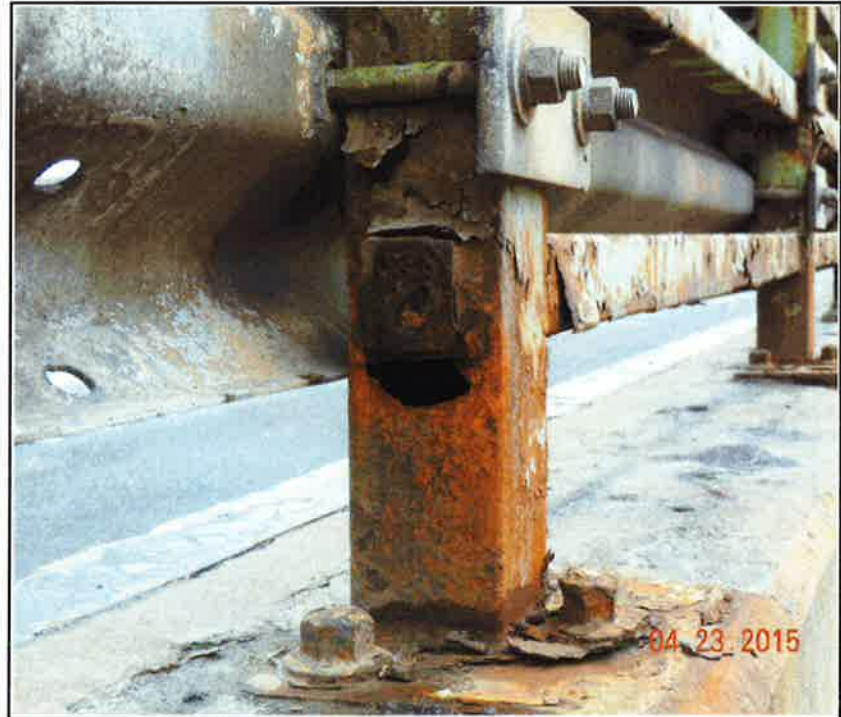
Location:	Photo Name:	Photo #:
Right railing, post 1.	225.48-350-22-00-15RtP1_.JPG	18

Rail and posts of 4 rail bridge rail have areas of pitting and delamination. Worst post locations are outside leg of right railing posts 3, 5, & 6 having pitting to 1/8" deep resulting in 50% loss to outside leg of these posts. Worst rail location is end 18" of right side top rail which is rusted completely through.
Right post 1 has a 1 1/2" x 3" rust through hole located on begin face at 5" above base just below bottom rail end cap.
Previous split post at left railing post 3 has been weld repaired.
Post remains bulged at base.

Description(s):
- 1 1/2" x 3" rust through hole near base of post.

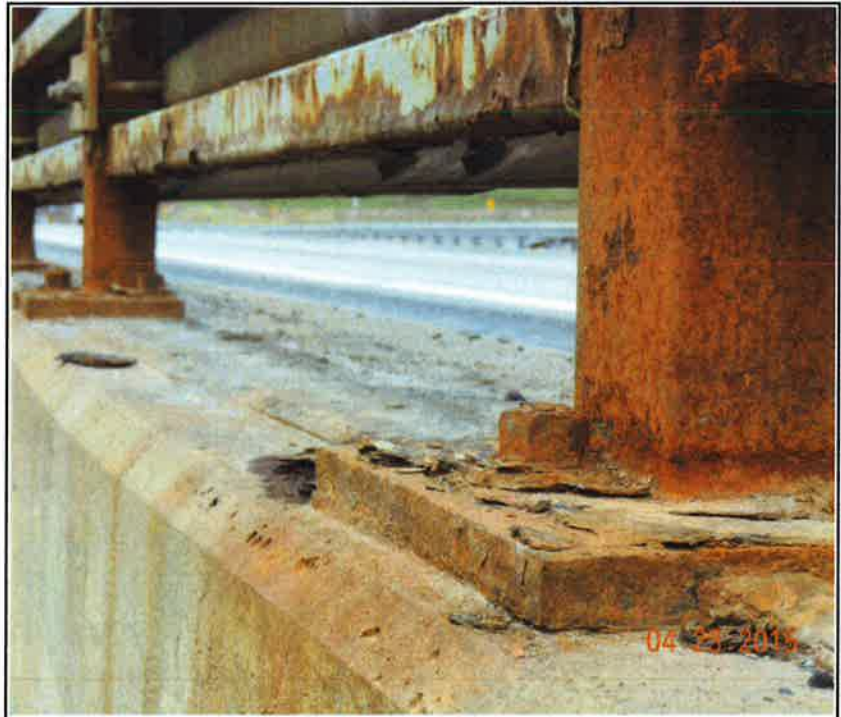
Location:	Photo Name:	Photo #:
Right railing, post 6.	225.48-350-22-00-15RtP6Pt.JPG	19

Description(s):
- Pitted at base; 50% section loss to outside leg of post (typ of right posts 3 & 5).

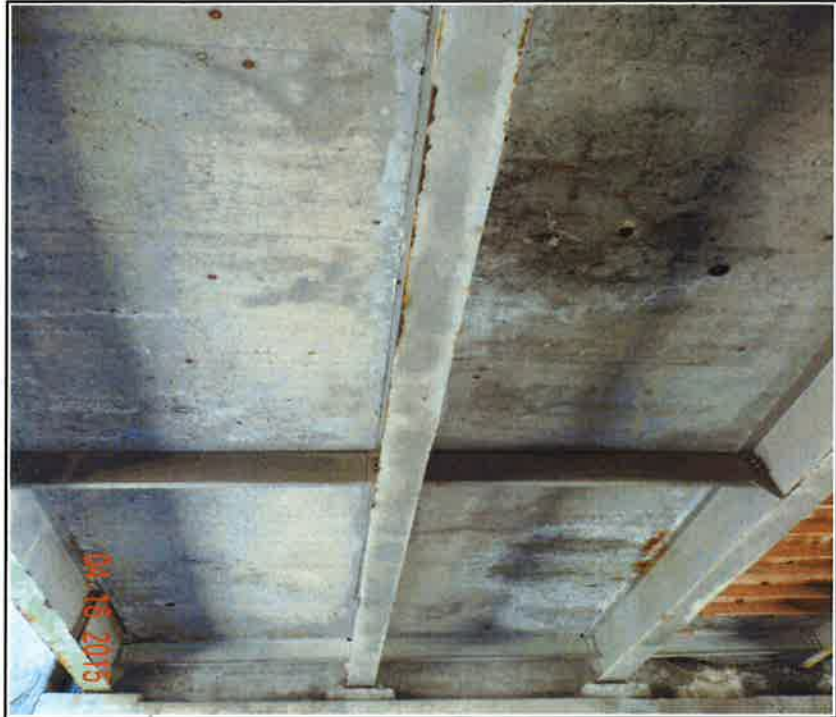
70% +/- of overall deck area has damp and discolored concrete with cracking and efflorescence. Bays 1, 3, 5 & 6 are worse with deterioration full length of bridge. Bays 4, 5, & 6 have extensive areas of 2" +/- deep spalling with delaminated reinforcing bars exposed; worst are full length for 1' to 3' wide along each side of G5 top flange and a 15sf area near midspan of both bay 5 & bay 6. Previous small delaminated area near midspan of bay 5 has been removed by maintenance personnel.
Bay 3 has wood shoring installed to prevent deteriorated loose deck concrete from falling onto traffic, timbers are becoming discolored from water penetration.
Water and efflorescence are actively leaking along full length of right fascia girder top flange. Rusting and deck leakage is also evident along top flange for full length of G1 and end half of G3. See deck sketch.
Deck actively pumps under load causing impact to and deflection of girders. Full length of right 3 girders is worst where areas of deck spall expose up to 1/4" gaps between deck and girder top flanges. Plans indicate no shear studs.

- Chalky, damp, discolored areas of deck leakage.

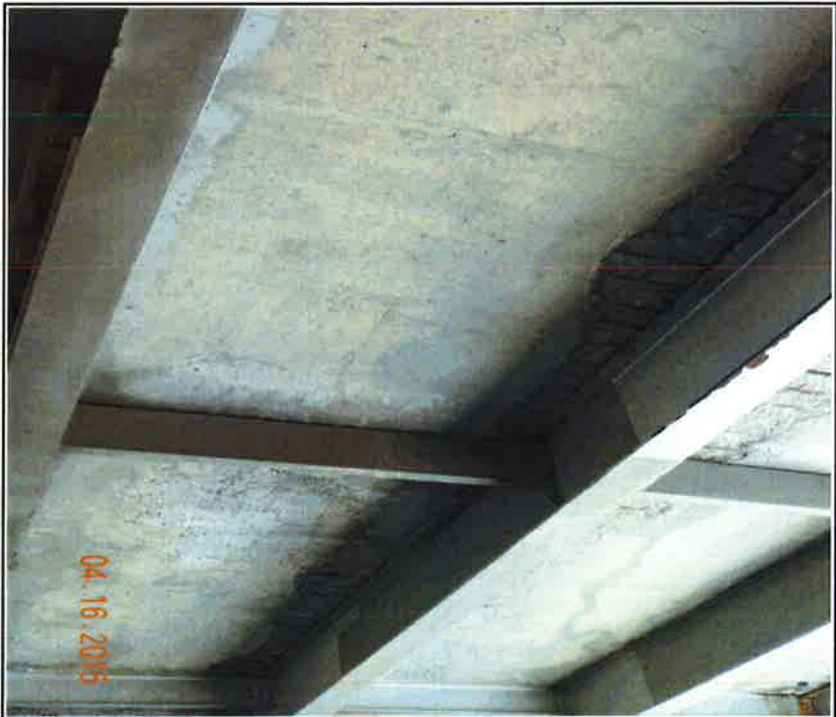
Location:	Photo Name:	Photo #:
Underside of deck, bay 4 along G5.	225.48-350-27-00-15Bay4G5.JPG	21

- Spalled deck along G5 due to leakage.

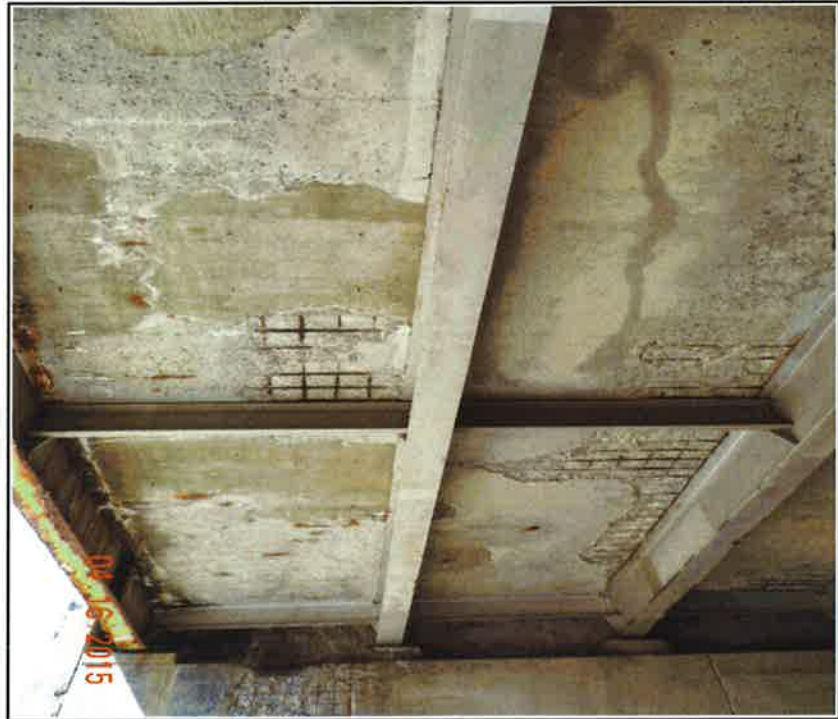
Paint failure with surface rust and delamination with minor section loss along fascia girder flanges and lower areas of webs. Interior girder flanges in areas of deck leakage have paint failure and minor surface rust, minimal section loss. 5% to 10% overall paint failure. Right fascia girder is worst having 70% paint failure to flanges and outside of web.

- Deteriorated areas of deck; active water/efflorescence along G7 top flange.
- Fascia girder has significant paint failure; 5% paint failure elsewhere.

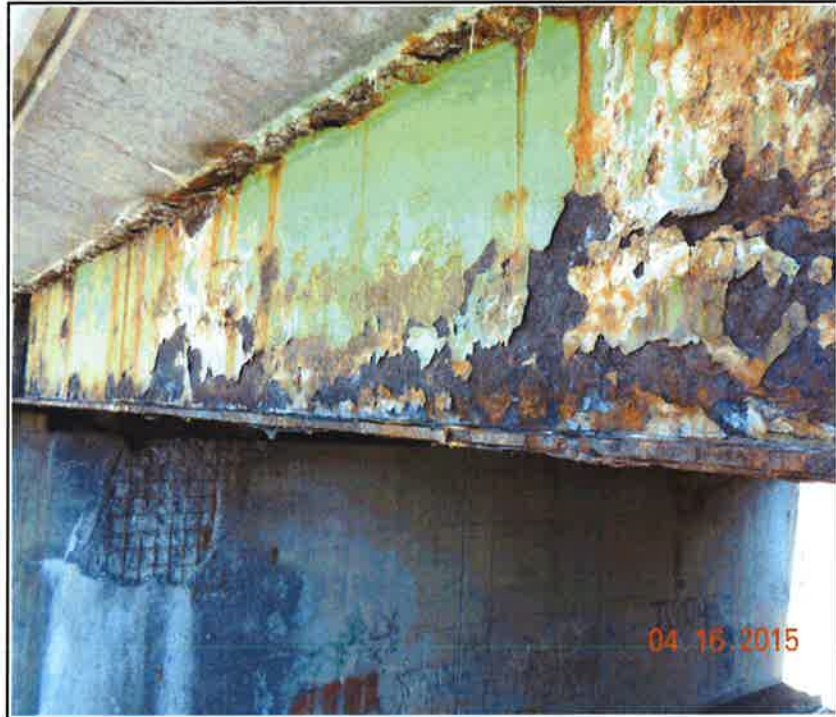
- Delaminated girder; 15% loss to outside leg of bottom flange.
- 70% paint failure to outside of girder.

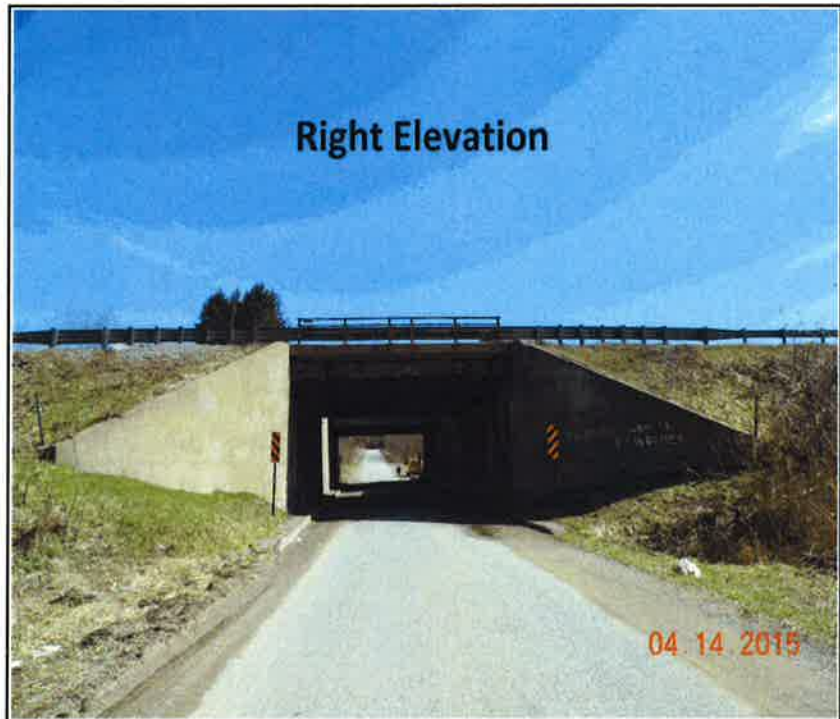
Description(s):
- New horizontal clearance markers on existing posts.
