Asbestos Containing Material Roof Survey

The Angola Service Center Angola, New York

Prepared for the:
New York State Thruway Authority
Department of Engineering

December 7, 2009

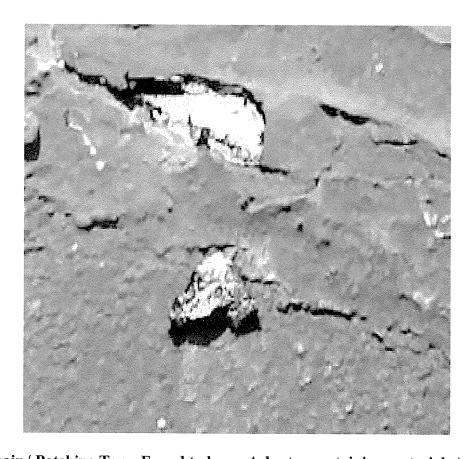
Sample #9 - Patching / Repair Tar was found to be positive for containing asbestos by PLM analysis. Patching / Repair Tar should be removed and disposed of as asbestos waste.

Sample #9 Repair / Patching Tar – Found to be an Asbestos containing material. Approximate quantity of material located on the roof is less than 10 square feet.
