LIMITED INSPECTION FOR ASBESTOS-CONTAINING MATERIALS

**Sloatsburg and Modena Service Areas
“Exterior Roof Renovation Projects”**

Project #Q11-6611

November 9, 2011

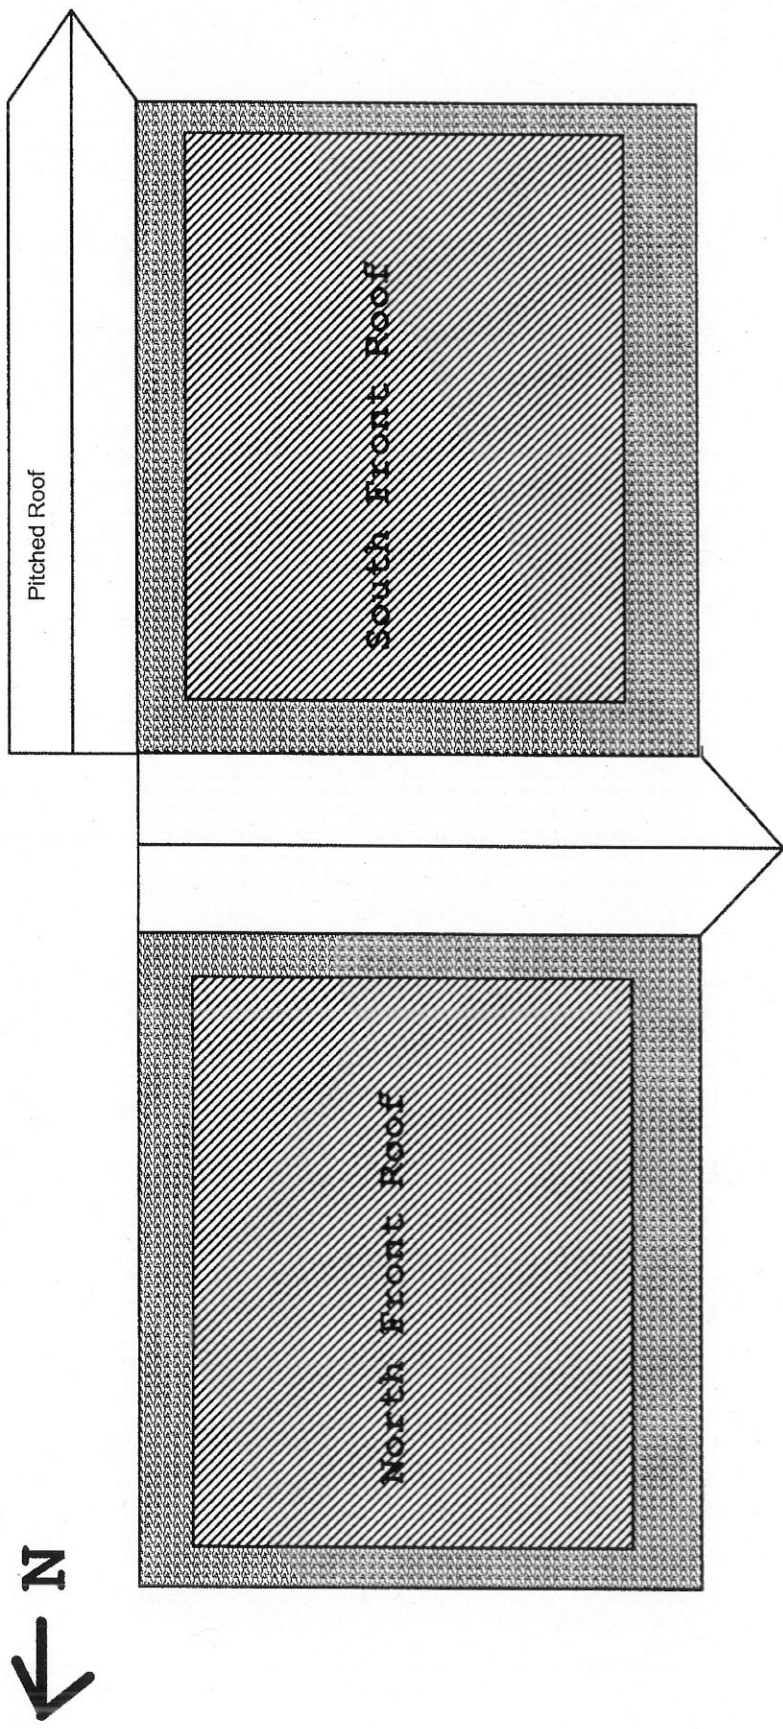
NYS THRUWAY AUTHORITY
 SLOATSBURG SERVICE AREA
 ** APPROX. FRONT ROOFS ACM LOCATIONS **

Throughout Roofs (Lower, North & South)	ACM Tar, on Metal Vent Pipes and Flues (12)	12 SF (total)	No	Good
Throughout Lower Roof	ACM Tar, on Wooden Stanchions	100 SF (total)	No	Good
Throughout Roofs (Upper, Lower, North & South)	ACM Flashing Tar, on Metal Parapet Wall Flashing at seams	150 SF (total)	No	Good

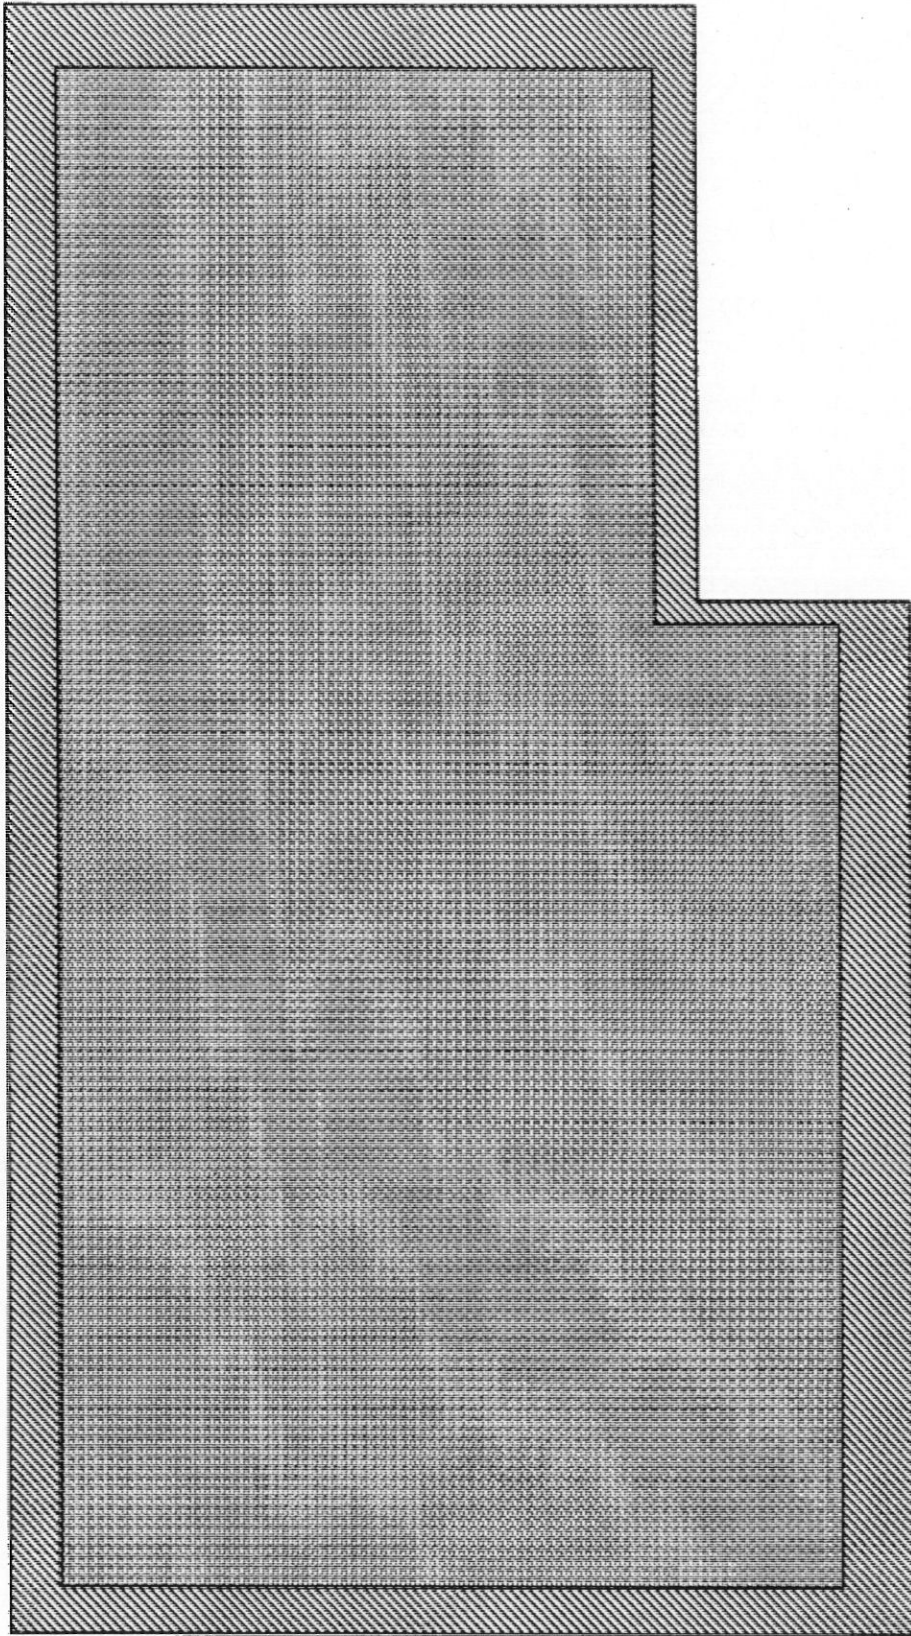
NYS THRUWAY AUTHORITY
MODENA SERVICE AREA
** APPROX. ROOF ACM LOCATIONS **

Throughout Roof	ACM Tar, on Metal Vent Pipes (9)	9 SF (total)	No	Good
Throughout Roof	ACM Caulk, on Metal to Brick & Mortar Façade Perimeter Parapet Walls	200 LF (total)	No	Good
