**PRE-RENOVATION ASBESTOS ASSESSMENT and BULK SAMPLE
RESULTS REPORT**

**SENECA SERVICE AREA
NEW YORK STATE THRUWAY AUTHORITY
DESIGN OF RENOVATIONS D212762
ONTARIO COUNTY, NEW YORK**

MAY 2000

WATTS ENGINEERS

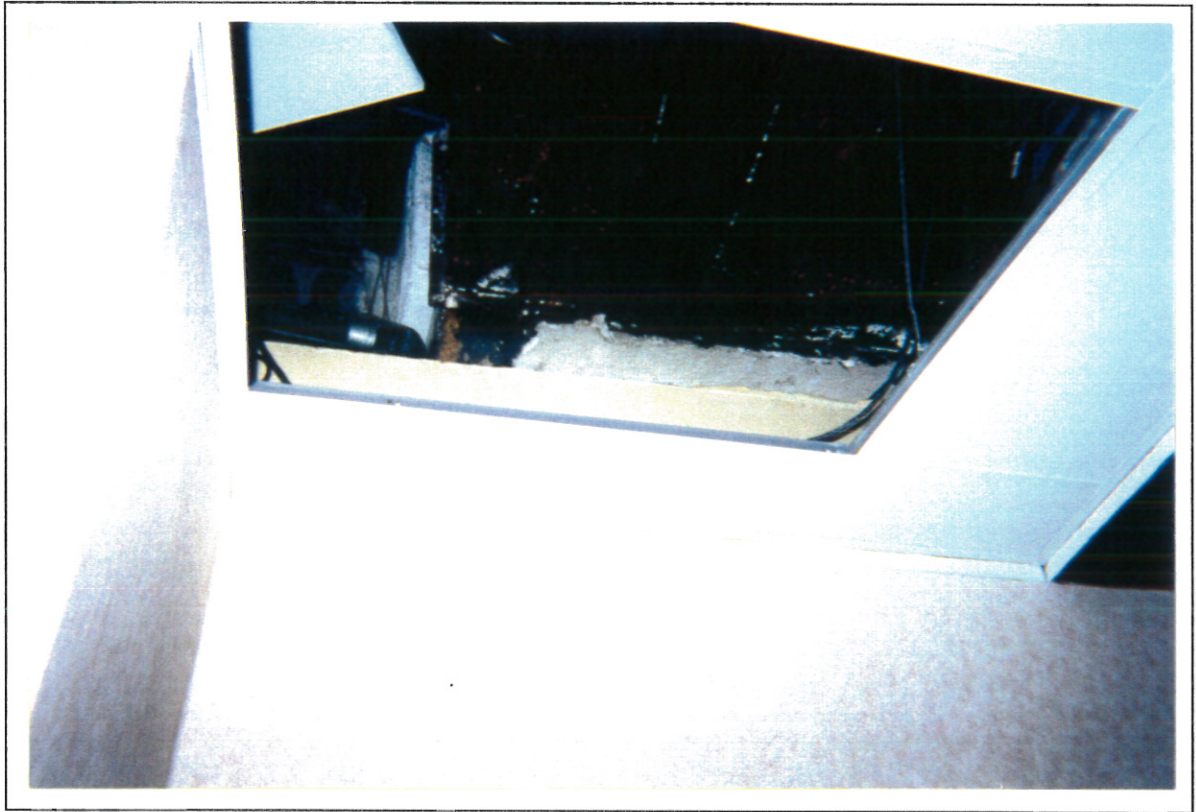
Photo 1: (Seneca Service Area (NYSTA) - Ontario County, New York) View of the asbestos-containing insulation on sections of the metal ducts above the drop ceiling near the restroom entrances.

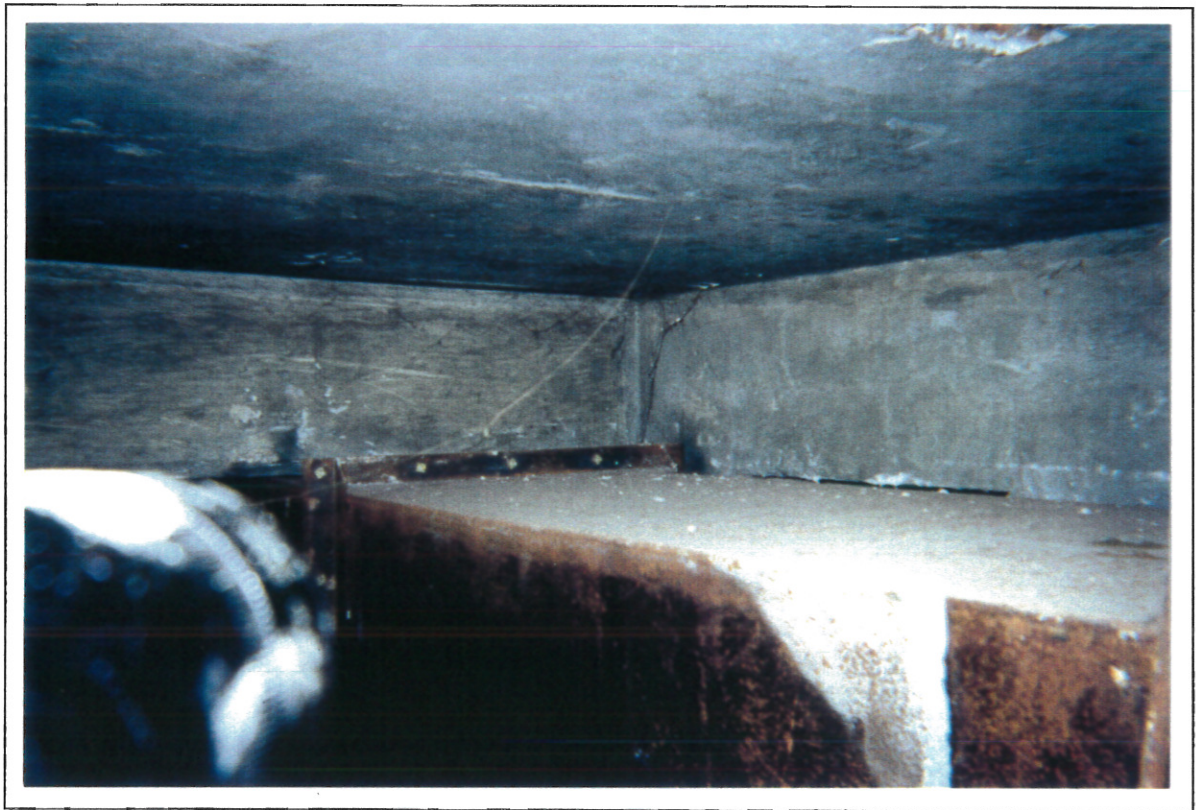
Photo 2: (Seneca Service Area (NYSTA) - Ontario County, New York) View of the asbestos debris on top of the chimney duct in the basement.

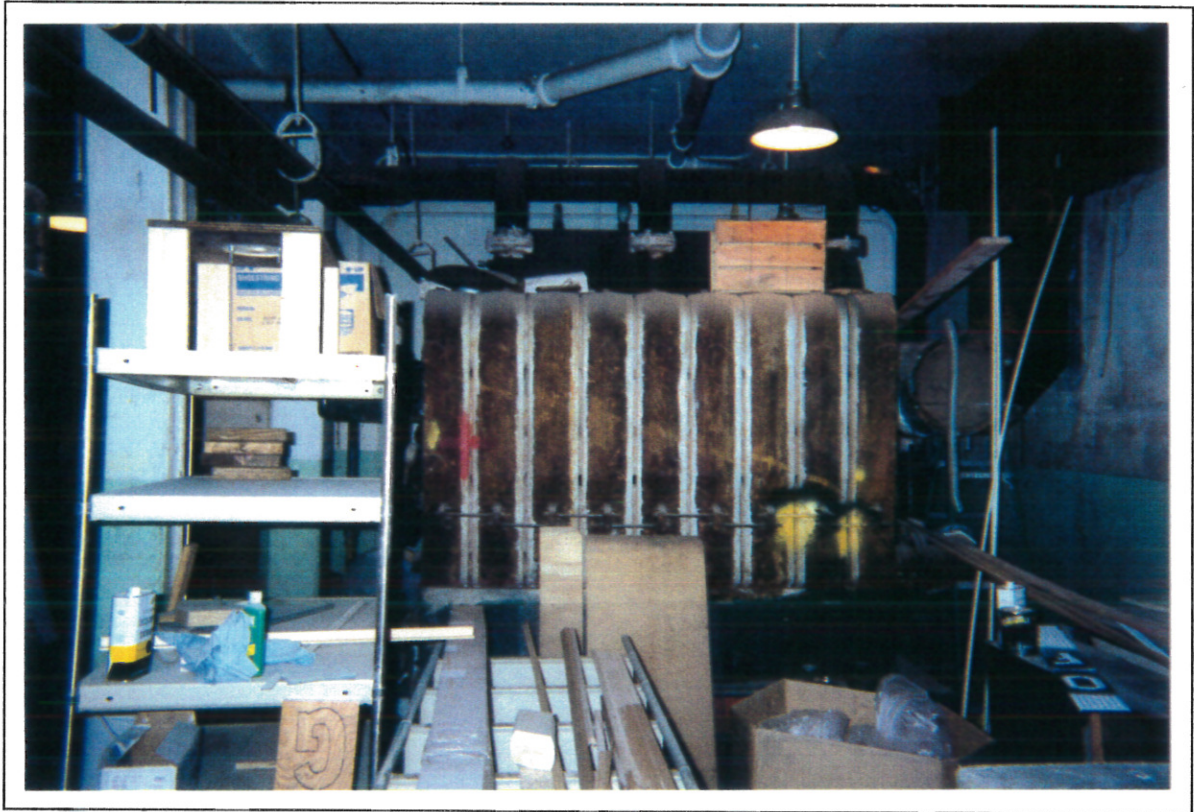
Rope-like Gasket	Boiler in Basement	M	Y0041.02-17	21% chrysotile	NA	Y

Photo 3: (Seneca Service Area (NYSTA) -Ontario County, New York) View of the side of the boiler in the basement. Notice the nine sections of the boiler. There is asbestos-containing material between the sections.

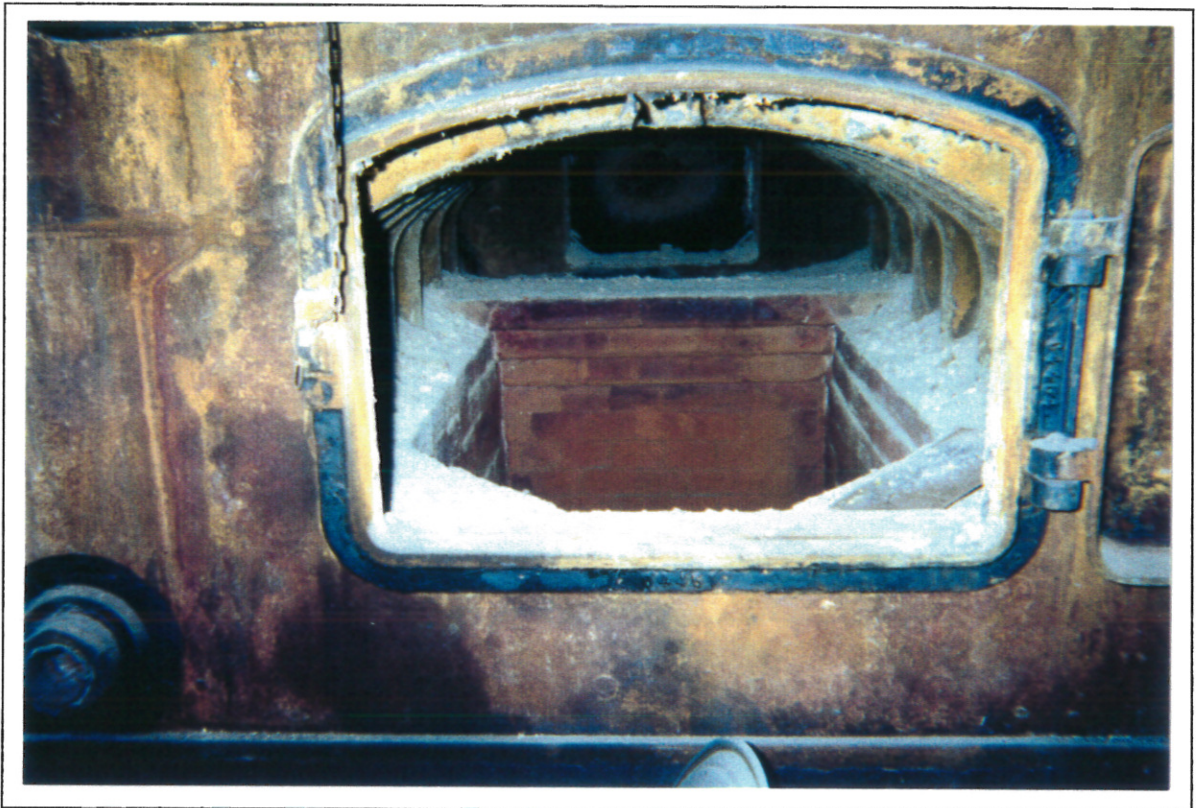
Photo 4: (Seneca Service Area (NYSTA) -Ontario County, New York) View of inside of the boiler in the basement. There is asbestos-containing material behind the black flanges of the doors. Additionally, the powdered material inside the boiler should be considered to be asbestos contaminated.

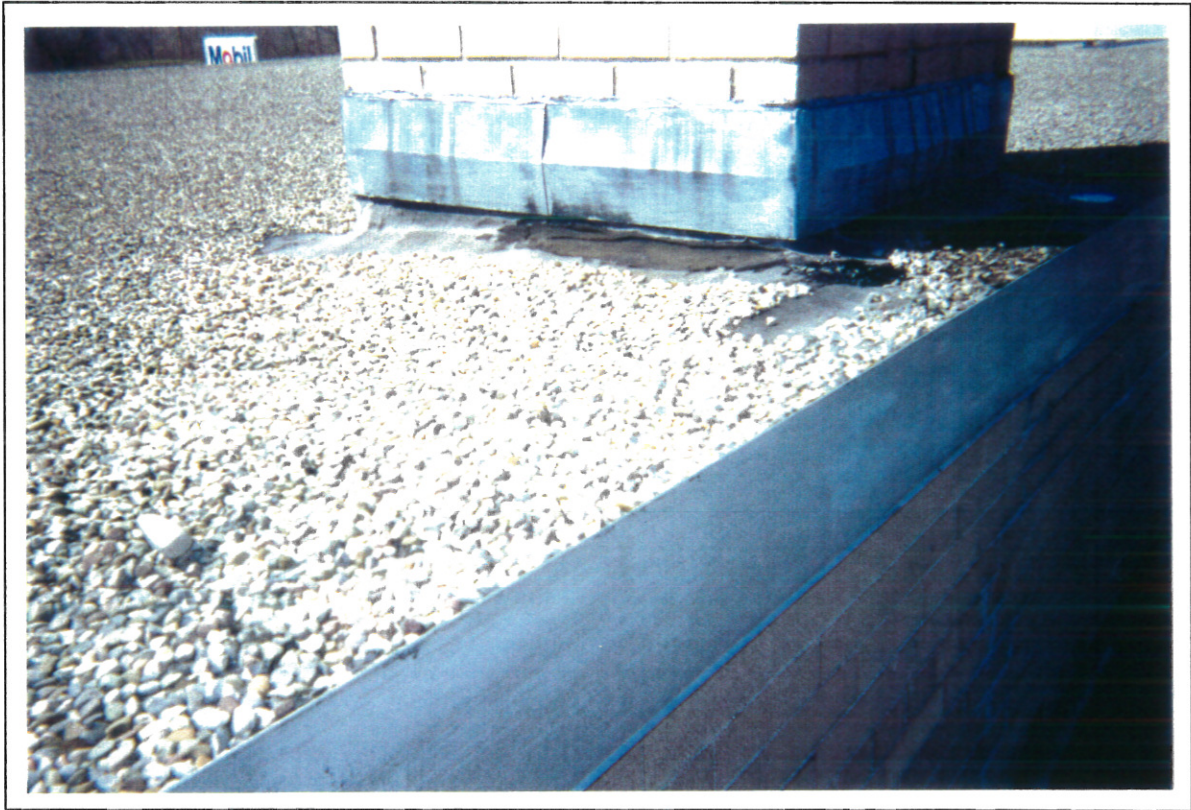
Photo 5: (Seneca Service Area (NYSTA) -Ontario County, New York) View of the asbestos-containing flashing around the chimney and the asbestos-containing built-up roof. This flashing is typical around the perimeter of the roofs and the roof top mounted units.

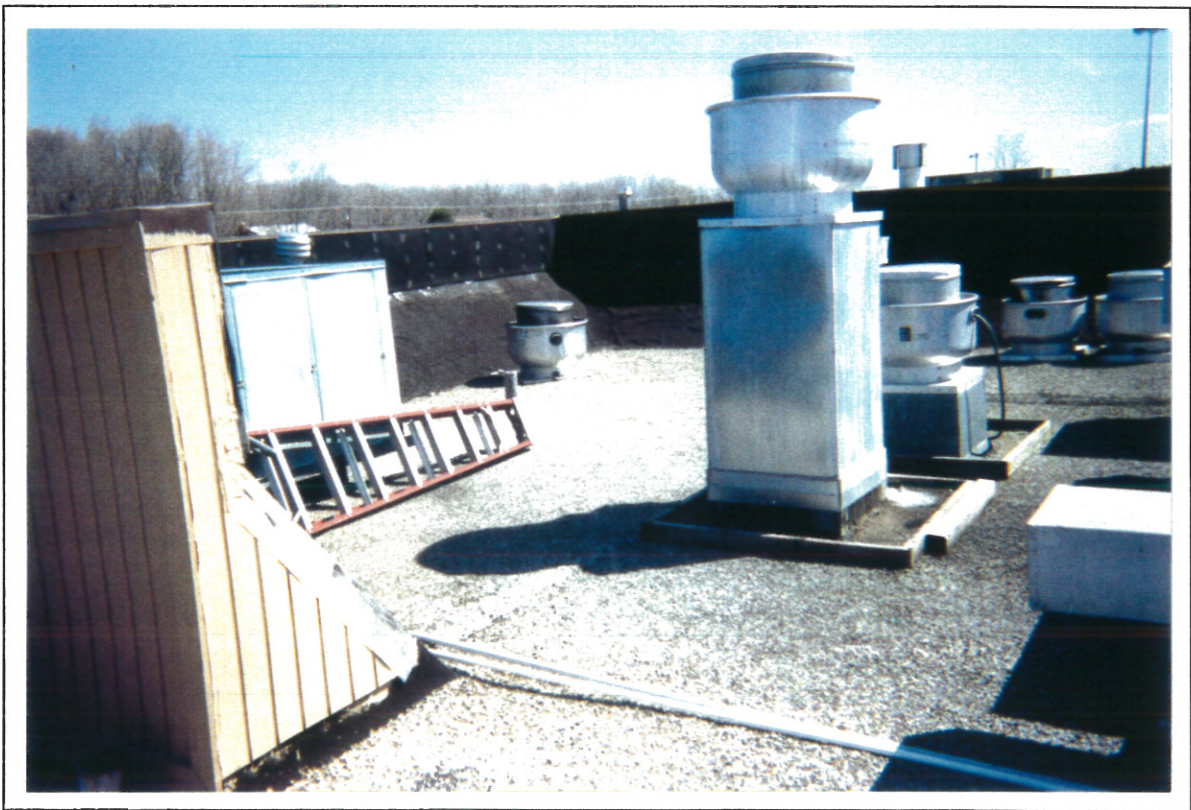
- The sealant around the nails on the rolled roofing around the perimeter of the original roof - approximately 295 square feet.
- The sealant on the slanted portions of the original roof - approximately 850 square feet.

Photo 6: (Seneca Service Area (NYSTA) -Ontario County, New York) View of the asbestos-containing sealants over the nails in the rolled roofing (background along top of parapet wall) and the asbestos-containing built-up roof.
