New York State Thruway Authority

General Large Culvert Inspection Report

Inspection Date: October 25, 2023

MP: 417.63 **CIN:** 41763011XX **Region:** 05 - Buffalo
Feature Carried: 90IX **County:** 3 - Erie
Feature Crossed: DRAINAGE DITCH **Political Unit:** Town of Cheektowaga
Orientation: 3 - East **Approximate Year Built:** 1952

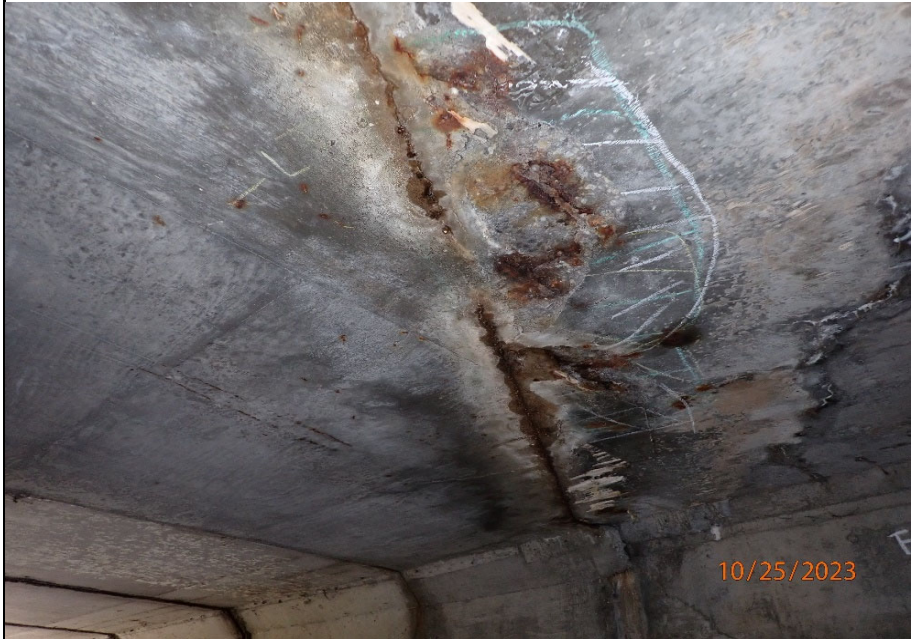
Photo Number	01	Photo Filename:	MP 417.63_CIN 41763011XX_2023_01
Attachment Description: Culvert top slab at left side cold joint between original culvert and closure pour looking toward end left

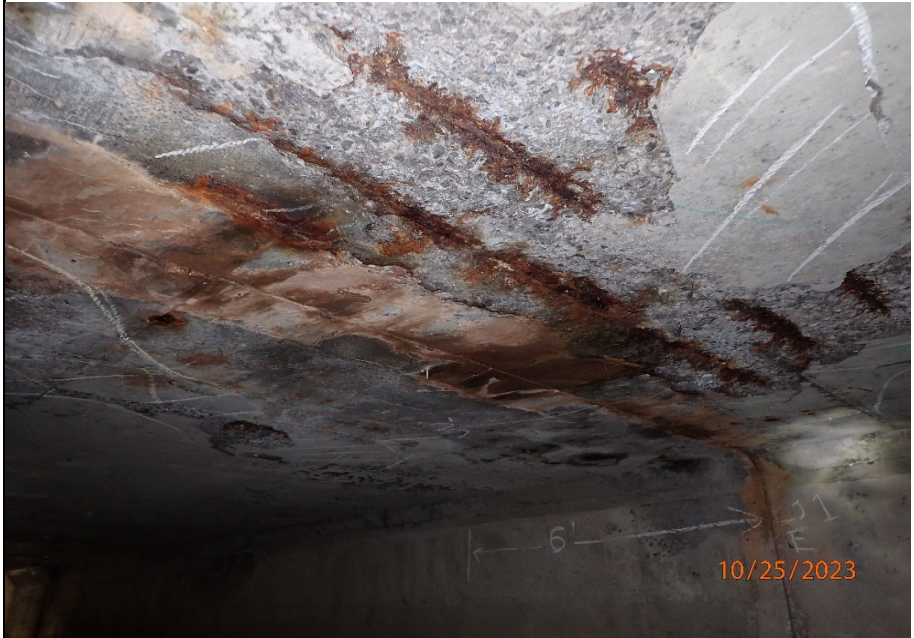
Photo Number	02	Photo Filename:	MP 417.63_CIN 41763011XX_2023_02
Attachment Description: Culvert top slab at CJ 1 looking toward end

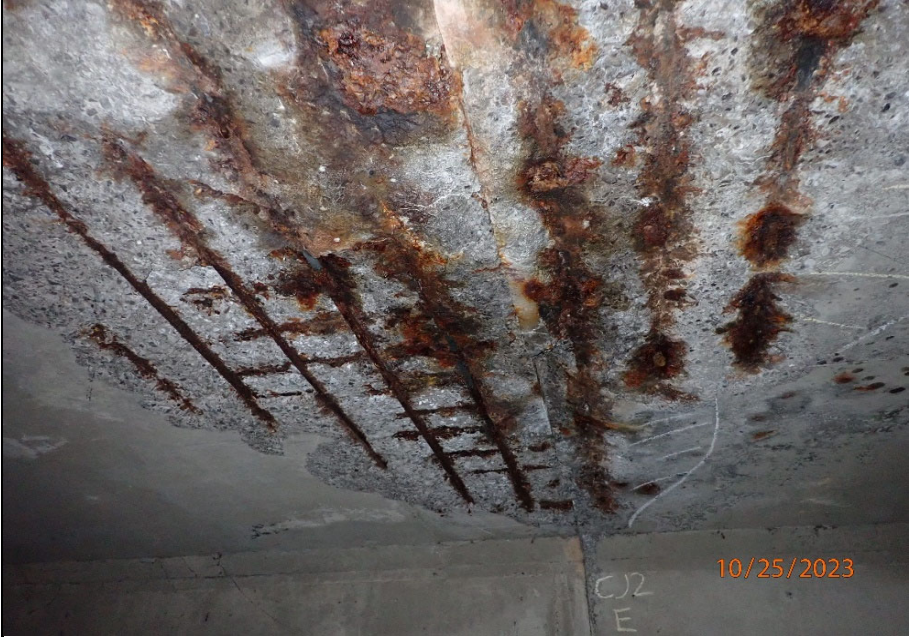
Photo Number	03	Photo Filename:	MP 417.63_CIN 41763011XX_2023_03
Attachment Description: Culvert top slab at CJ 2 looking toward end

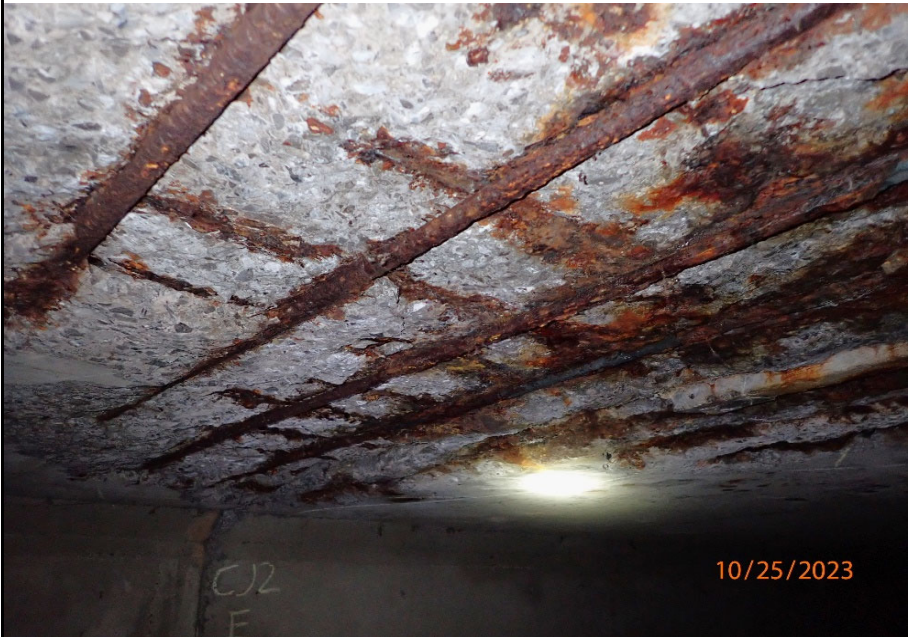
Photo Number	04	Photo Filename:	MP 417.63_CIN 41763011XX_2023_04
Attachment Description: Culvert top slab at CJ 2 looking toward end (Close-up of debonded rebar)

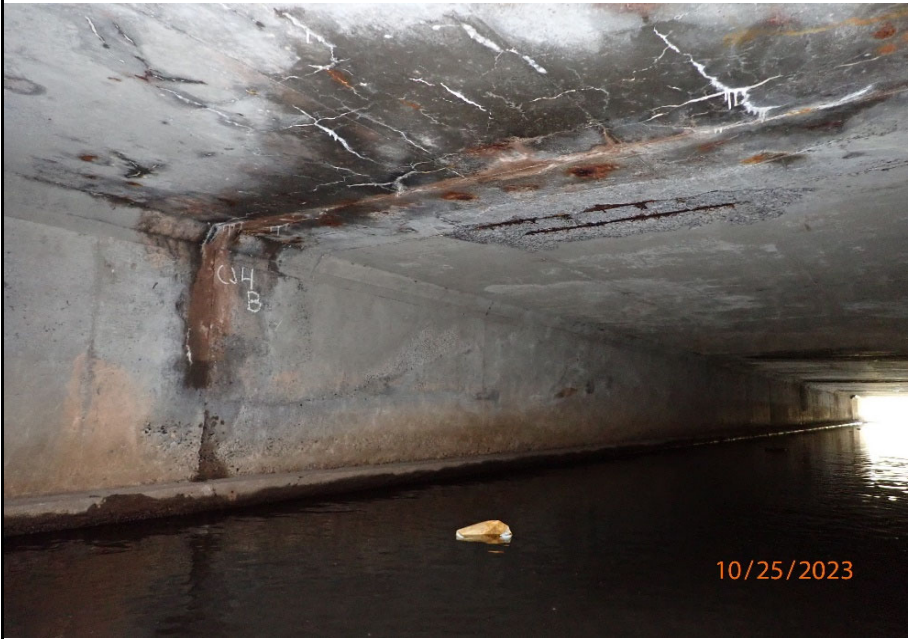
Photo Number	06	Photo Filename:	MP 417.63_CIN 41763011XX_2023_06
Attachment Description: Culvert top slab and begin stem at CJ 4 looking toward begin left

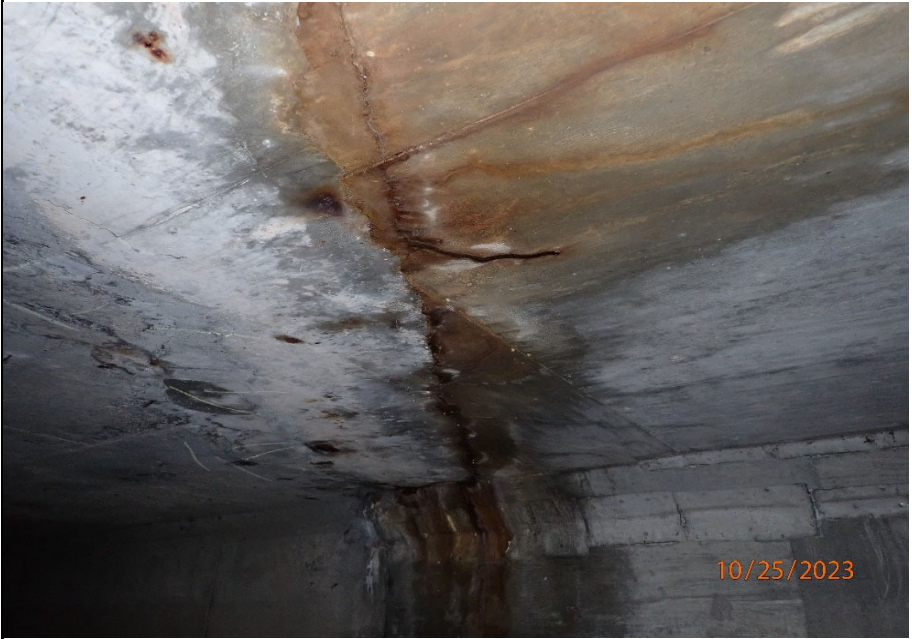
Span 1: 241 - Reinforced Concrete Culvert Referenced Photo(s): 1, 2, 3, 4, 5, 6, 7 Referenced Sketch(es): None	TQ	CS-1	CS-2	CS-3	CS-4	CS-5
	244	93	124	27		
<p>PRECAST EXTENSIONS At the left and right side of the original culvert, there are (4) precast concrete box culvert units and (1) precast concrete end section (assessed under Element 241) installed under TAB 98-23. The precast units are in good condition, except for minor dampness at joints, 4 LF x 2 sides = 8 LF CS-2.</p> <p>CLOSURE POURS There are closure pours at the transition from the original cast in place concrete culvert to the precast concrete extensions. The closure pours are generally in good condition, CS-1.</p> <p>ORIGINAL CAST-IN-PLACE CUVLERT The original culvert is generally in good to fair condition with areas of minor cracking, delamination, dampness, and isolated efflorescence, 75% (116 LF) CS-2. There is more severe deterioration at the following locations:</p> <p>LT FASCIA (Photo 1) - There is minor leakage and rust-staining at the cold joint with the closure pour. There are 1' to 2' wide delaminations along the cold joint and a 1 SF and 3 SF spall with exposed/corroded rebar, 2 LF CS-3.</p> <p>CJ 1 (Photo 2) - Damp with minor leakage and rust staining. Left side of joint exhibits a 3' wide x 8' long delaminated area with a 2 SF x 1"D spall. Right side of joint is spalled 1' to 2.5' wide x 6' long x 1"D with (3) exposed/corroded rebar and delaminated concrete adjacent, 5 LF CS-3.</p> <p>CJ 2 (Photos 3 & 4) - 6' wide x full span length x up to 2.5"D spall with (8) exposed/corroded longitudinal bars (up to 50% section loss). (4) of the (8) bars are debonded 3' to 4' long. Concrete adjacent to the spall is damp and delaminated. 6 LF CS-3.</p> <p>CJ 3 (Photo 5) - Left side of joint exhibits a 4' wide x 9' long x up to 2.5"D spall with (3) exposed longitudinal bars (up to 10% section loss). Concrete adjacent to the spall is damp and delaminated. Right side of the joint is damp and delaminated up to 2' wide. 6 LF CS-3</p> <p>2' RT of CJ 3: 2' wide x 4' long x 2" deep area of honeycombing with partially exposed rebar, 2 LF CS-3.</p> <p>CJ 4 (Photo 6) - Left side of joint exhibits a 2' wide x 6' long x 2" deep spall with (2) exposed/corroded rebar. Right side of joint exhibits a 3' wide x full length area of heavy dampness, mapcracking and moderate efflorescence. At the bottom of the begin stem there is a 1 SF x 4"D spall. 5 LF CS-3.</p> <p>RT FASCIA (Photo 7) - Leakage and rust staining at the cold joint with the closure pour, 1 LF CS-3.</p>

Photo Number	07	Photo Filename:	MP 417.63_CIN 41763011XX_2023_07
Attachment Description: Culvert top slab at right side cold joint between original culvert and closure pour looking toward end

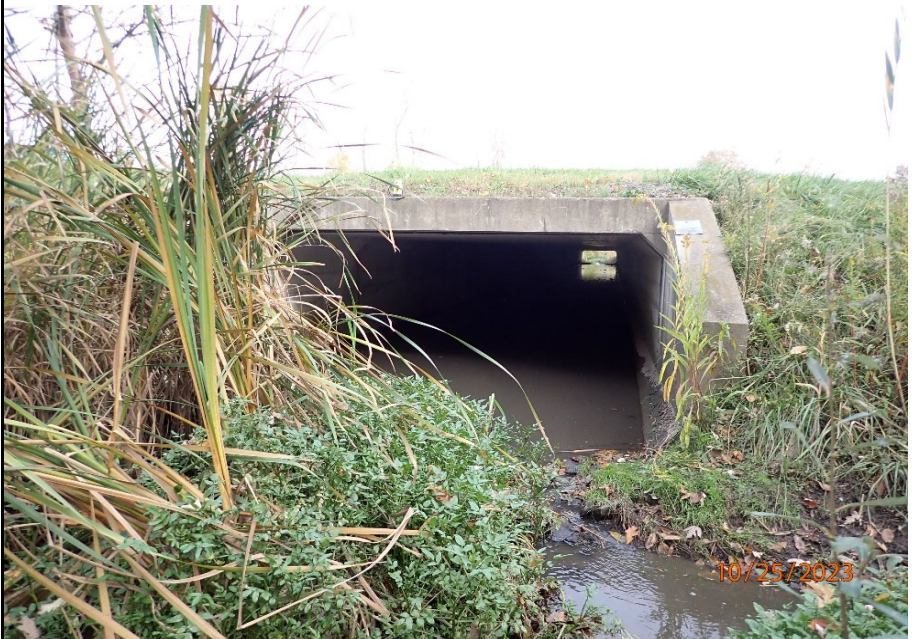
Photo Number	08	Photo Filename:	MP 417.63_CIN 41763011XX_2023_08
Attachment Description: Culvert outlet (right side) looking left

There is minor accumulation of vegetation at the culvert outlet (right side) in the begin half of the channel that slightly reduces the waterway opening.
