## **INSPECTION FOR ASBESTOS-CONTAINING MATERIALS (SCOPE ASBESTOS REPORT)**

**MANCHESTER MAINTENANCE SECTION  
NYS THRUWAY EXIT 43  
MANCHESTER, NY 14504**

**PROTOTYPE ADDITIONS TO VARIOUS MAINTENANCE SECTION BUILDINGS  
NYSTA CONTRACT D214672**

**Re: Limited Pre-Demolition Asbestos Inspection  
Manchester Maintenance Section Addition and Roof Replacement  
1190 New York State Route 21  
Shortsville, New York 14548**

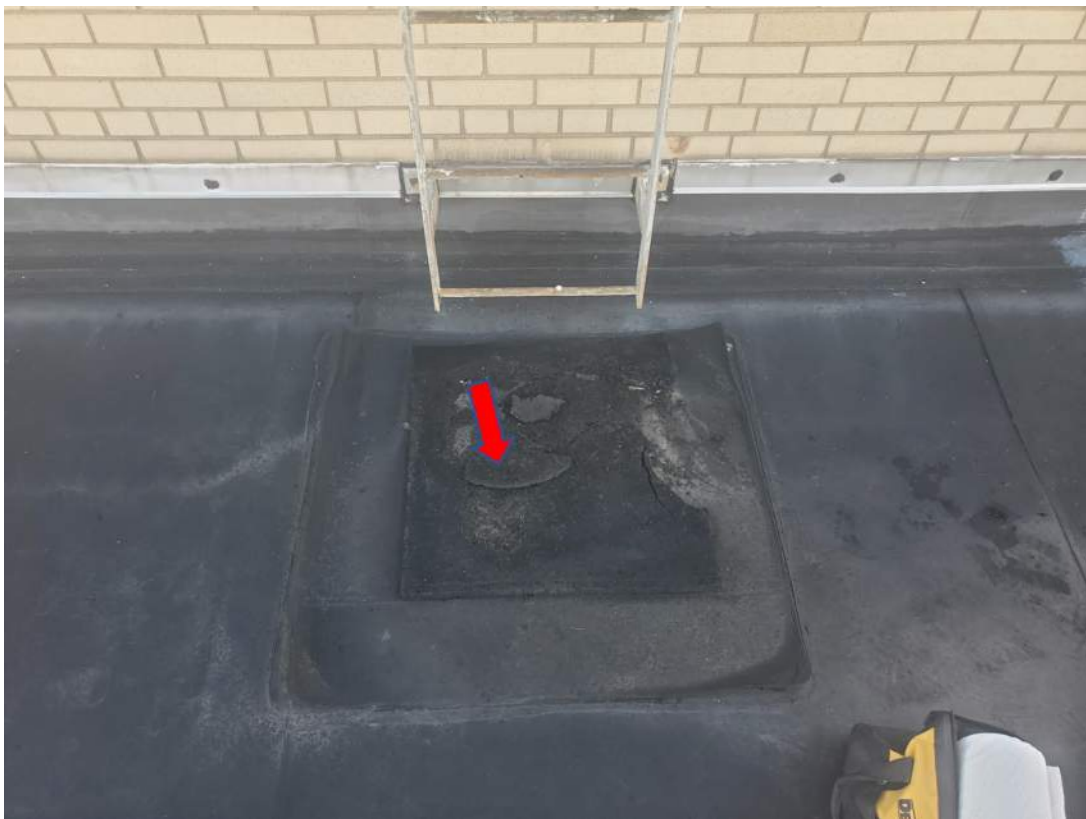
Photograph 1 – View of Roof 7 & Roof 3 non-ACM Black Fibrous Mat Material (ACM-1 & ACM-2)

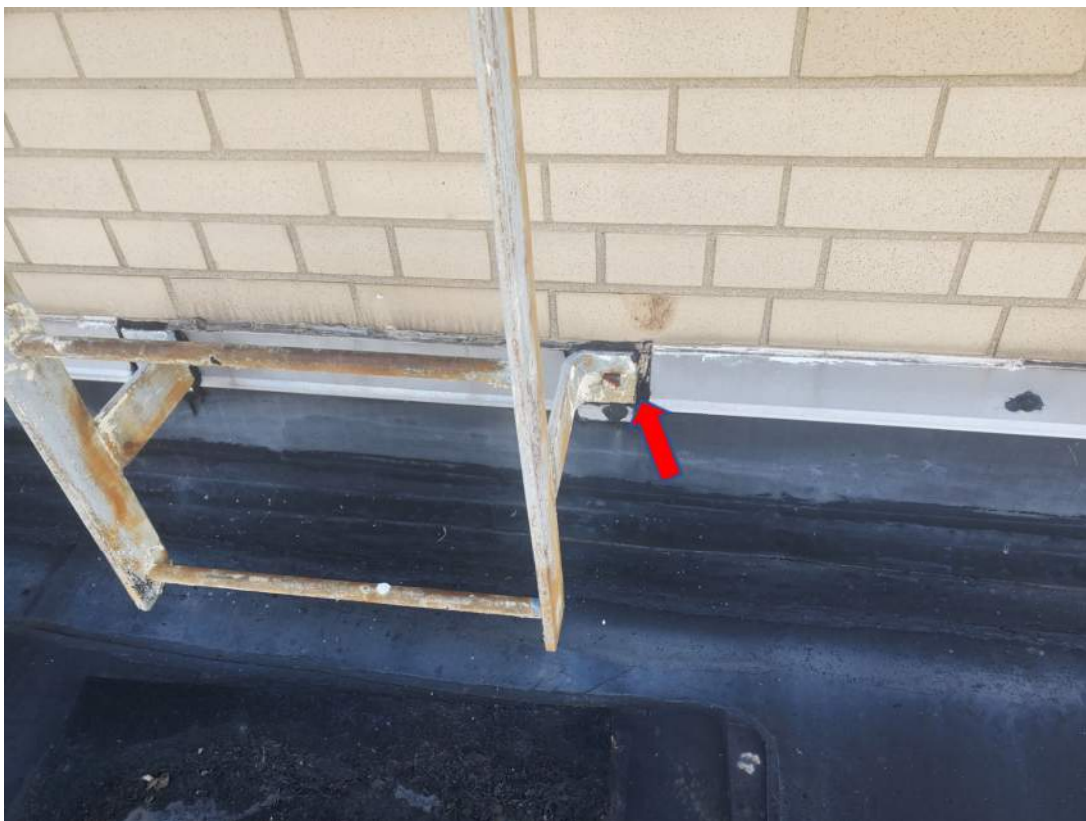
Photograph 2 – View of Roof 7 non-ACM Black Caulking/Sealant on Ladder Bolts (ACM-3 & ACM-4)

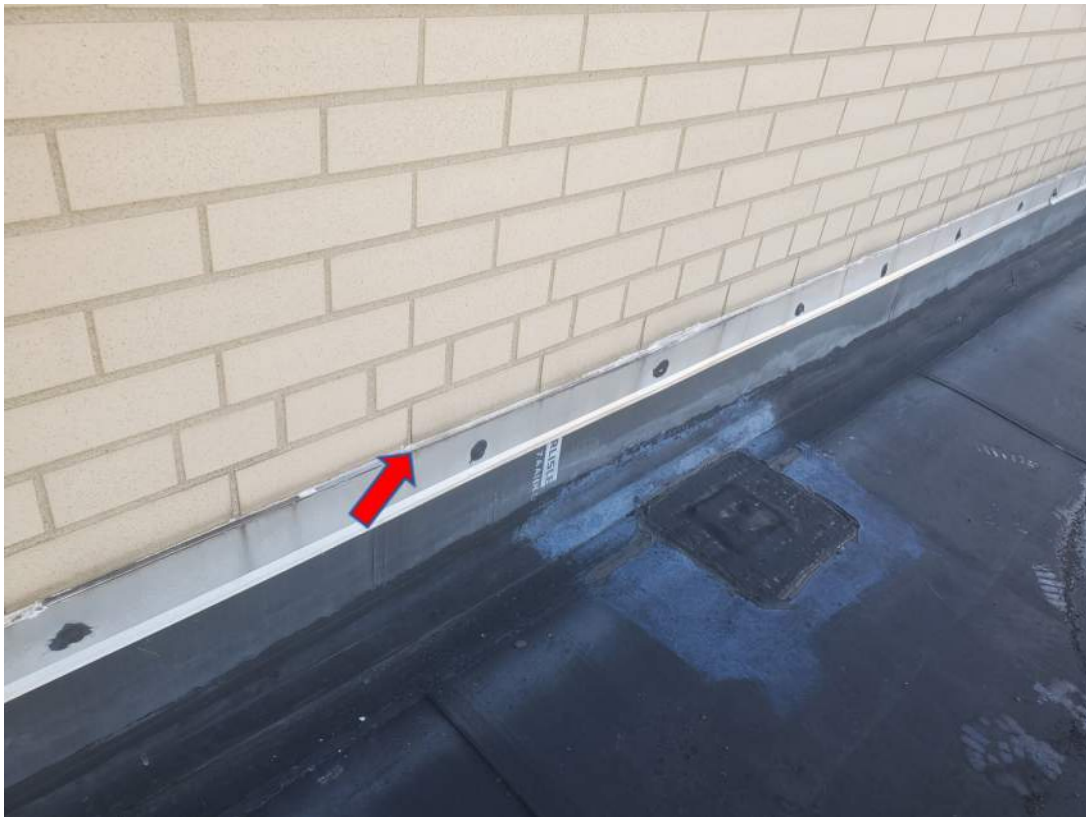
Photograph 3 – View of Roof 7 non-ACM White Caulking on Flashing (ACM-5 & ACM-6)

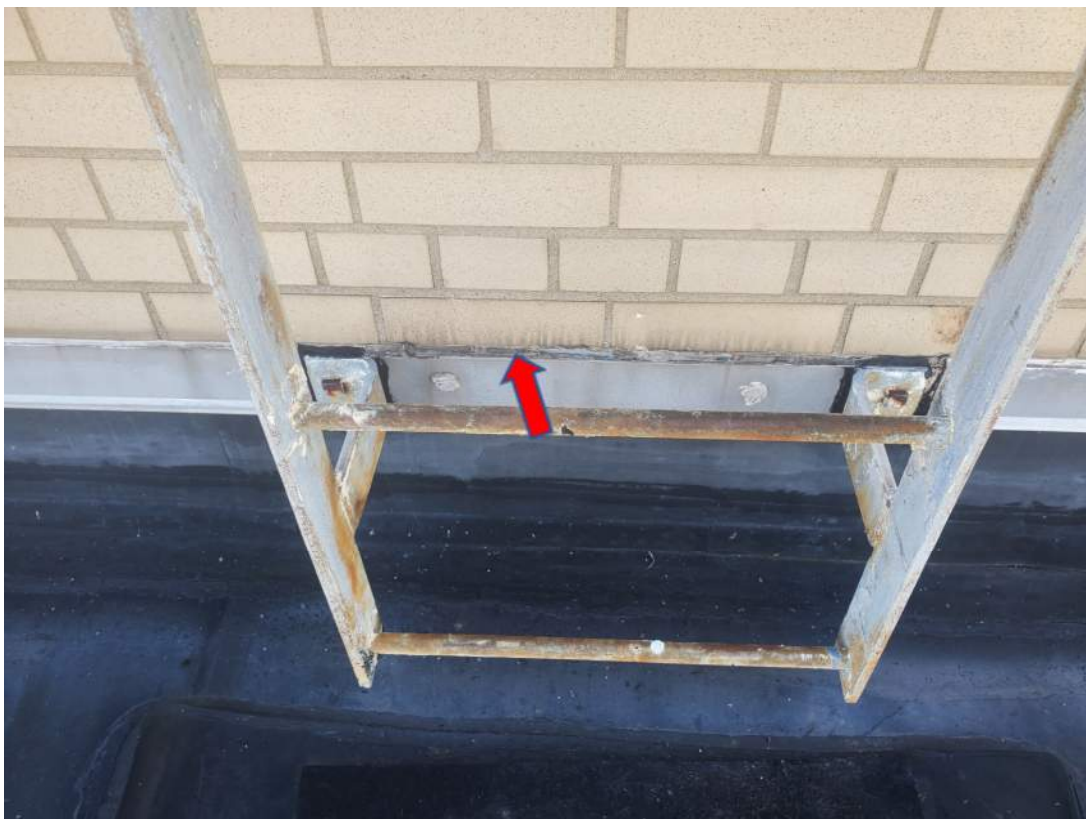
Photograph 4 – View of Roof 7 non-ACM Light Black Caulk Behind Ladder on Flashing (ACM-7 & ACM-8)

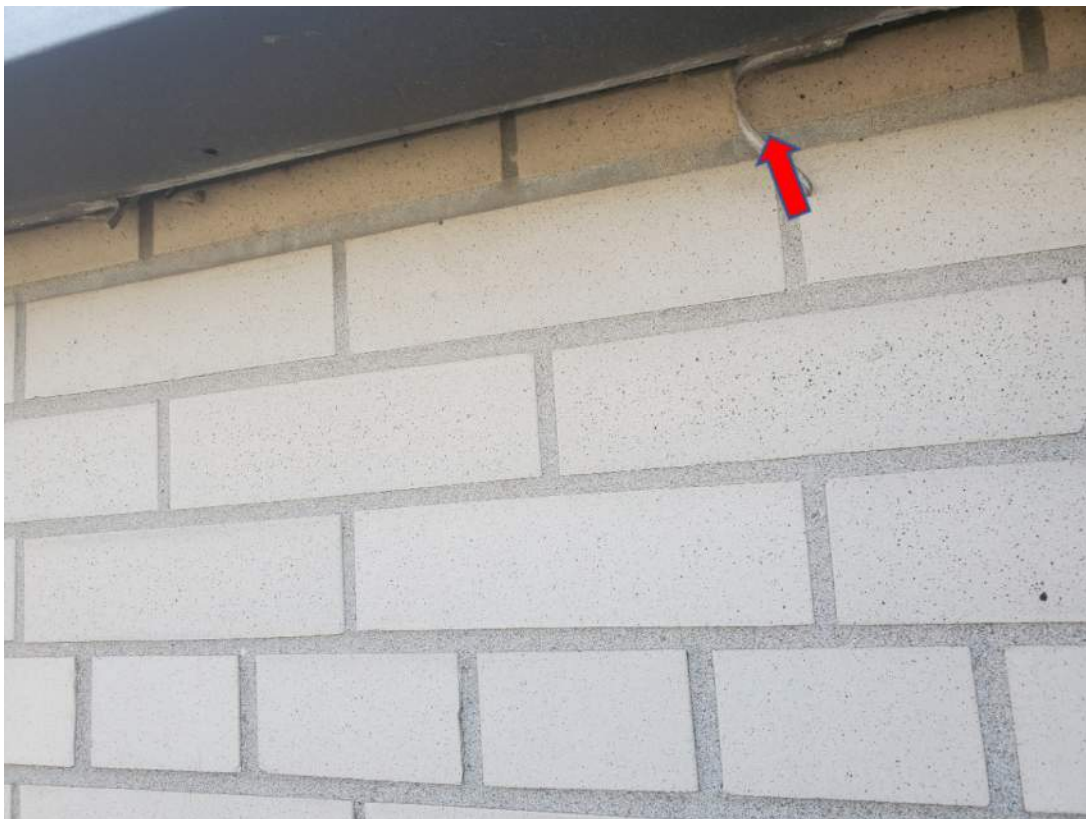
Photograph 5 – View of Roof 3 ACM Grey Fibrous Caulk Underneath Overhang (ACM-9 & ACM-10)

Sample ID	Percent (%) Asbestos*	Quantity	Condition	Potential for Disturbance
Station				
Roof 3 - Grey Fibrous Caulk Underneath Overhang of Roof 7 and West Side of Roof 3				
ACM-9	1.0%	+/- 4.75 SF	Damaged	Low
ACM-10	Positive Stop			
Roof 3 - Grey Fibrous Caulk Underneath Overhang East Side of Roof 3				
ACM-53	2.2%	+/- 11.5 SF	Damaged	Low
ACM-54	Positive Stop			
Notes:				
*All asbestos detected was identified as Chrysotile unless otherwise noted.				
SF = Square Feet

If demolition or repair activities are planned in areas containing the identified ACMs, these materials must be removed and disposed of in accordance with regulatory standards. Certified professionals must prepare detailed abatement plans that outline containment, removal, and disposal methods,

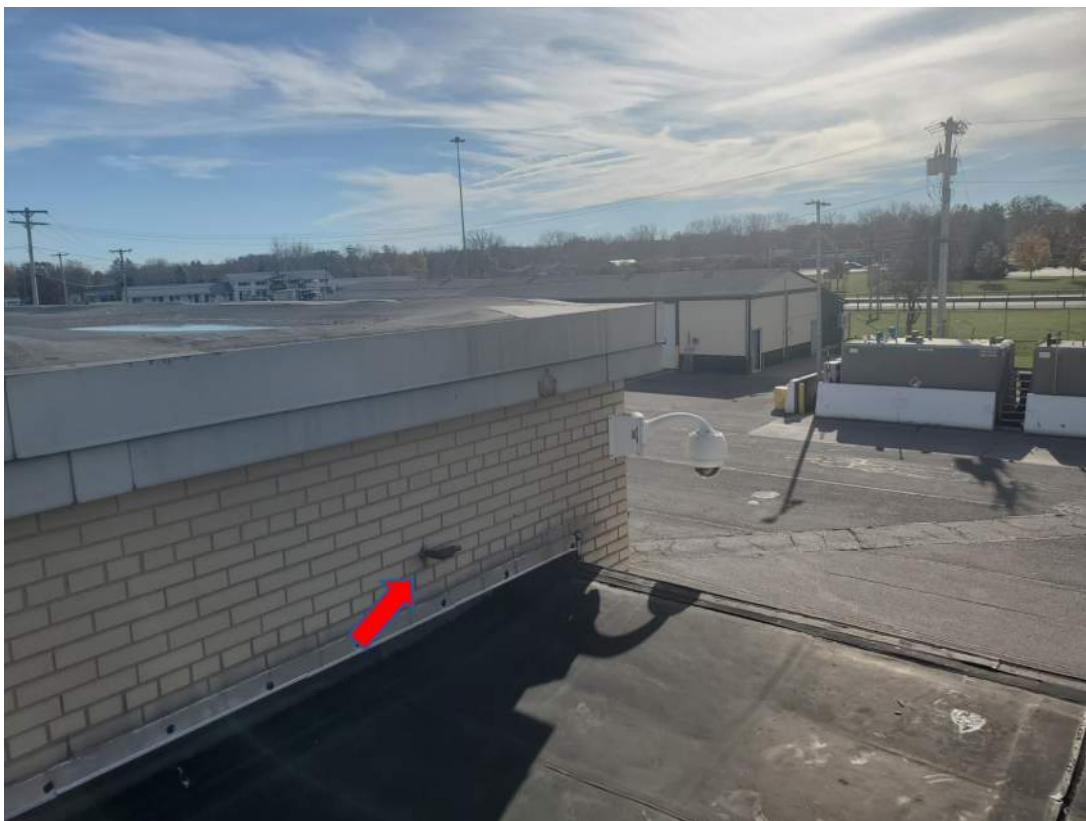
Photograph 6 – View of Roof 3 wall non-ACM Grey Penetration Putty Around Pipe (ACM-11 & ACM 12)

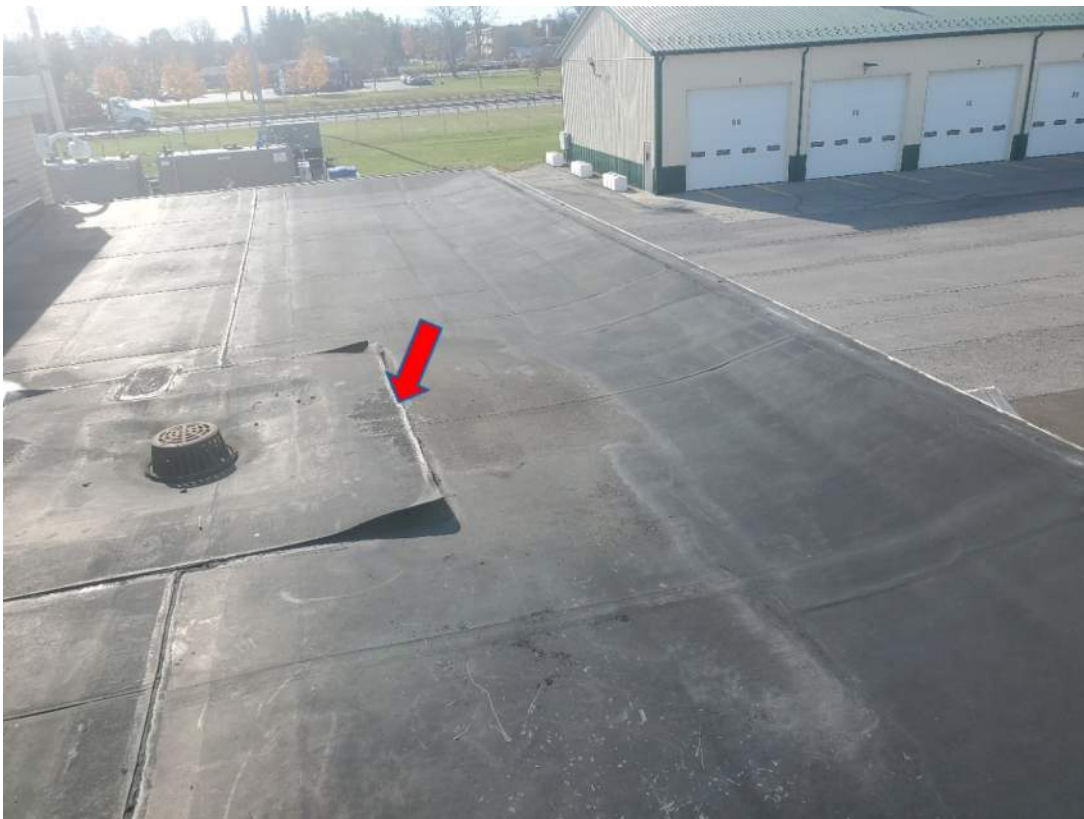
Photograph 7 – View of Roof 7 non-ACM Black Sealant Material from Roof Drain Section and Seams (ACM-13, ACM-14, ACM-15 & ACM-16)

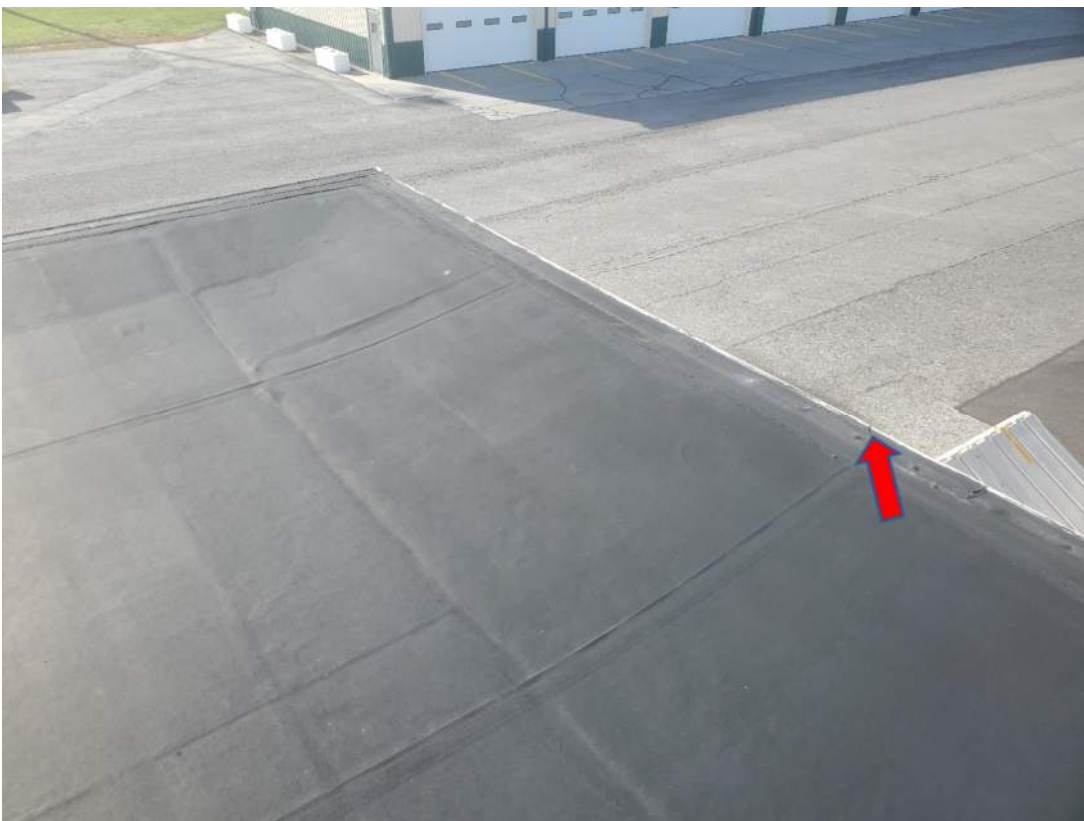
Photograph 8 – View of Roof 7 non-ACM Black Fibrous Caulk/Sealant from Roof Edge (ACM-17, ACM-18 & ACM-19)

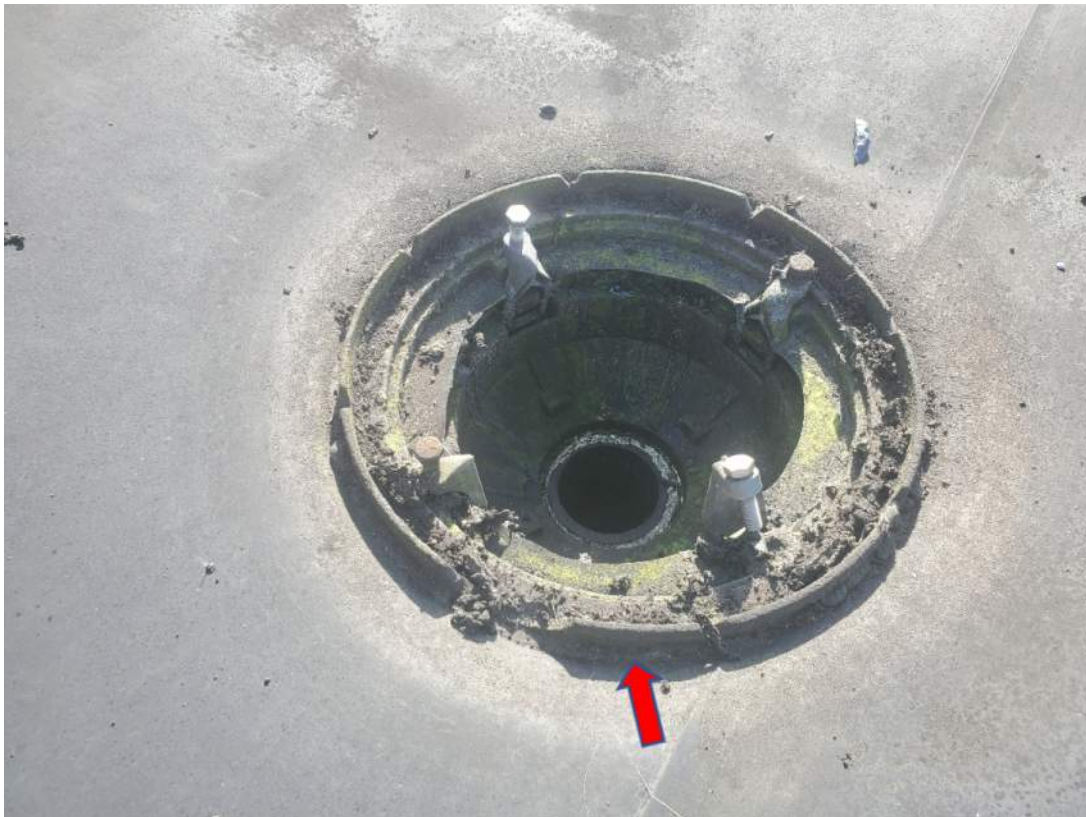
Photograph 9 – View of Roof 7 non-ACM Roof Drain Black Sealant Material (ACM-20 & ACM-21)

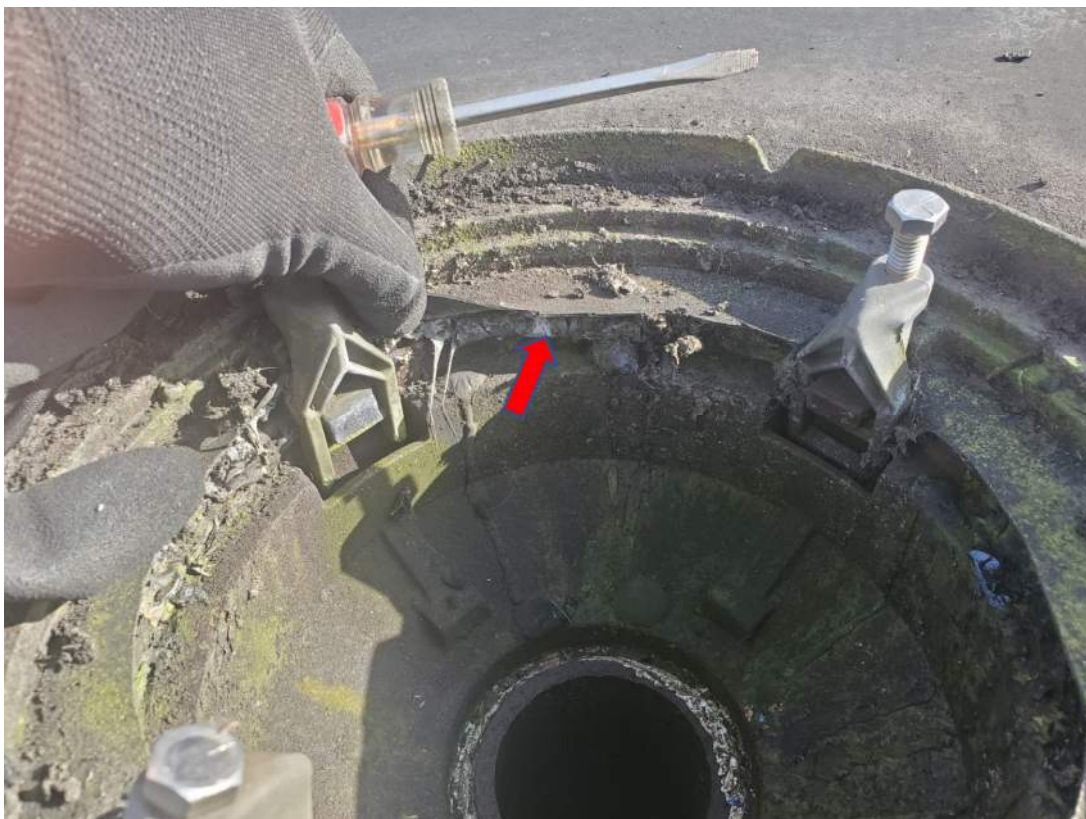
Photograph 10 – View of Roof 7 Roof Drain non-ACM Roof Drain White Sealant material Between Roof Membrane and Underlayment (ACM-22 & ACM-23)

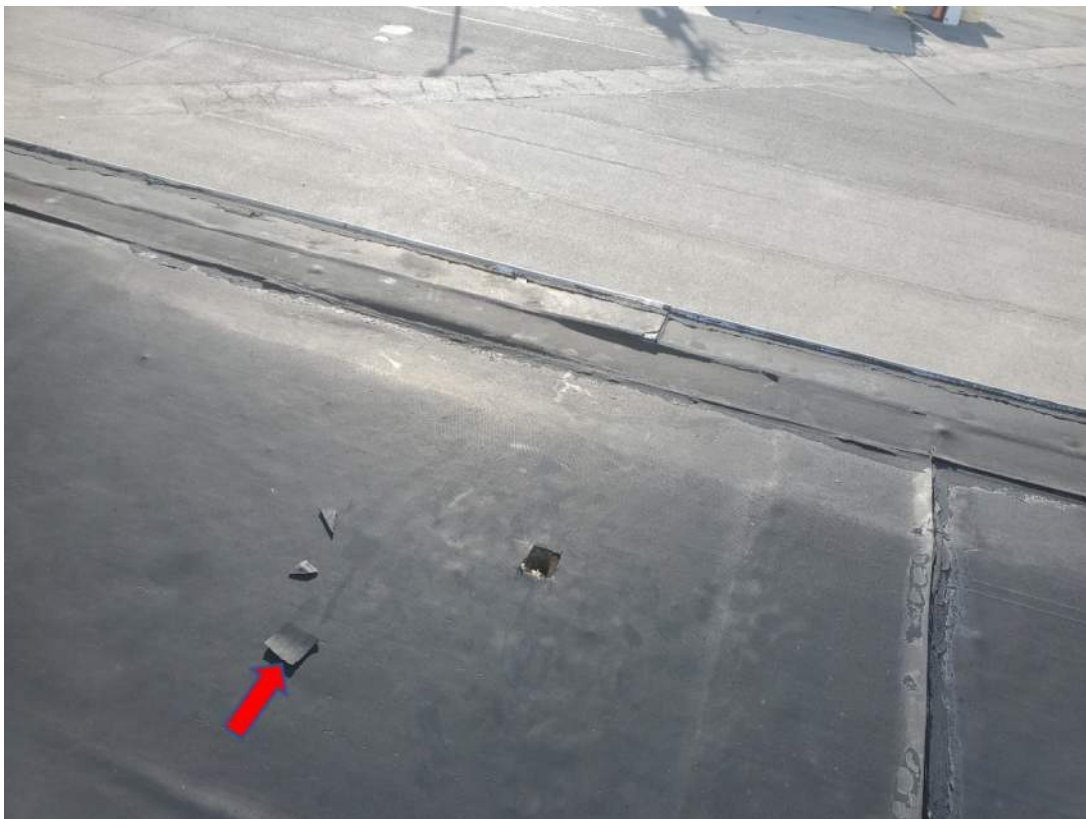
Photograph 11 – View of Roof 7 non-ACM Black Roof Membrane with Fibrous Backing Material (ACM-24 & ACM-25)

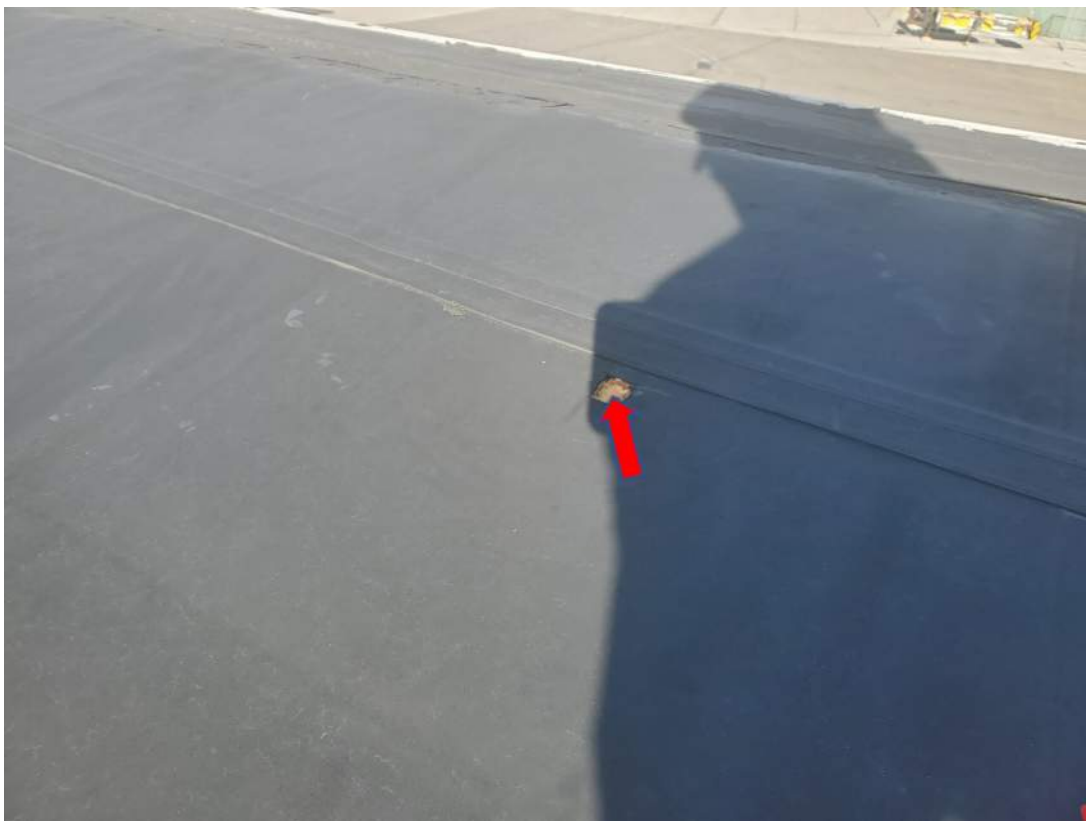
Photograph 12 – Roof 7 non-ACM Black Fibrous Backing Material with Tan Foam Material (ACM-26 & ACM-27)

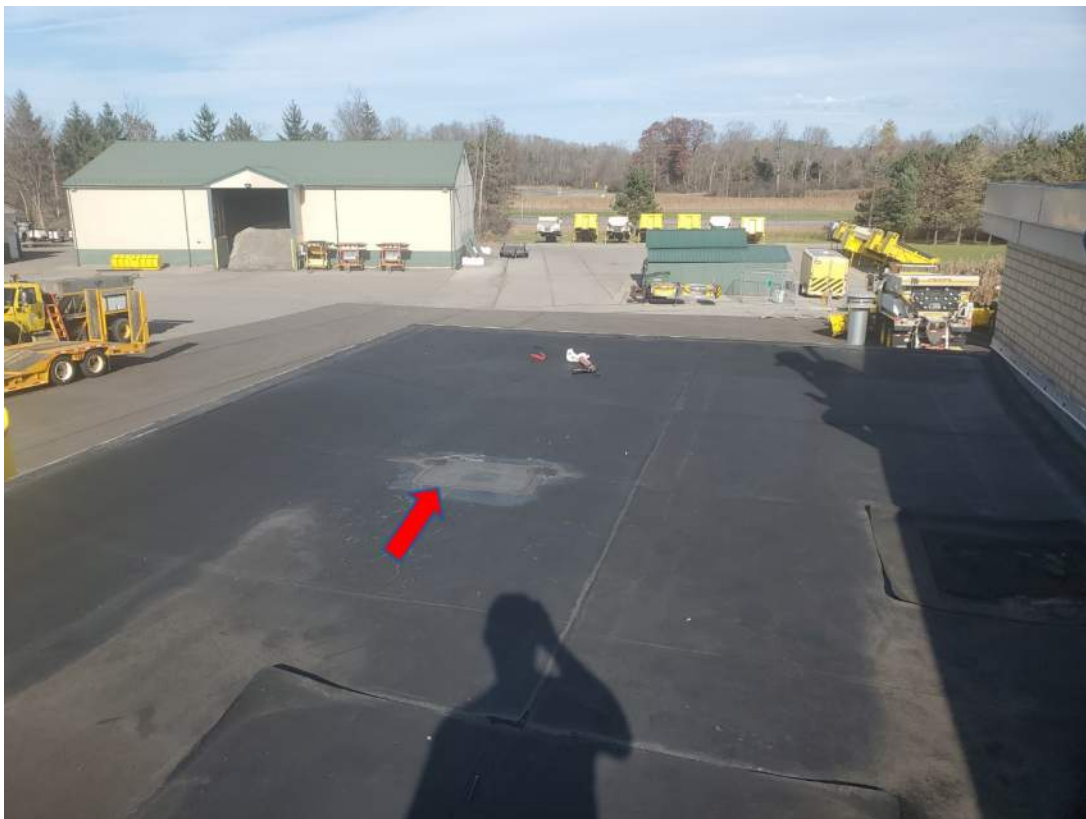
Photograph 13 – View of Roof 7 non-ACM New Black Patching Sealant Material (ACM-28 & ACM-29)

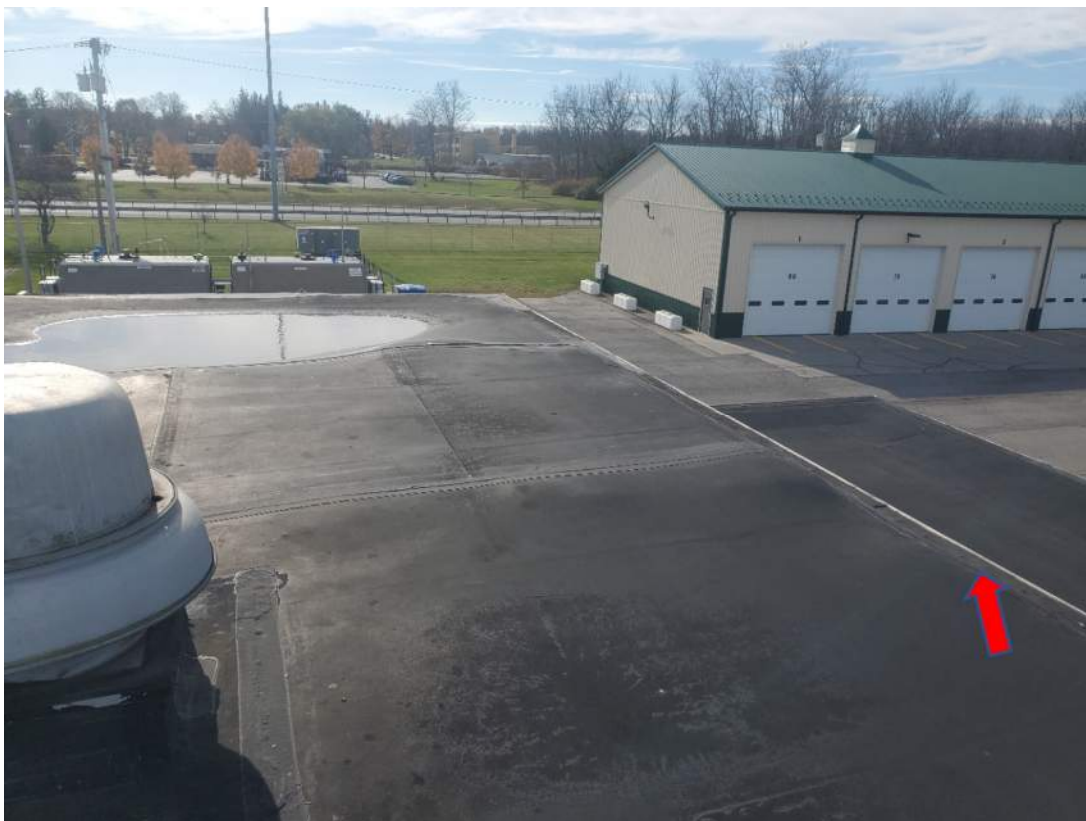
Photograph 14 – View of Roof 3 non-ACM Black Edge Sealant (ACM-30, ACM-31, ACM-32 & ACM-33)

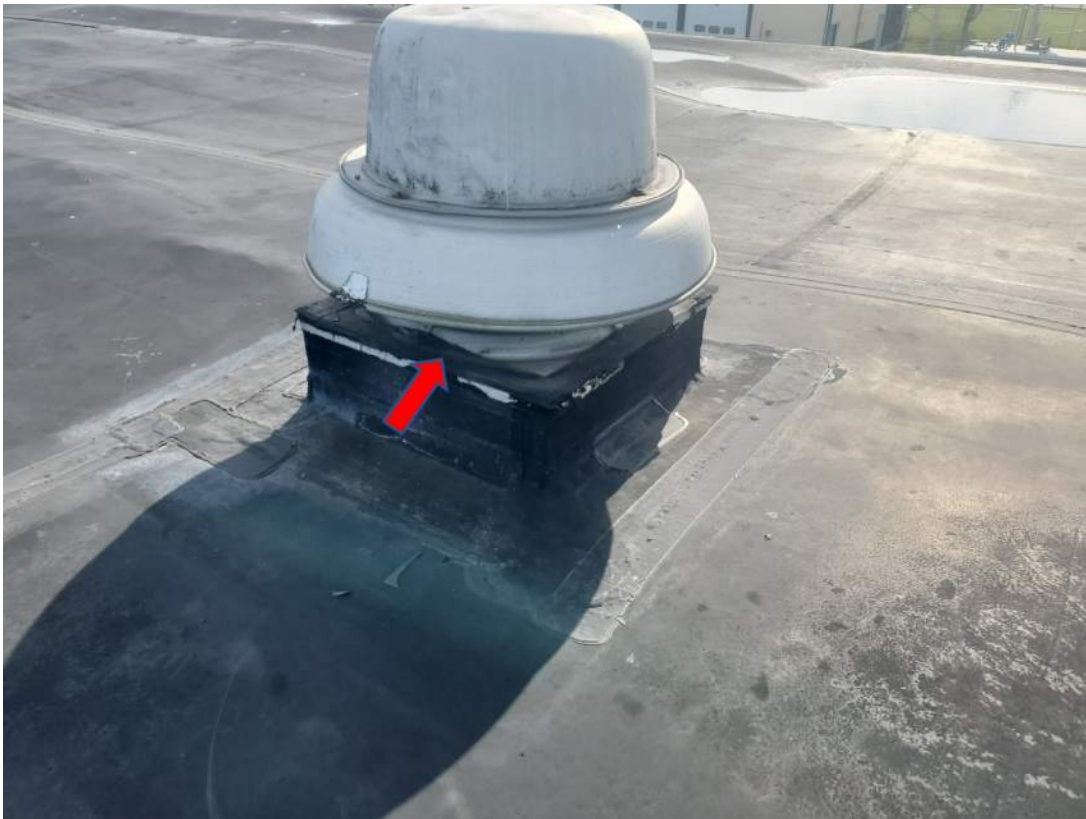
Photograph 15 – View of Roof 3 non-ACM Fan Housing Black Sealant (ACM-34 & ACM-35)

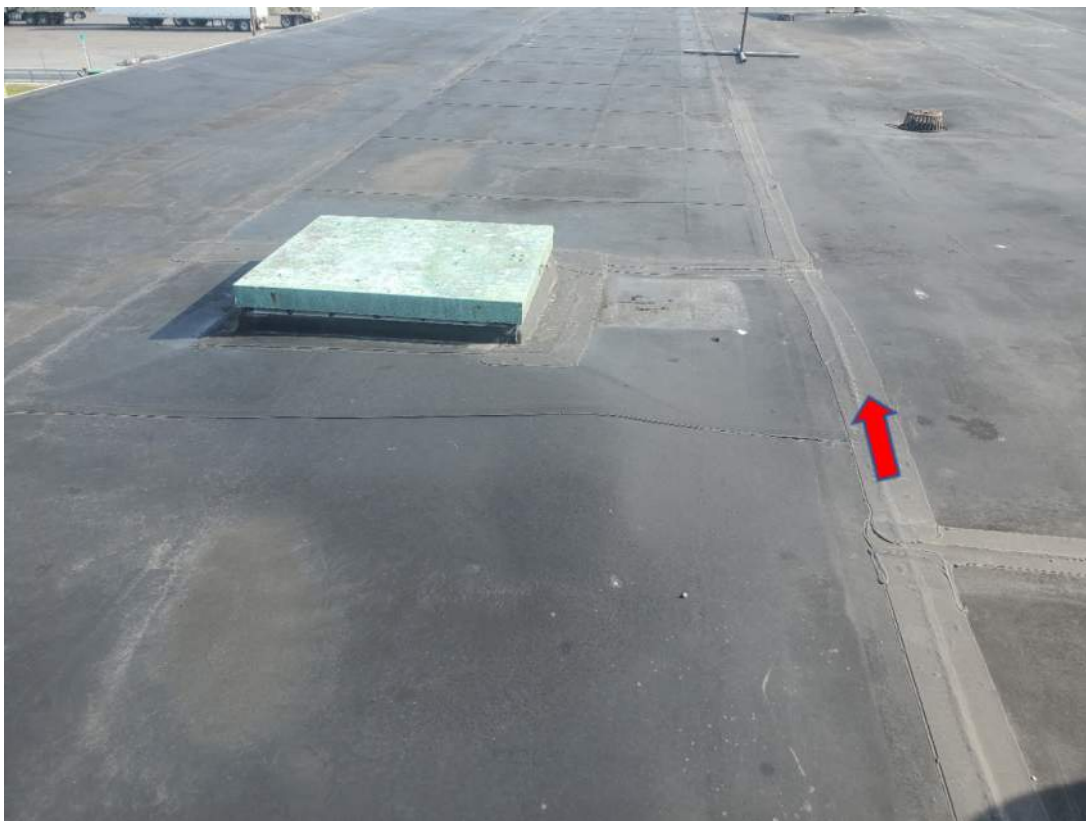
Photograph 16 – View of Roof 3 non-ACM black Seam Sealant Material (ACM-36, ACM-37, ACM-38 & ACM-39)

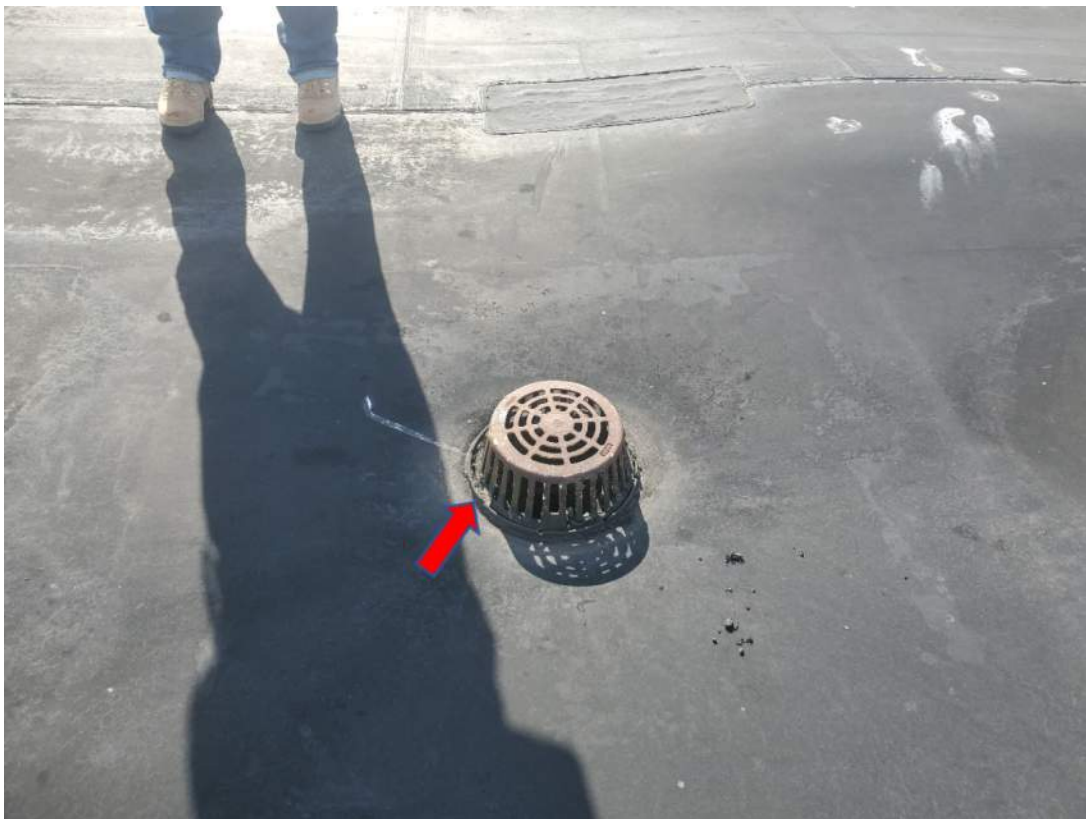
Photograph 17 – View of Roof 3 non-ACM Roof Drain Black Sealant (ACM-40 & ACM-41)

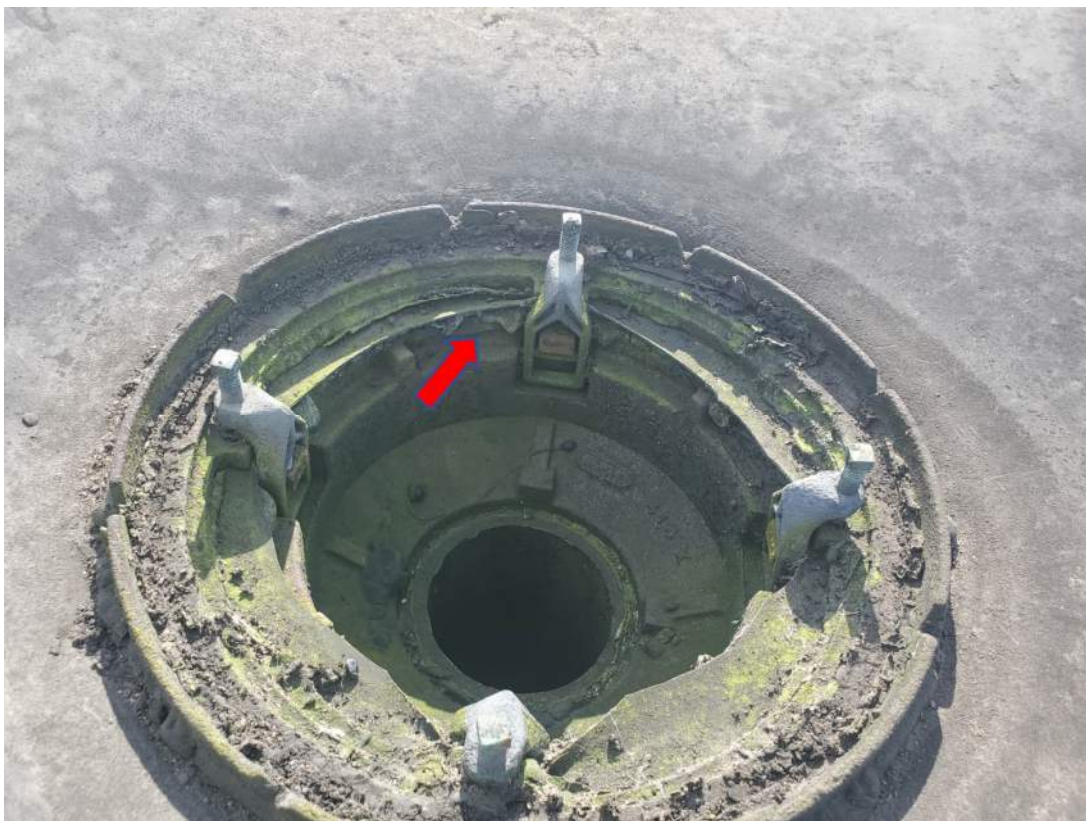
Photograph 18 – View of Roof 3 non-ACM Roof Drain Grey Sealant Between Roof Membrane and Underlayment (ACM-42 & ACM-43)

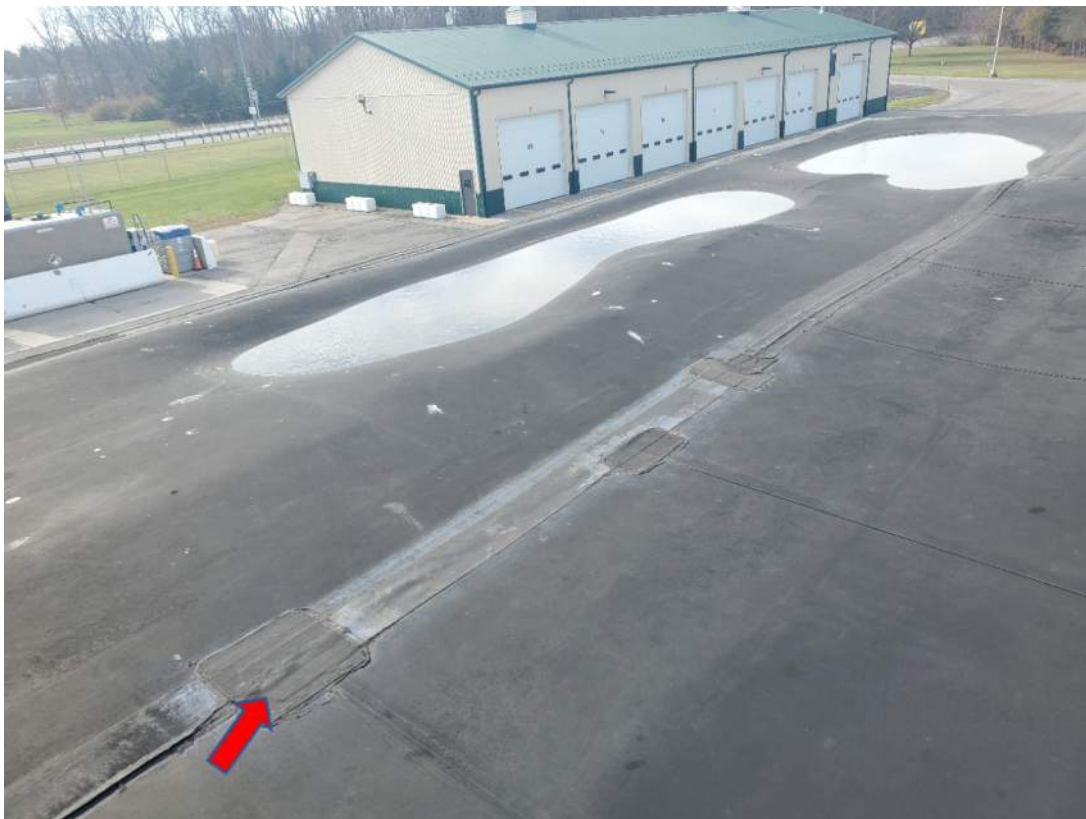
Photograph 19 – View of Roof 3 non-ACM Black Patching Sealant Material (ACM-44, ACM-45 & ACM-46)

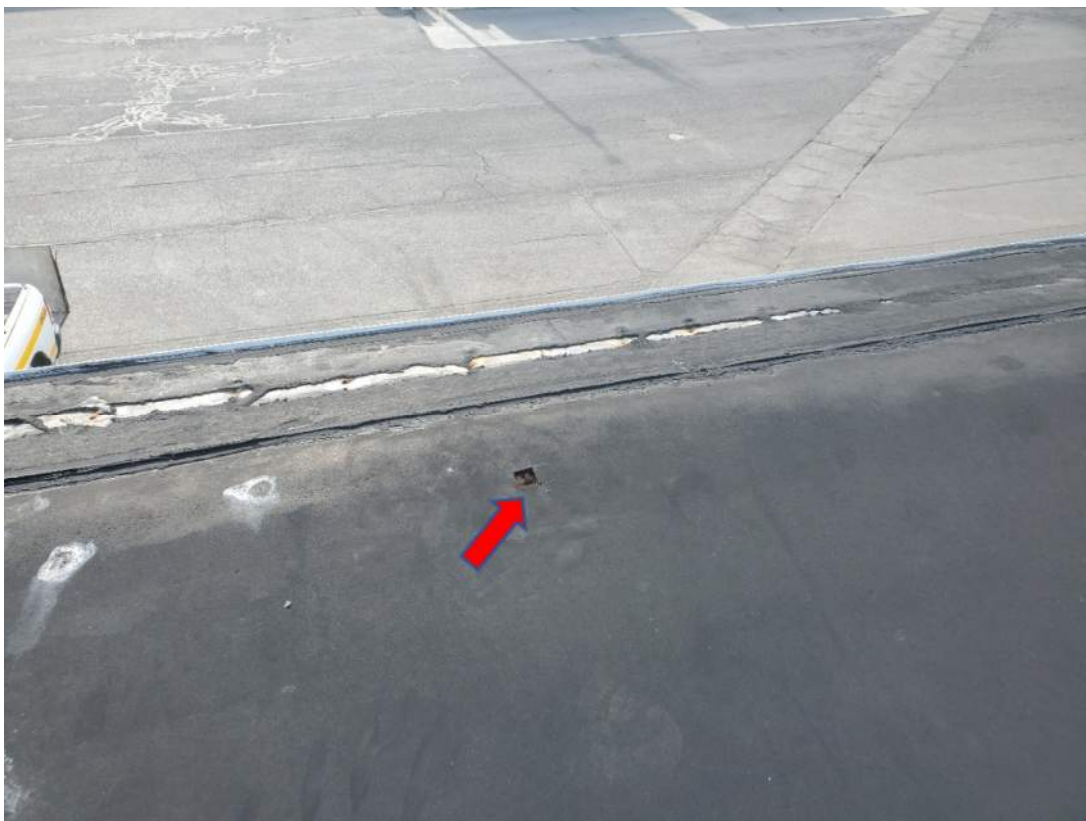
Photograph 20 – View of Roof 3 non-ACM Black Roof Membrane with Fibrous Black Backing Material (ACM-47, ACM-48 & ACM-49)

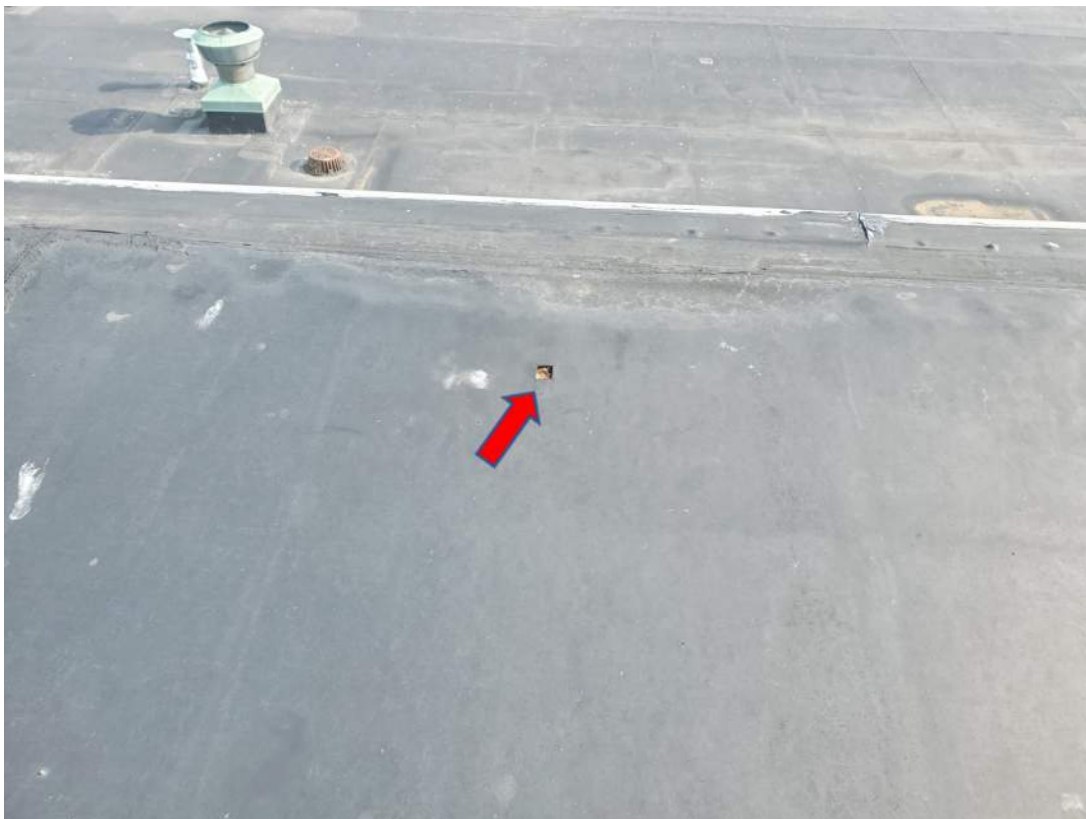
Photograph 21 – View of roof non-ACM Black Fibrous Backing with Tan Foam Material (ACM-50, ACM-51 & ACM-52)

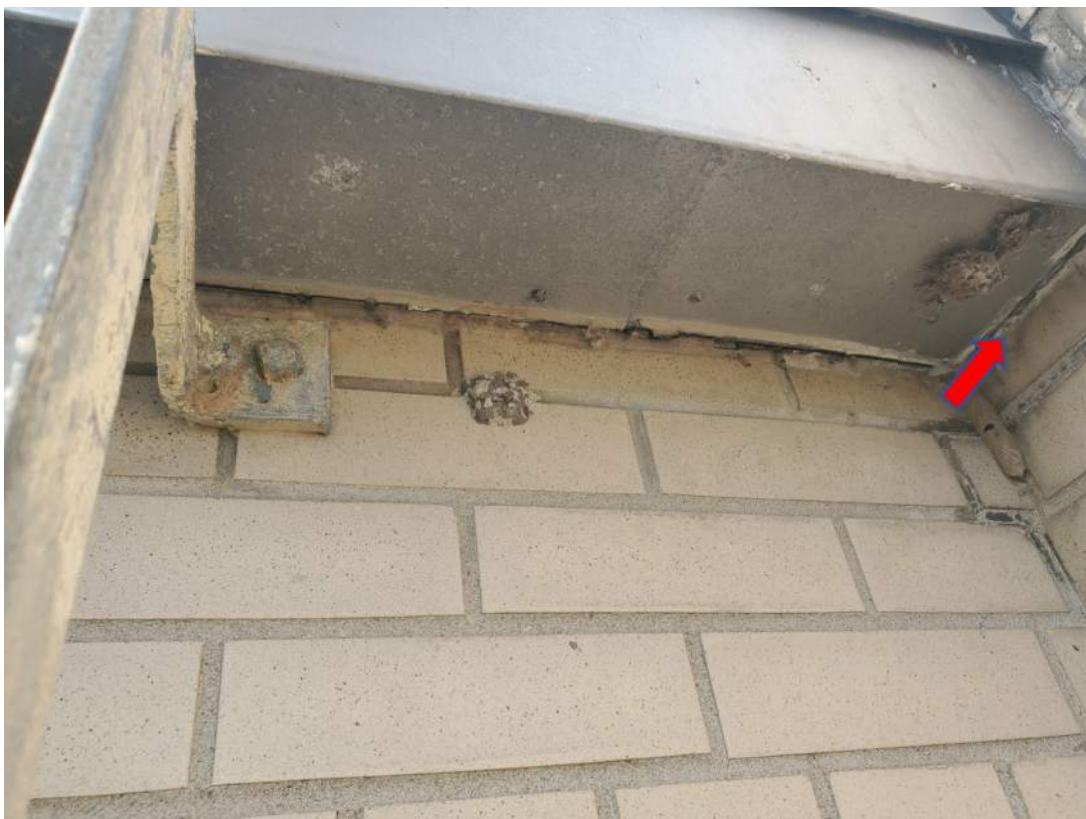
Photograph 22 – View of Roof 3 ACM Overhang of Roof 1 Grey Fibrous Caulk (ACM-53 & ACM-54)

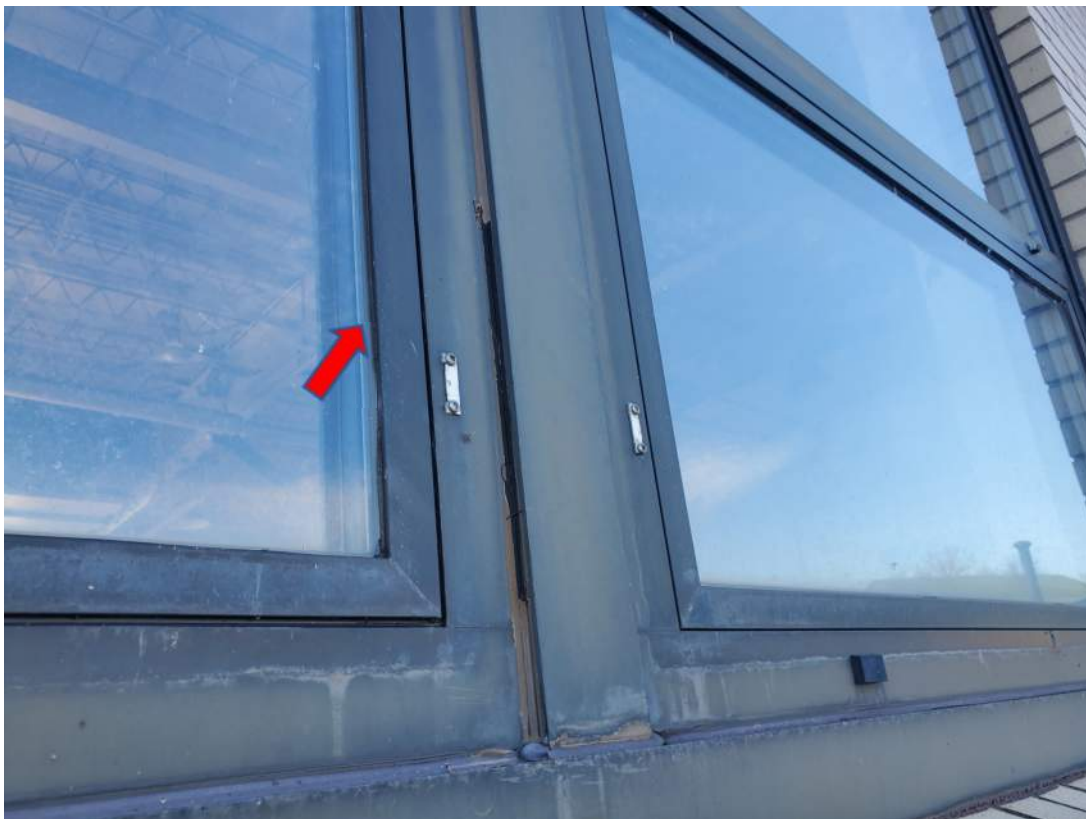
Photograph 23 – View of Garage Exterior non-ACM Black Window Glazing (ACM-63, ACM-64 & ACM-65)

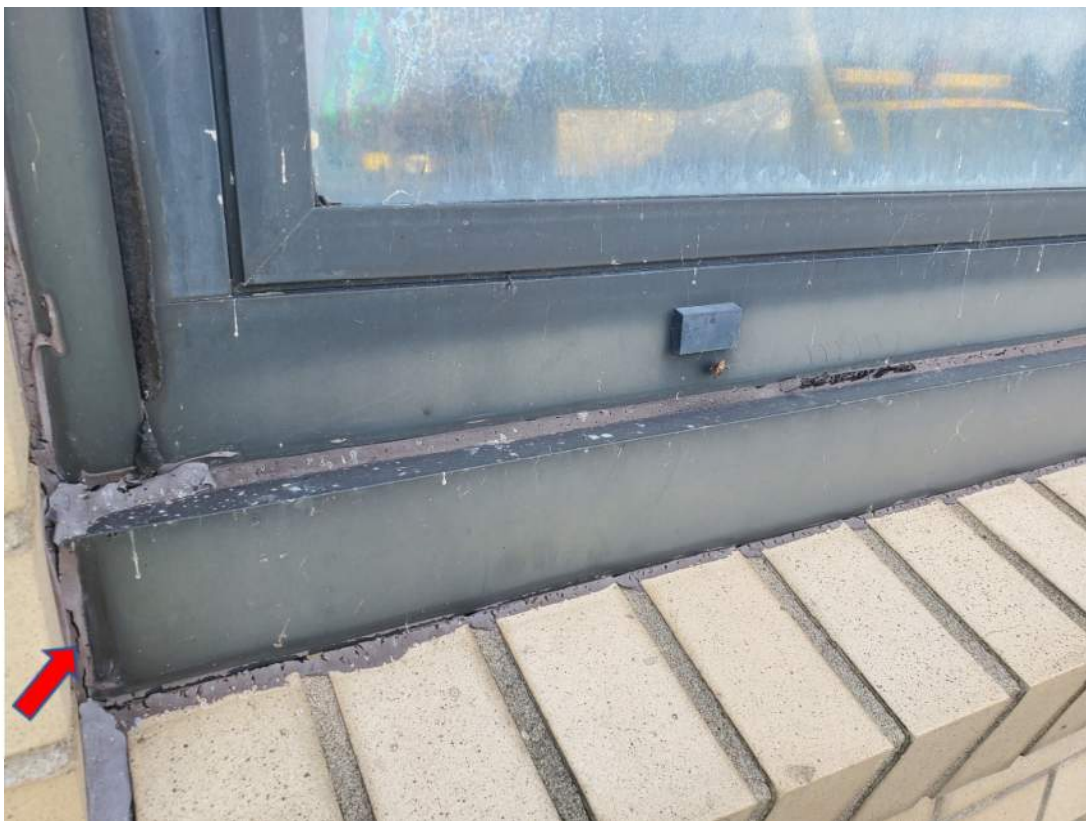
Photograph 24 – View of Garage Exterior non-ACM Light Black Window Framing Caulk (ACM-66, ACM-67 & ACM-68)

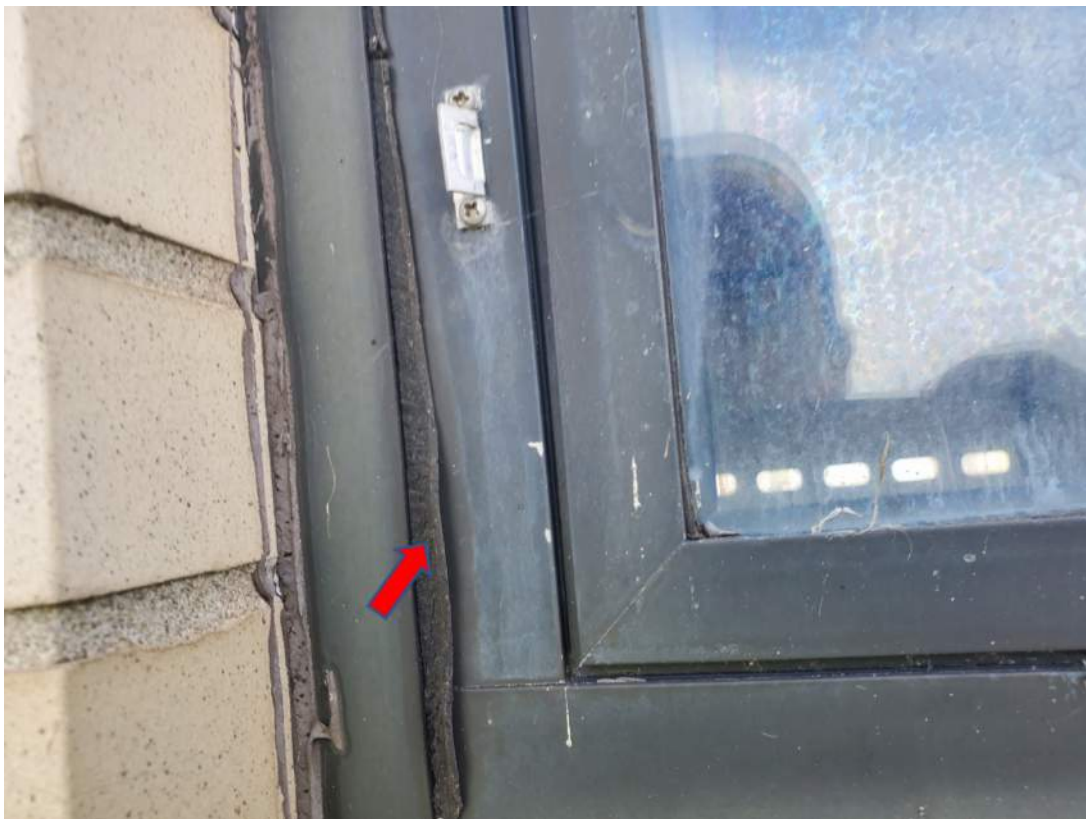
Photograph 25 – View Garage Exterior non-ACM Black Gasket Material (ACM-69 & ACM-70)
