## **INSPECTION FOR ASBESTOS-CONTAINING MATERIALS (SCOPE ASBESTOS REPORT)**

**MANCHESTER MAINTENANCE SECTION  
NYS THRUWAY EXIT 43  
MANCHESTER, NY 14504**

**PROTOTYPE ADDITIONS TO VARIOUS MAINTENANCE SECTION BUILDINGS  
NYSTA CONTRACT D214672**

**Re: Limited Pre-Demolition Asbestos Inspection  
Manchester Maintenance Section Addition and Roof Replacement  
1190 New York State Route 21  
Shortsville, New York 14548**

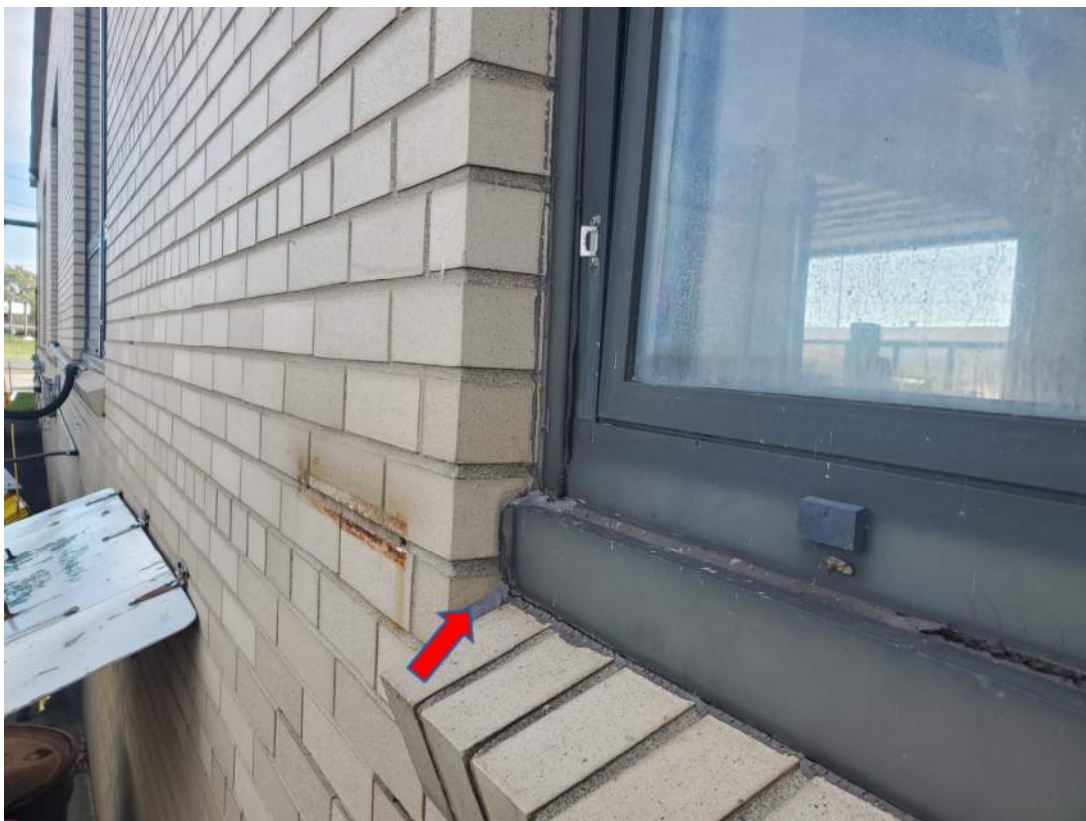
Photograph 26 – View of Garage Exterior non-ACM Light Grey Window Caulking (ACM-71 & ACM-72)

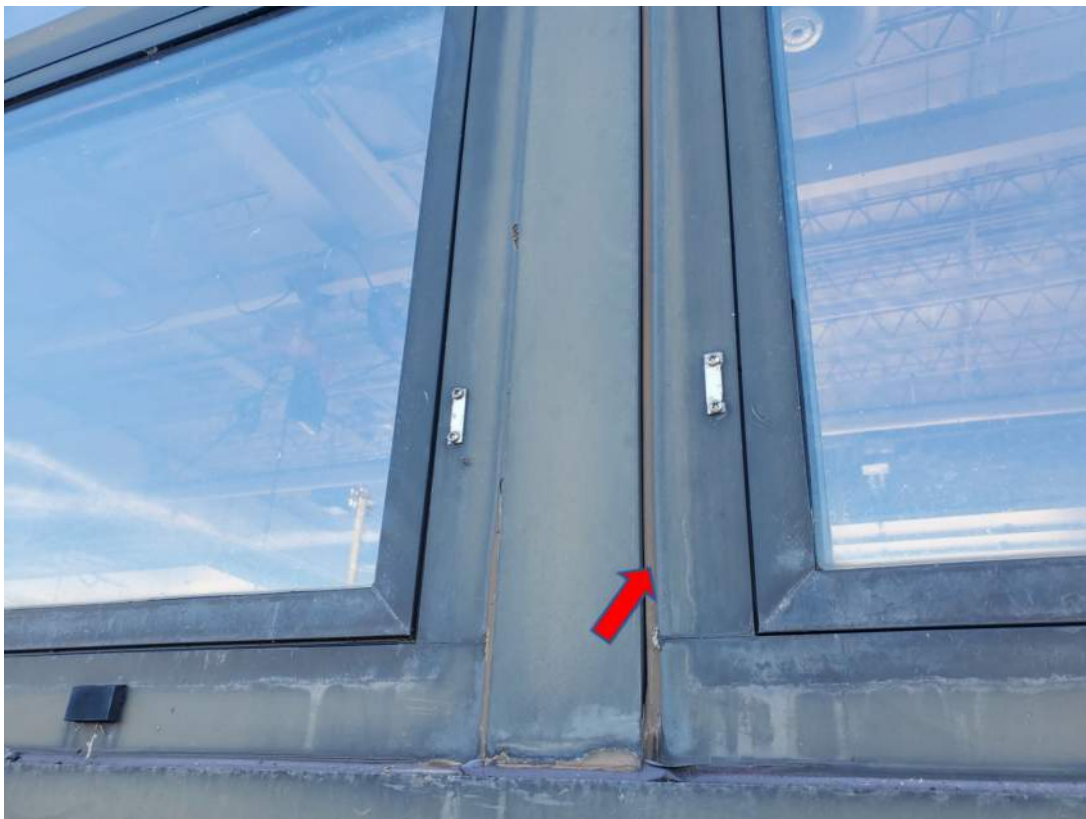
Photograph 27 – View of Garage Exterior non-ACM Brown Window Caulking (ACM-73, ACM-74 & ACM-75)

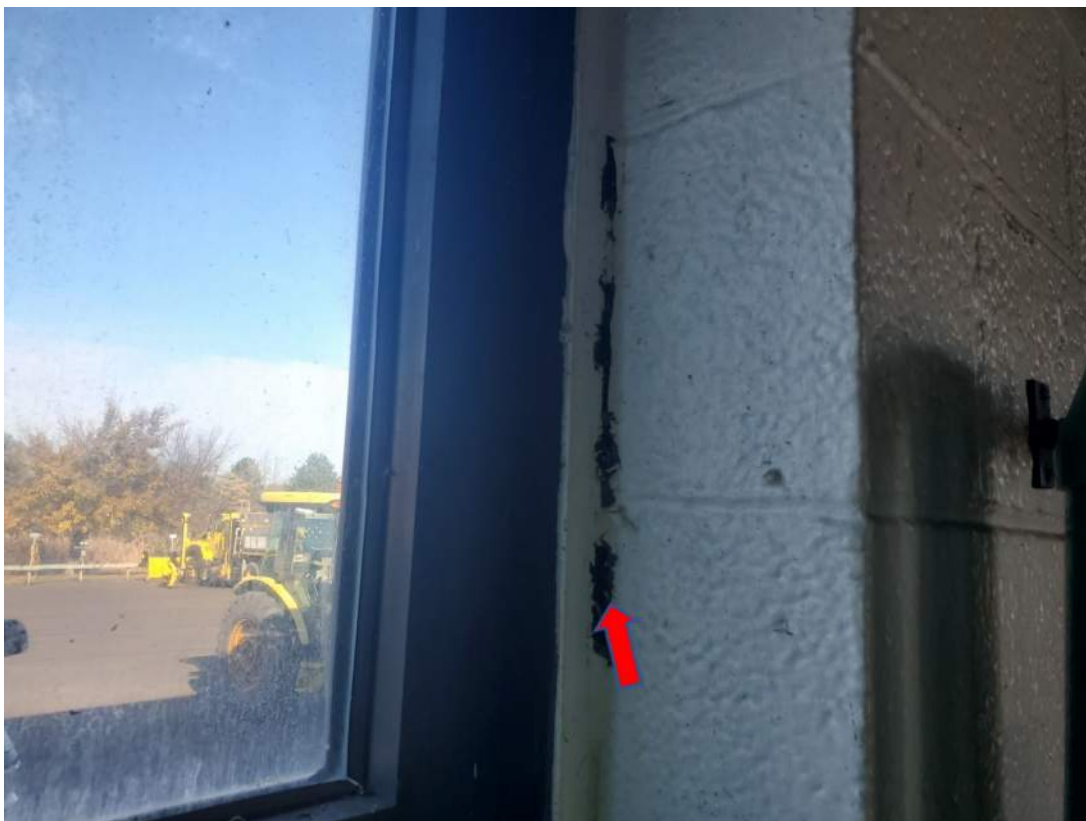
Photograph 28 – View of Garage Interior non-ACM Black Window Caulking (ACM-76, ACM-77 & ACM-78)
