FINAL DESIGN REPORT

Bridge Project
Interchange 35 Ramp over Interstate I-90
MP 278.93, BIN 5510090
PIN S52886 B413.1
Town of DeWitt
Onondaga County

PROJECT APPROVAL SHEET

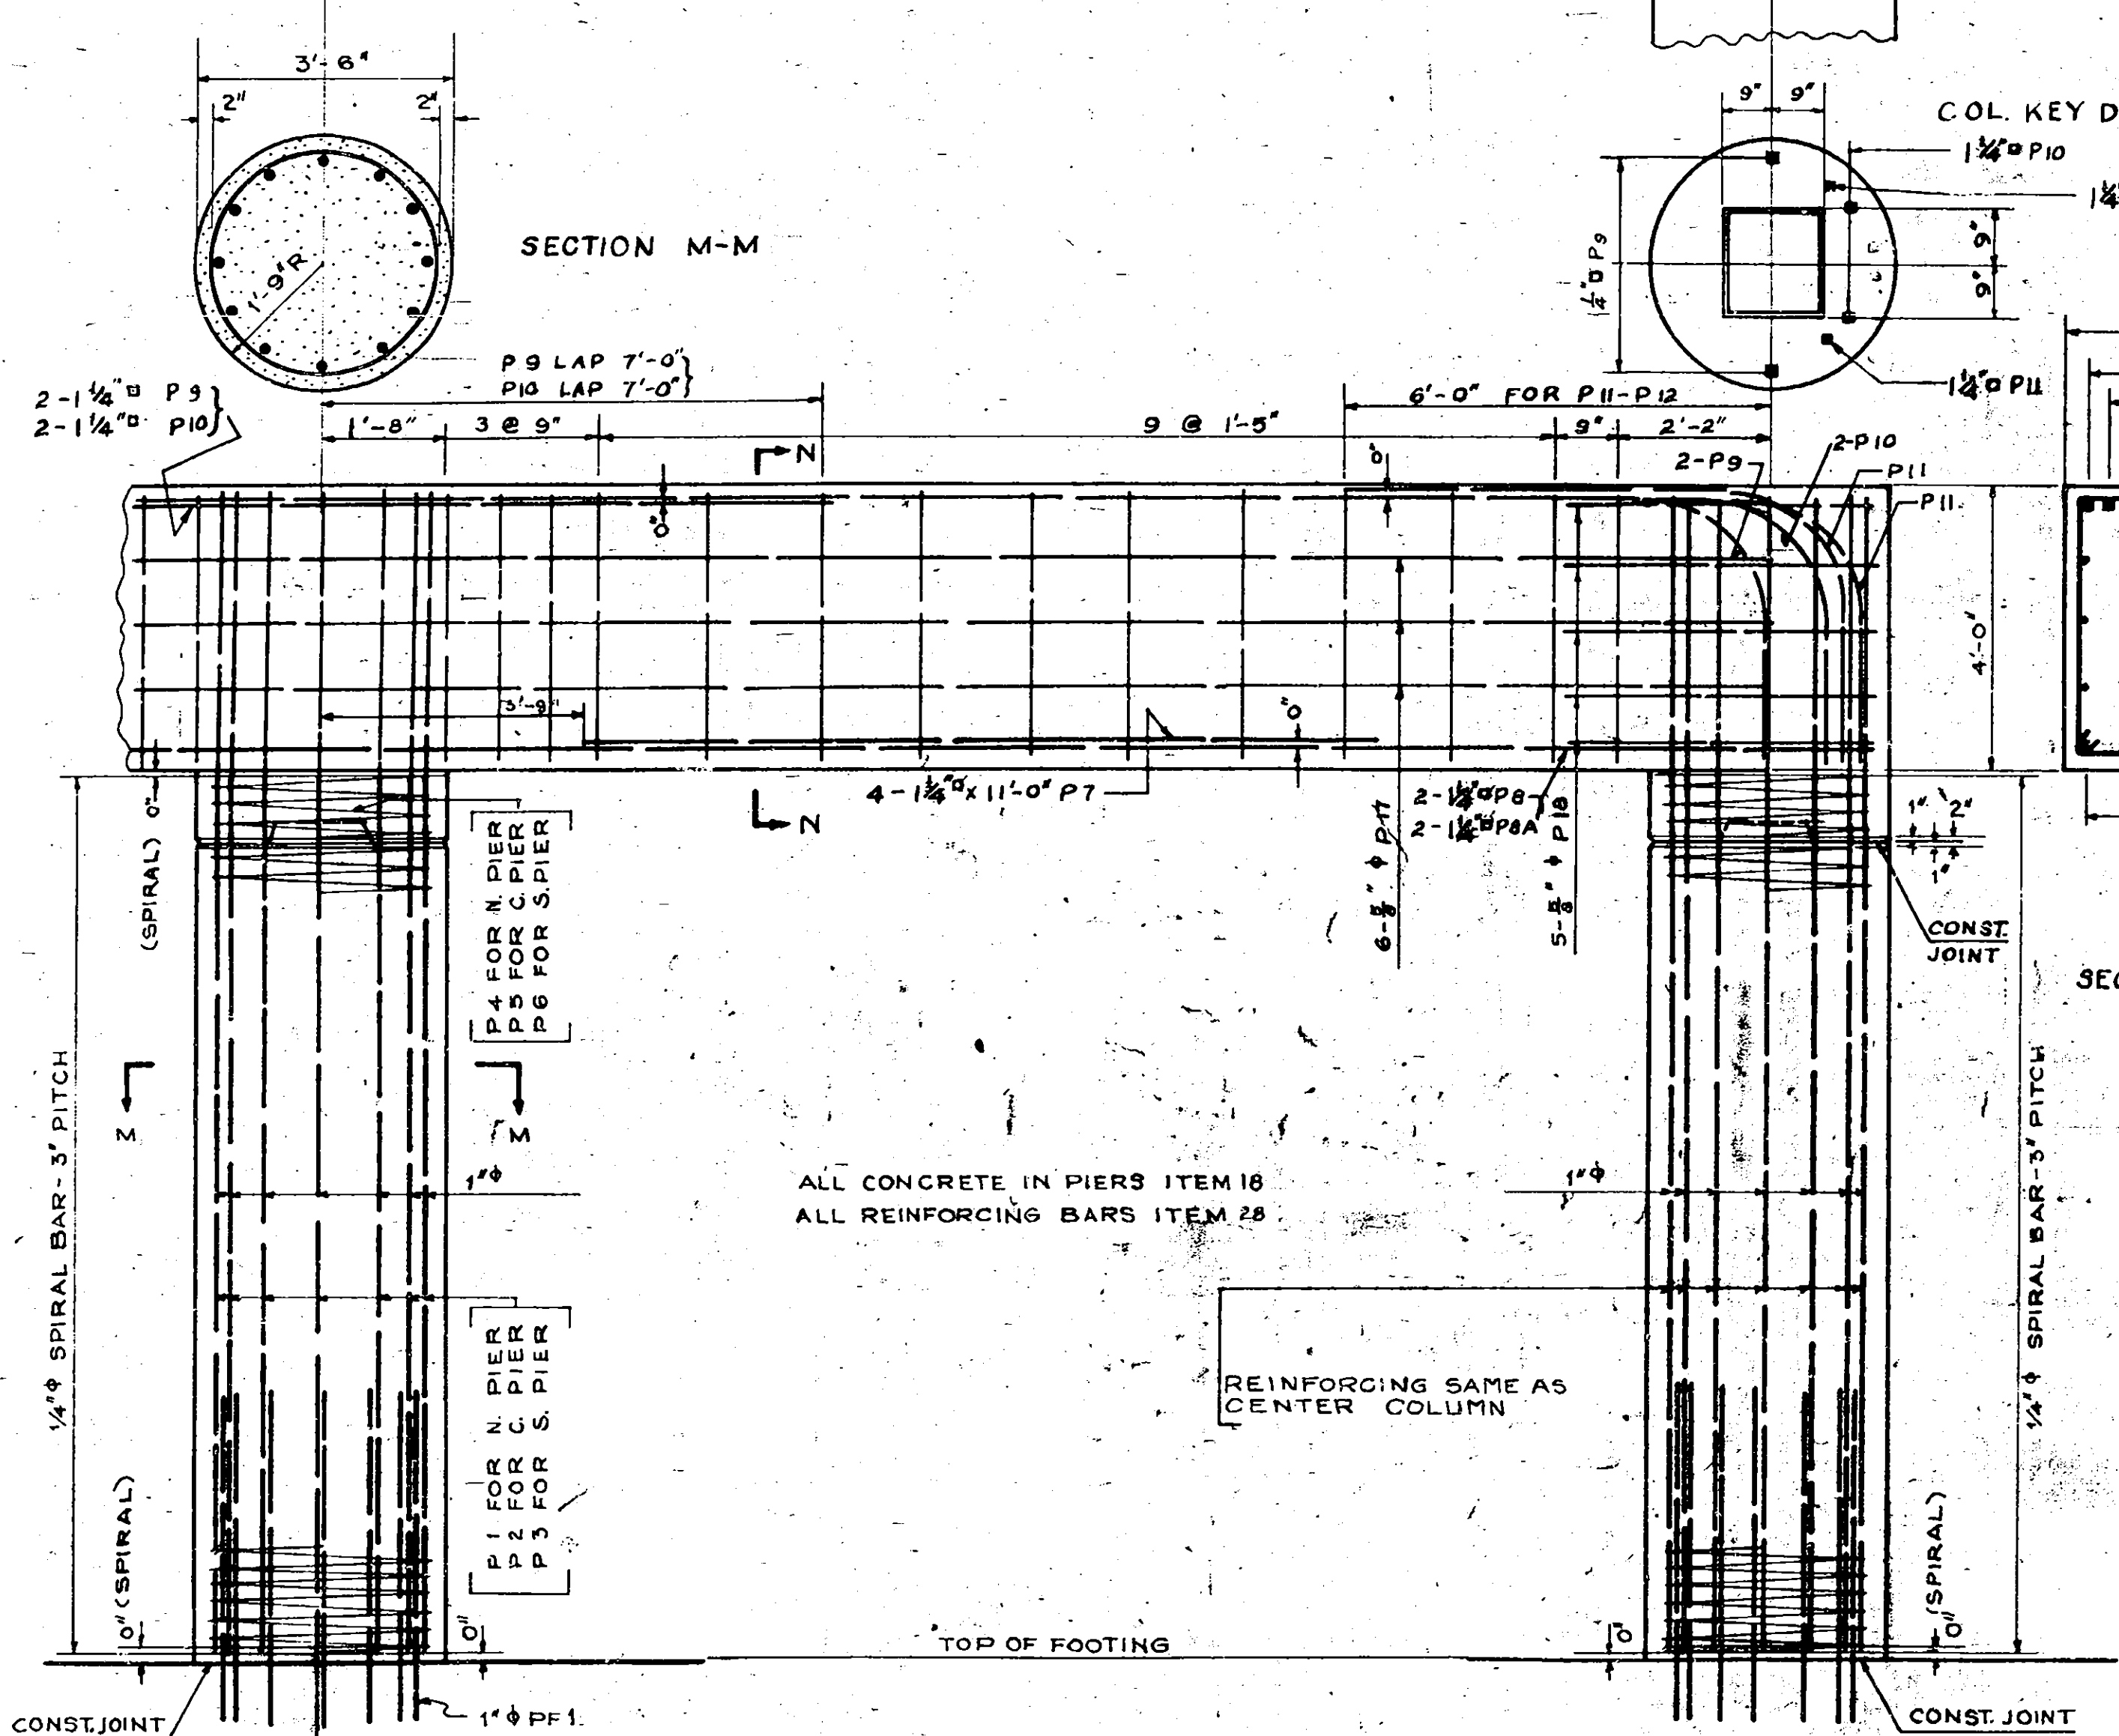
PIER DETAILS - ALL PIERS
SCALE 1/4"=1'-0"

FOR LAYOUT OF PIERS SEE SHEET 46
FOR DETAILS OF REINFORCING BARS SEE SHEET 54
FOR DETAILS OF PIER FOUNDATIONS SEE SHEET 46
FOR DETAILS OF ANCHOR BOLTS SEE SHEET 52

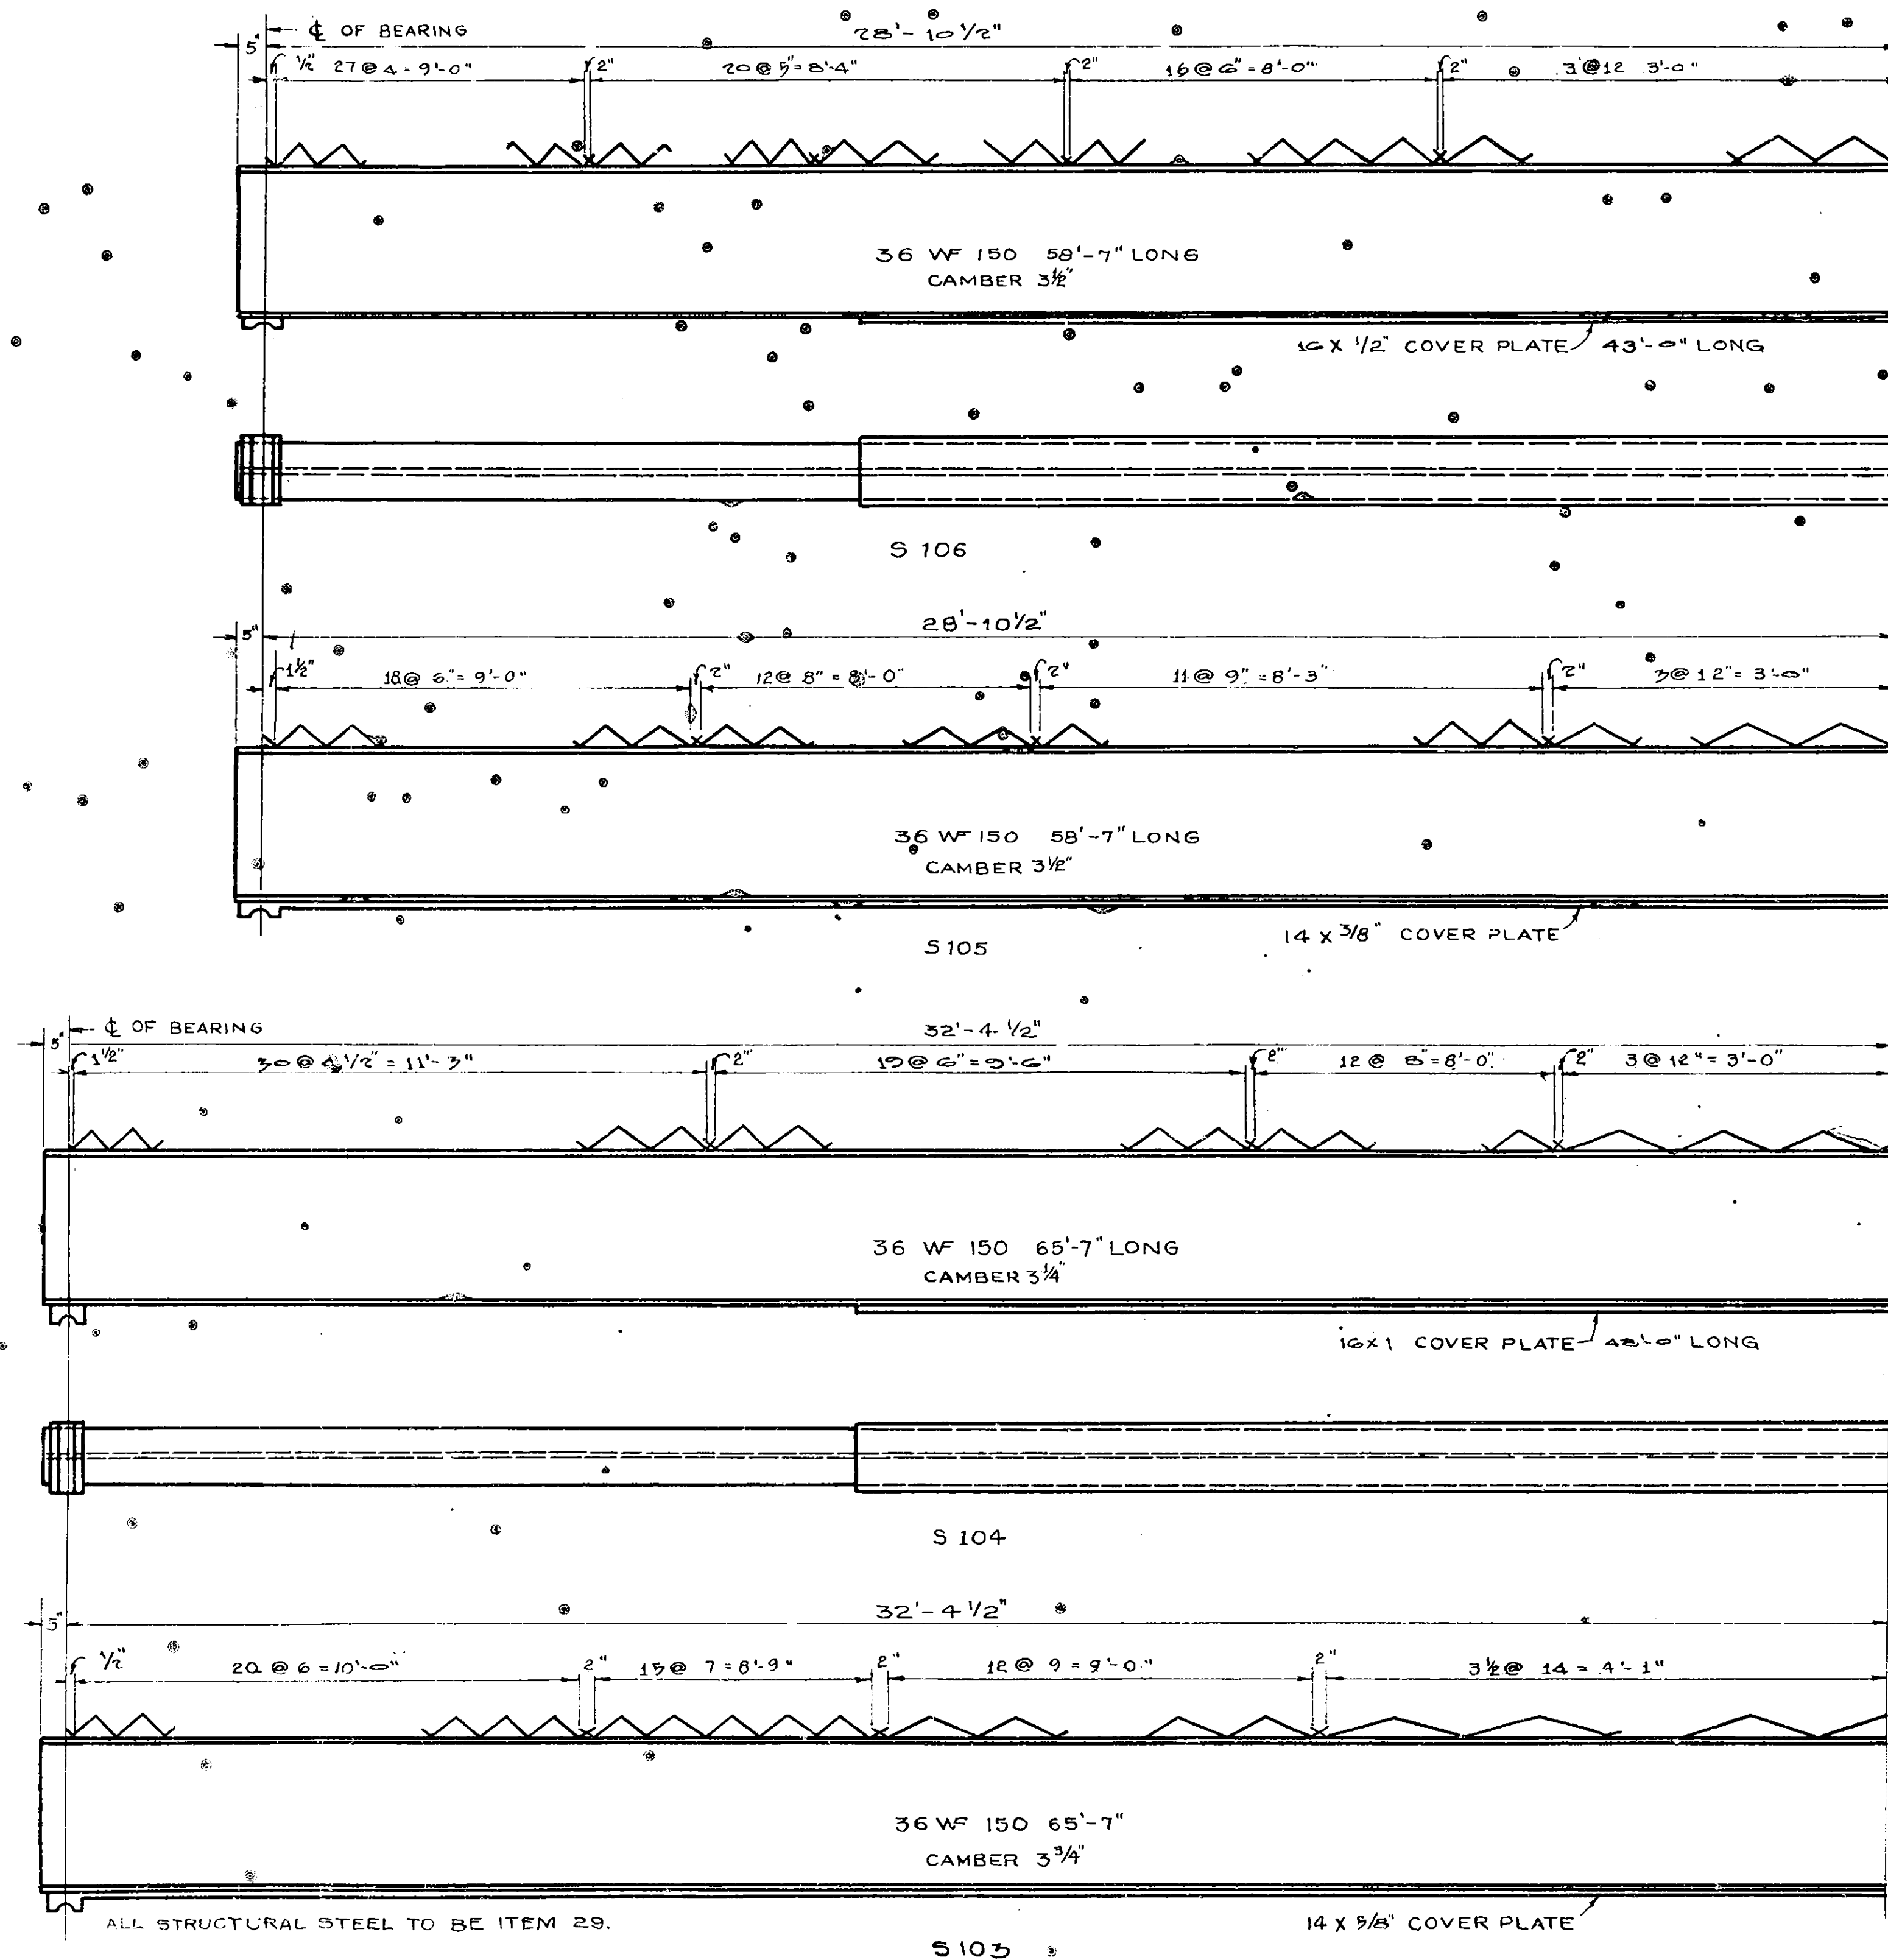
ALL COVER PLATES
TO BE WELDED WITH
5/16" CONTINUOUS
FILLET WELDS.

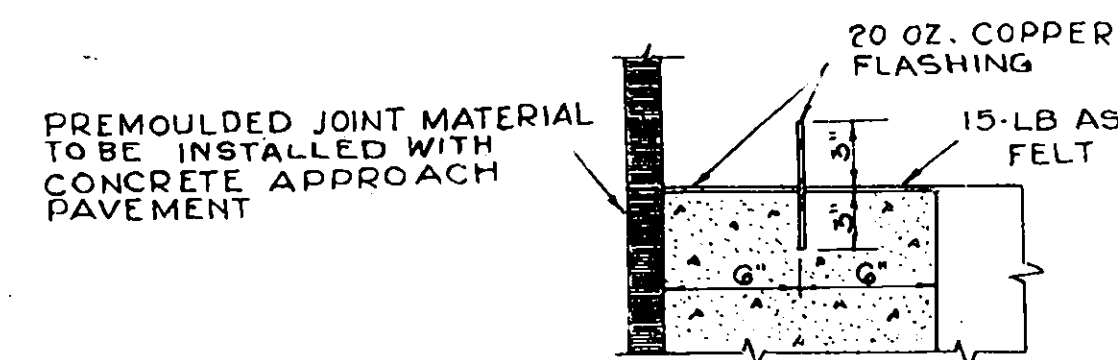
DETAIL B
SCALE 1/2" = 1'-0"

NOTE
FLASHINGS OR WATERSTOPS ARE TO BE PROTECTED FROM DAMAGE DURING THE COURSE OF CONSTRUCTION AS ORDERED BY THE ENGINEER BENDING OR ALTERING THE SHAPE AS SHOWN IN ANY MANNER WILL NOT BE ALLOWED.

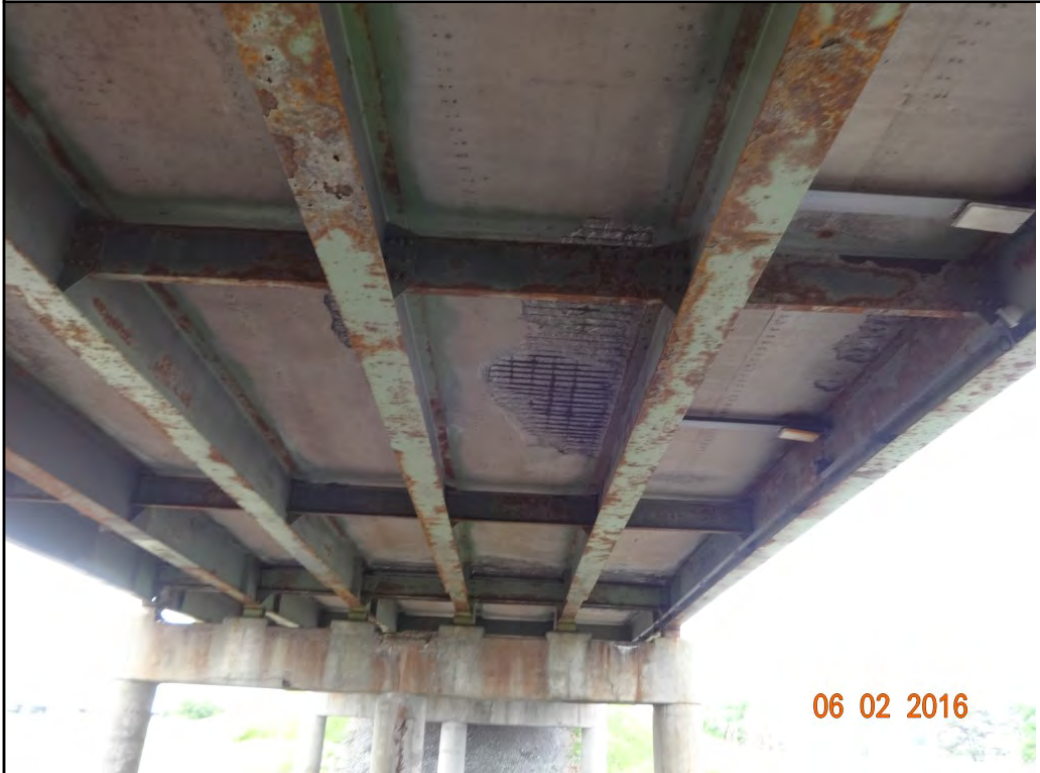
Photo Number: 2

Attachment Description:
Span 3 Paint and Deck -
Looking Towards Begin in
Bay 2 (Typical Condition)

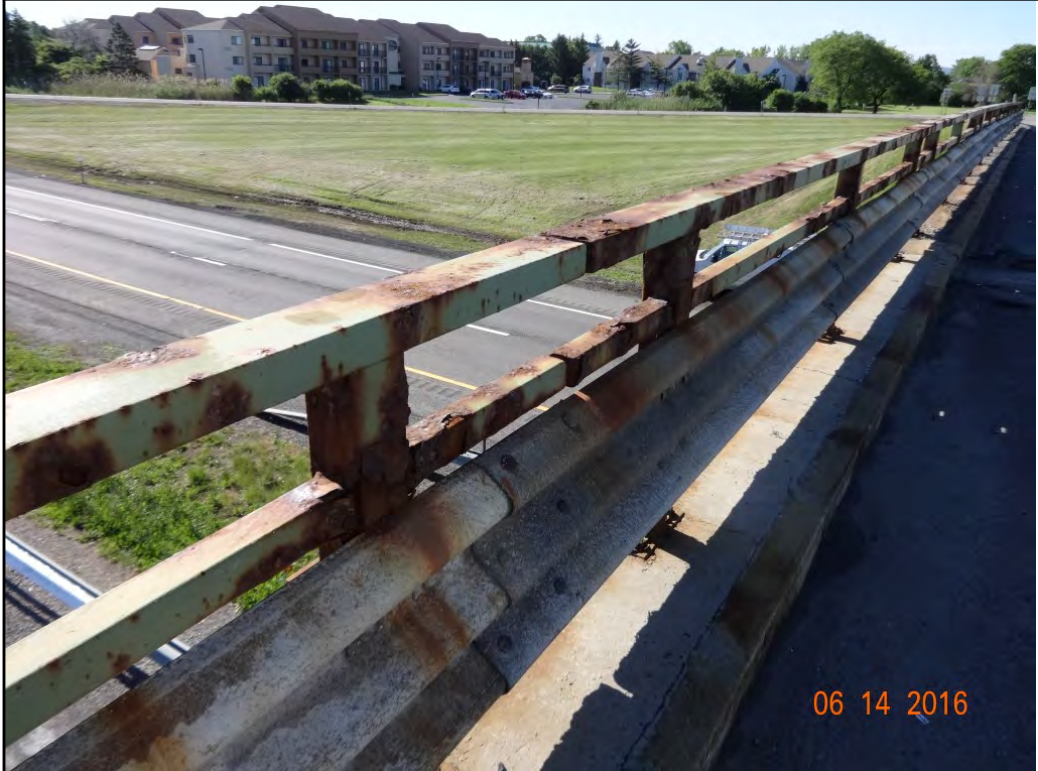
Photo Number: 4

Attachment Description:
Span 3 Railing Paint -
Looking Towards Begin at
Right Side Railing (Typical
Condition)

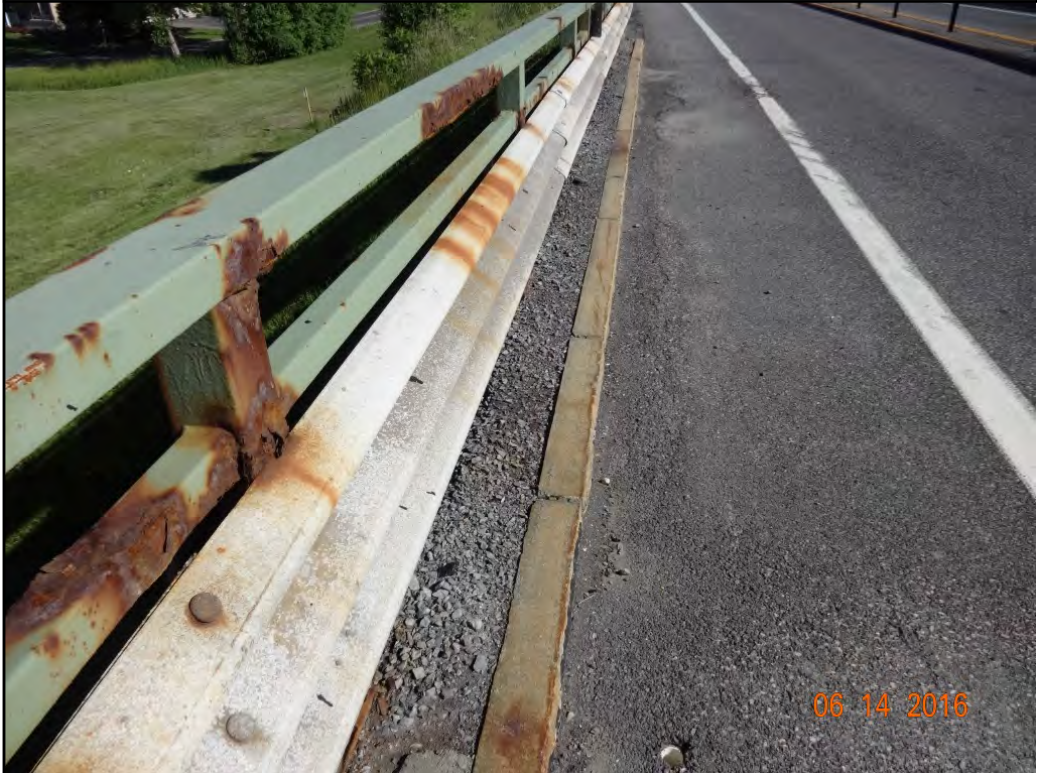
Photo Number: 6

Attachment Description:
Span 4 Sidewalk - Looking
Towards End Along Left
Sidewalk (Typical
Condition)

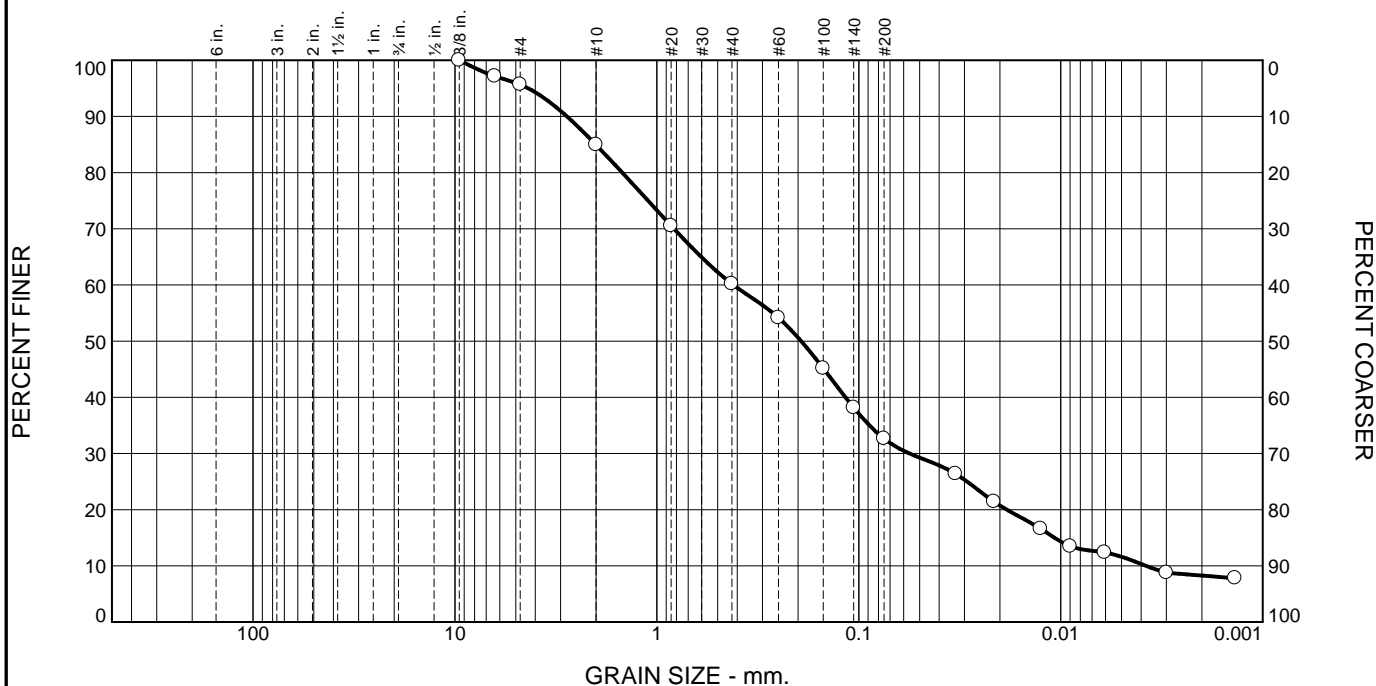
Particle Size Distribution Report

% +3"	% Gravel		% Sand			% Fines	
	Coarse	Fine	Coarse	Medium	Fine	Silt	Clay
0.0	0.0	4.3	10.8	24.7	27.6	21.0	11.6

TEST RESULTS (D422)			
Opening Size	Percent Finer	Spec.* (Percent)	Pass? (X=Fail)
.375"	100.0		
.25	97.1		
#4	95.7		
#10	84.9		
#20	70.5		
#40	60.2		
#60	54.2		
#100	45.2		
#140	38.2		
#200	32.6		
0.0332 mm.	26.4		
0.0214 mm.	21.4		
0.0126 mm.	16.6		
0.0090 mm.	13.5		
0.0061 mm.	12.4		
0.0030 mm.	8.8		
0.0014 mm.	7.8
