# **SYRACUSE DIVISION BUNDLED BRIDGES**

**TAS 17-37B, Contract D800001**

## **DB CONTRACT DOCUMENTS PART 7 ENGINEERING DATA**

# HAZARDOUS WASTE/CONTAMINATED MATERIALS SCREENING (FINAL)

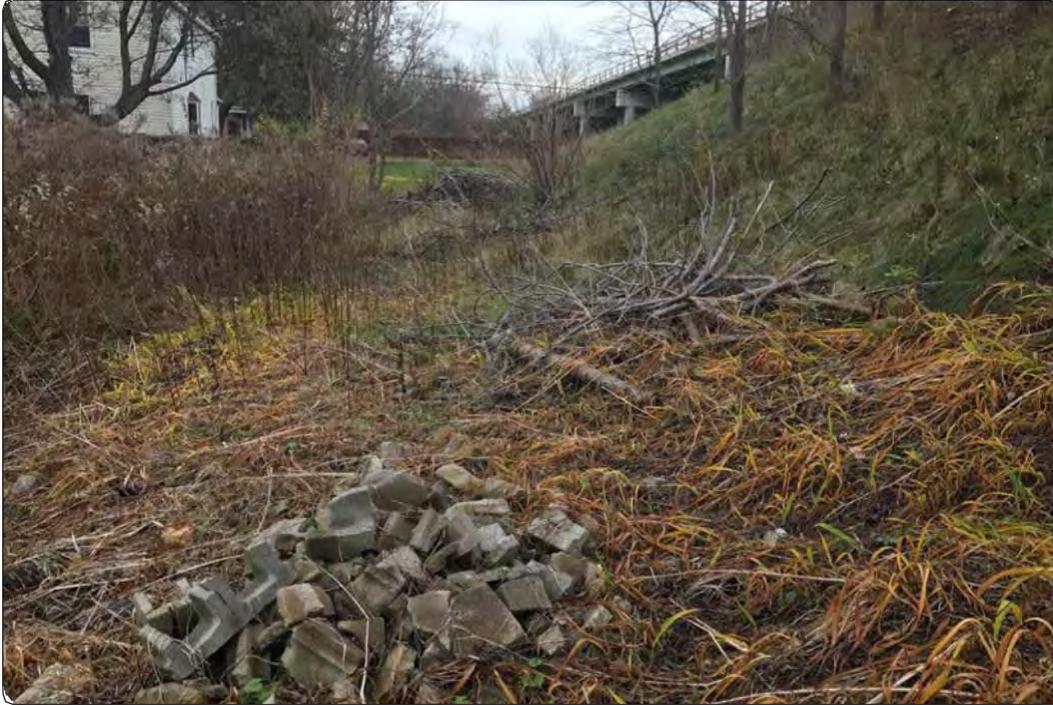
Photo 7

Example of solid waste debris noted at edge of Study Area; elevated section of Thruway over Main Street visible

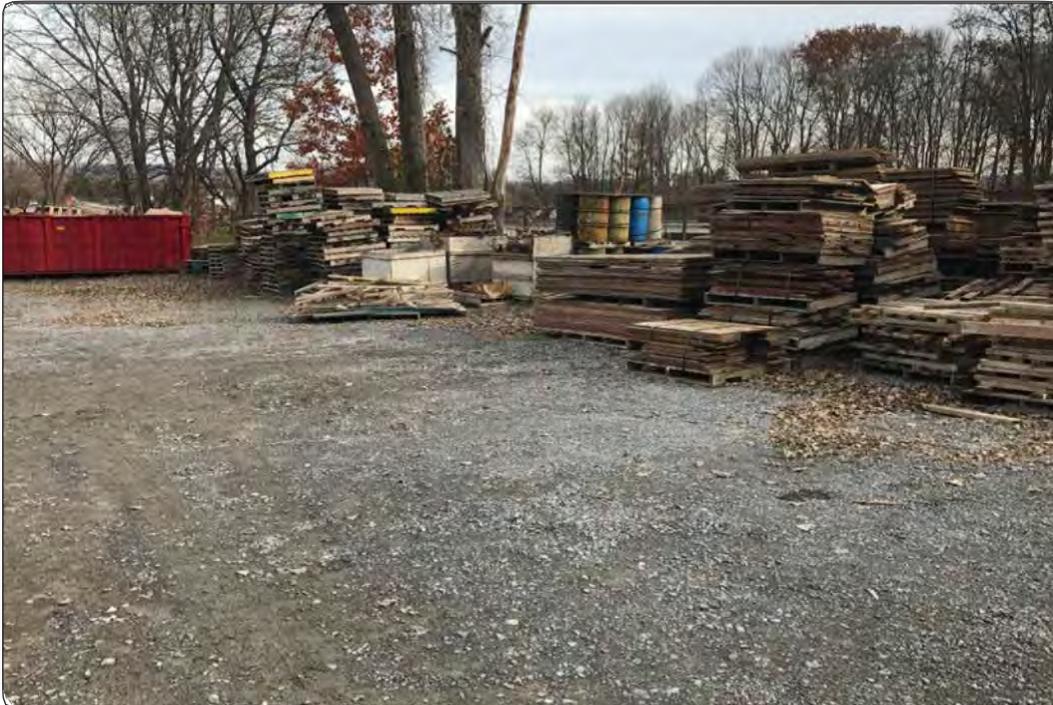
Photo 8

- Murnane Associates, Inc., a commercial building contractor, is located adjacent to the Study Area to the north of the Thruway. A storage yard on this parcel was noted to contain building supplies as well as several 55-gallon drums. This property is a registered Petroleum Bulk Storage facility, and which reportedly has one current 1,000-gallon fuel oil Underground Storage Tanks (UST). This facility also has reportedly had historic USTs containing gasoline. No spills or releases have been reported for this adjacent property. However, due to the use of oil and/or hazardous materials (OHM) and proximity to the Study Area, soils excavated adjacent to this parcel should be observed for potential evidence of contamination. As needed, appropriate sampling is recommended.

Construction materials and drums noted at Murnane Associates, adjacent to Study Area

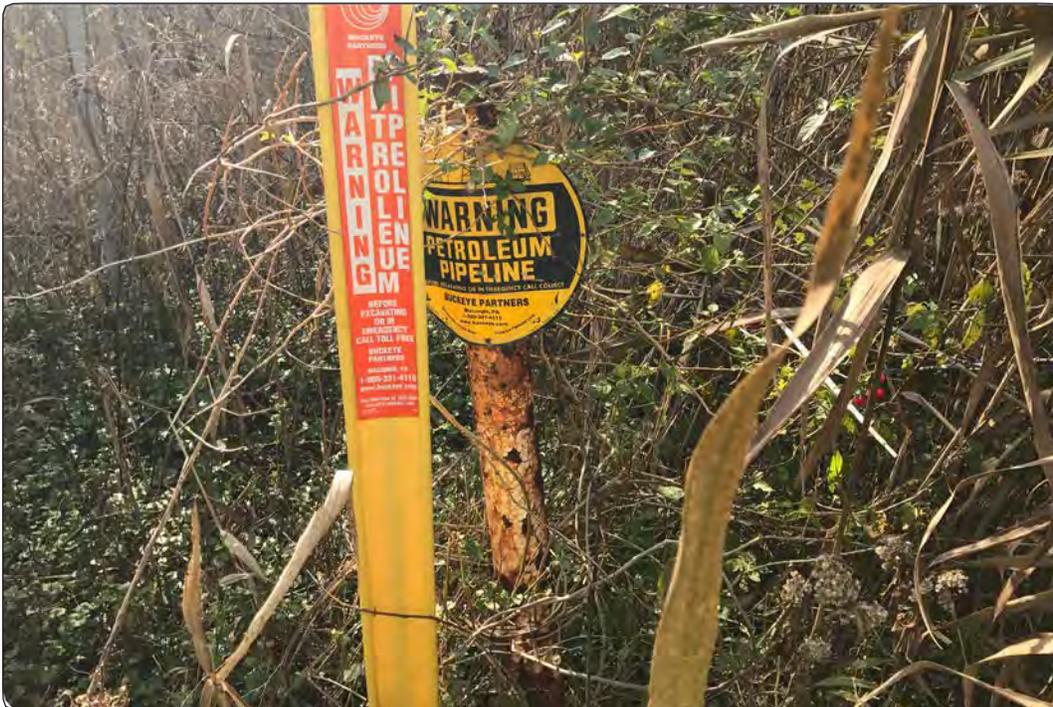
Photo 4

- A marker indicating the presence of a buried petroleum pipeline was observed along Watkins Street, adjacent to the Study Area. Based on the location of this marker, it is expected that the buried petroleum pipeline runs parallel to the Thruway in an east/west direction adjacent to the Study Area. Prior to excavations for the proposed Project, the location of the pipeline should be confirmed to avoid potential impacts to this pipeline.

View of marker for buried petroleum pipeline noted adjacent to the Study Area
