BIN: 5512790 **MP:** 262.01
Region: 2 **County:** 4 MADISON
Feature Carried: NORTH MAIN ST
Feature Crossed: 90IX
General Recommendation: 4
Condition Rating: 4.11
Inspect Date: 7/29/2015

New York State Thruway Authority - Bridge Inspection Report

2015 INSPECTION

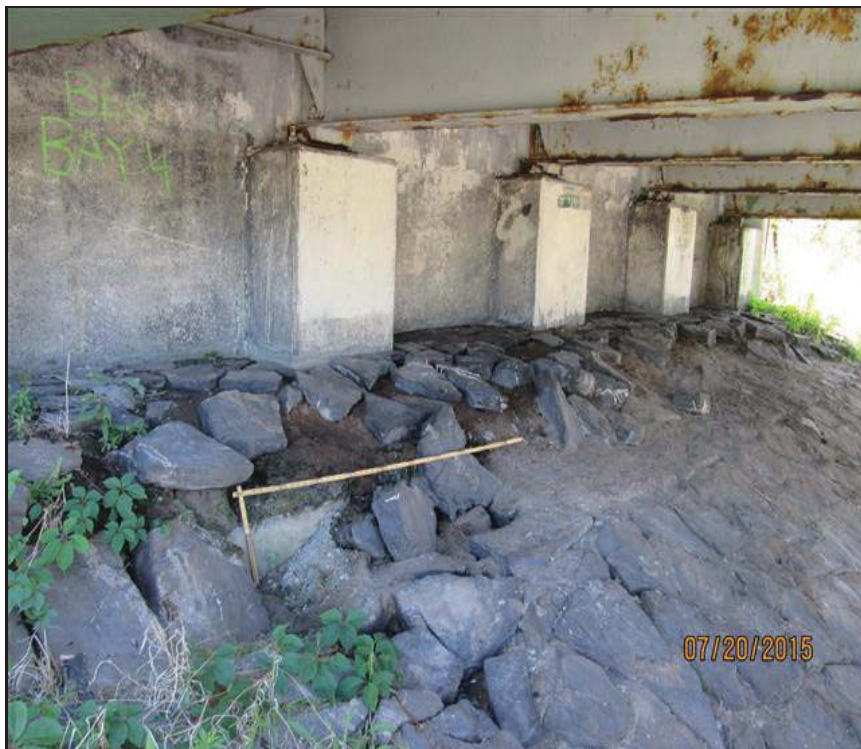
Location:	Photo Name:	Photo #:
Begin Abutment Slope Protection	262.01-349-32-00-15EroBeg.JPG	1

Form:	Item:	Item Desc:	Rate:
349	32	Erosion or Scour (Begin)	5

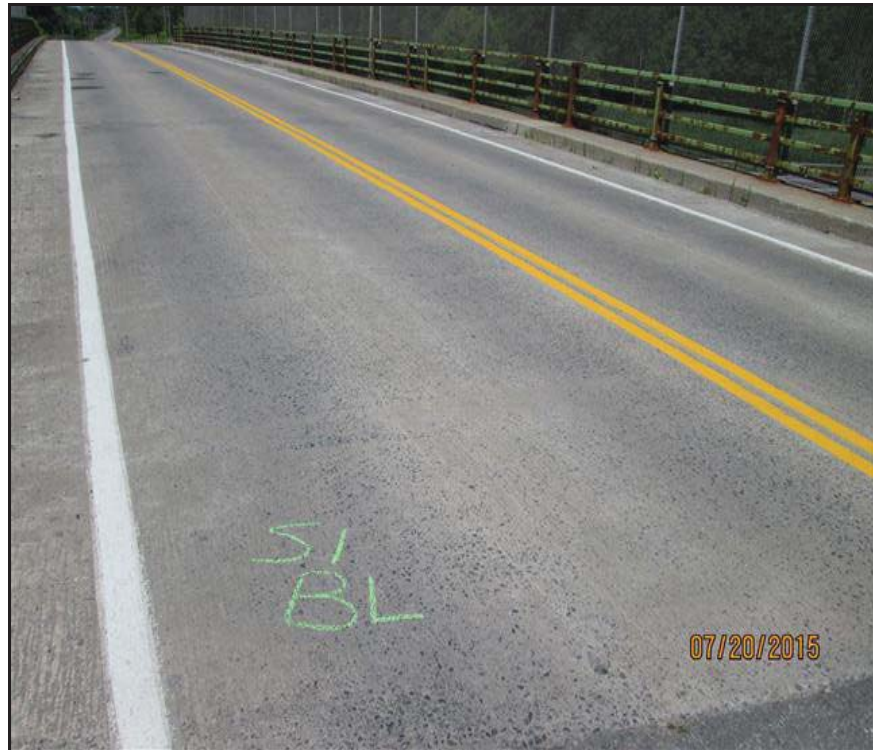
In all 4 Spans, the concrete Wearing Surface exhibits a general loss of the transverse grooving throughout. The exposed aggregate surface is fairly smooth, and the skid resistance of the wearing surface has been significantly reduced.

Form:	Item:	Item Desc:	Span:	Rate:
350	19	Wearing Surface	1	4

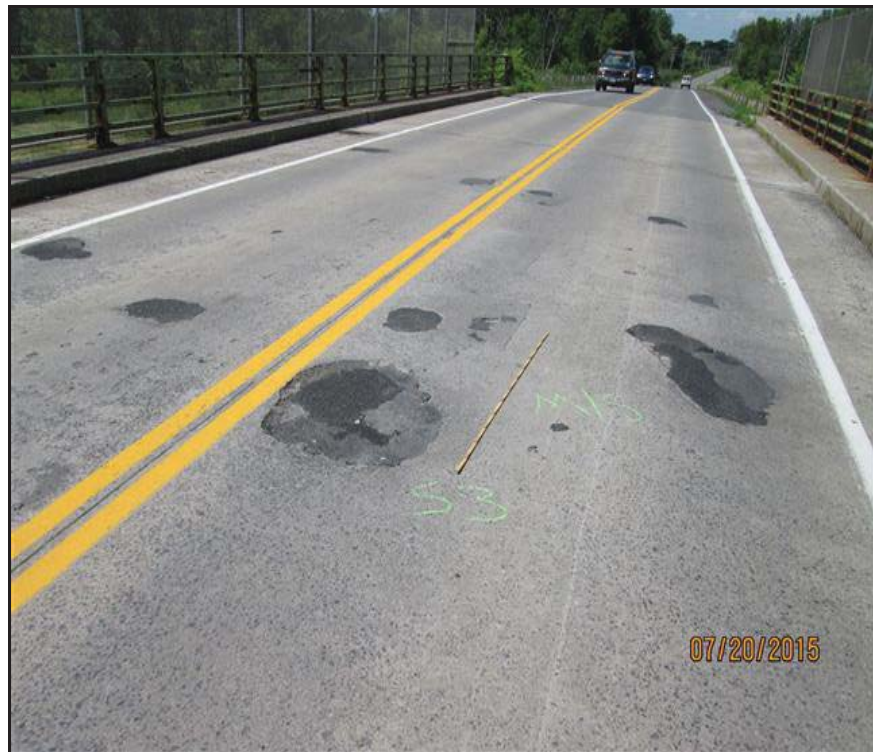
Location:	Photo Name:	Photo #:
Span 2, Wearing Surface in Left Travel Lane at Midspan	262.01-350-19-02-15WSsp2L.JPG	3

In Span 2, the Wearing Surface in the Left travel lane has several 2 SF areas of uneven asphalt patchwork near Midspan. The affected area represents 1% of the total surface in the span. Ride quality is slightly diminished.

Form:	Item:	Item Desc:	Span:	Rate:
350	19	Wearing Surface	3	3

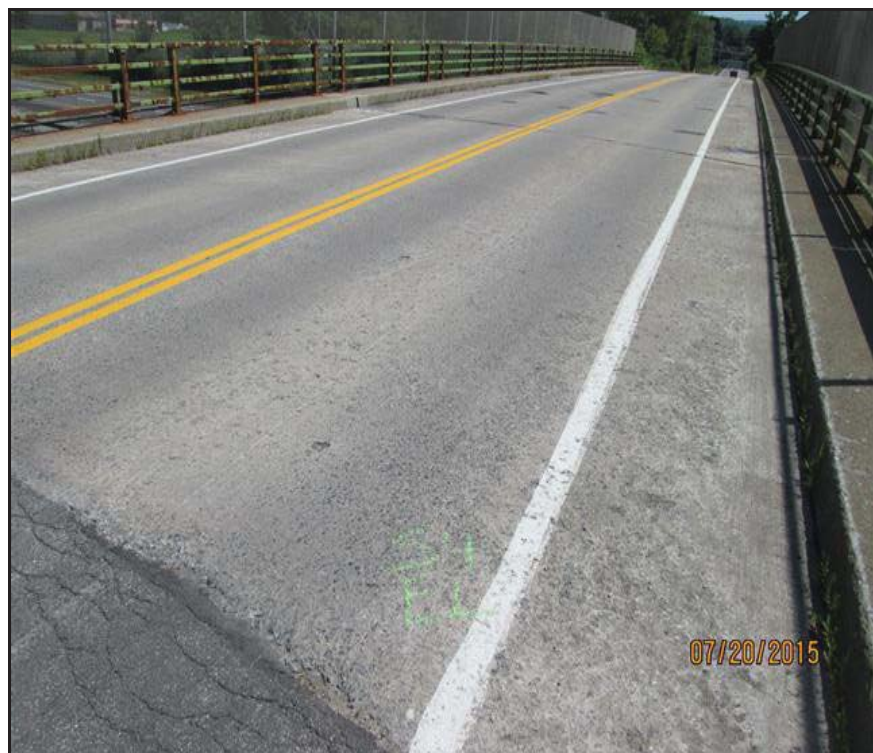
Location:	Photo Name:	Photo #:
Span 4, Wearing Surface from End Left.	262.01-350-19-04-15WSsp4E.JPG	5

Form:	Item:	Item Desc:	Span:	Rate:
350	19	Wearing Surface	4	4

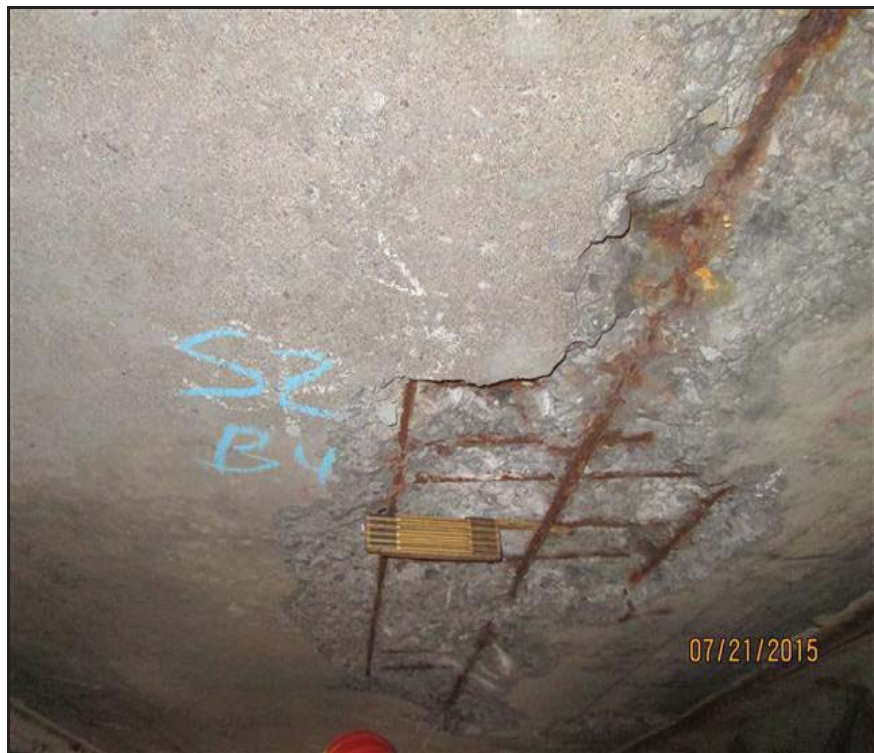
Location:	Photo Name:	Photo #:
Span 2, Bay 4 at Midspan from Begin	262.01-350-27-02-15DeckB2.JPG	9

Form:	Item:	Item Desc:	Span:	Rate:
350	27	Deck Structural	2	4

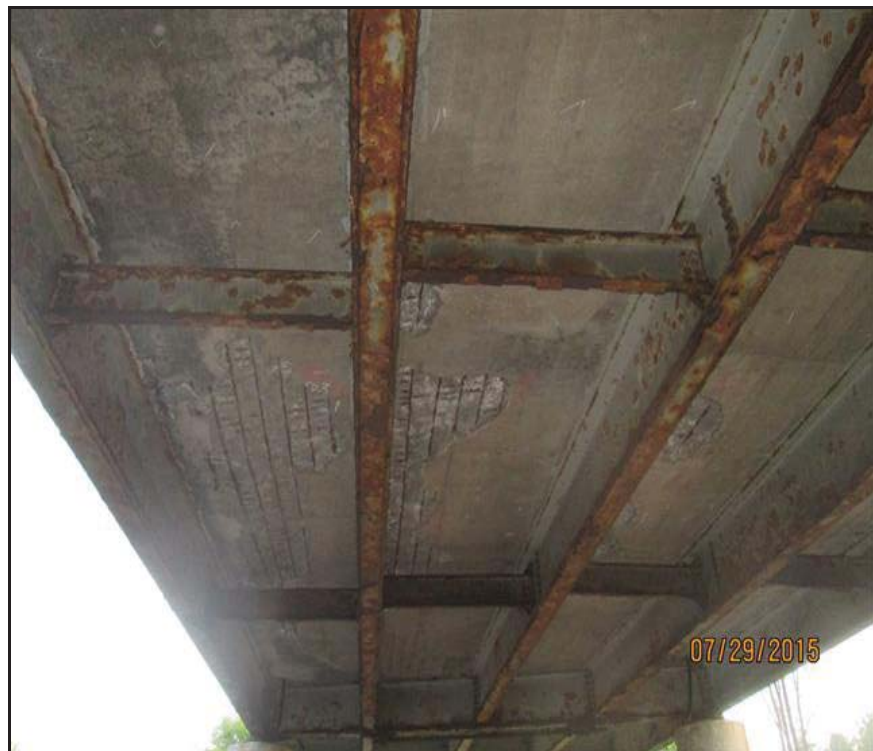
Location:	Photo Name:	Photo #:
Span 3 from Begin Left	262.01-350-27-03-15DeckS3.JPG	11

Form:	Item:	Item Desc:	Span:	Rate:
350	27	Deck Structural	3	3
350	30	Paint	3	3

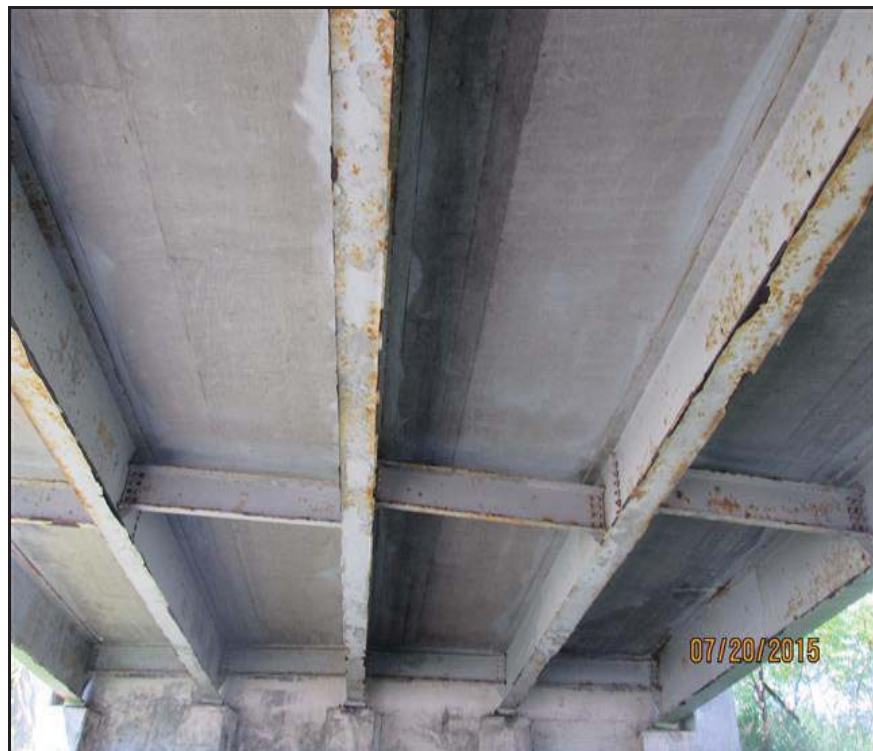
Location:	Photo Name:	Photo #:
Span 4 from Begin	262.01-350-27-04-15DeckS4.JPG	13

Form:	Item:	Item Desc:	Span:	Rate:
350	27	Deck Structural	4	5
350	30	Paint	4	4

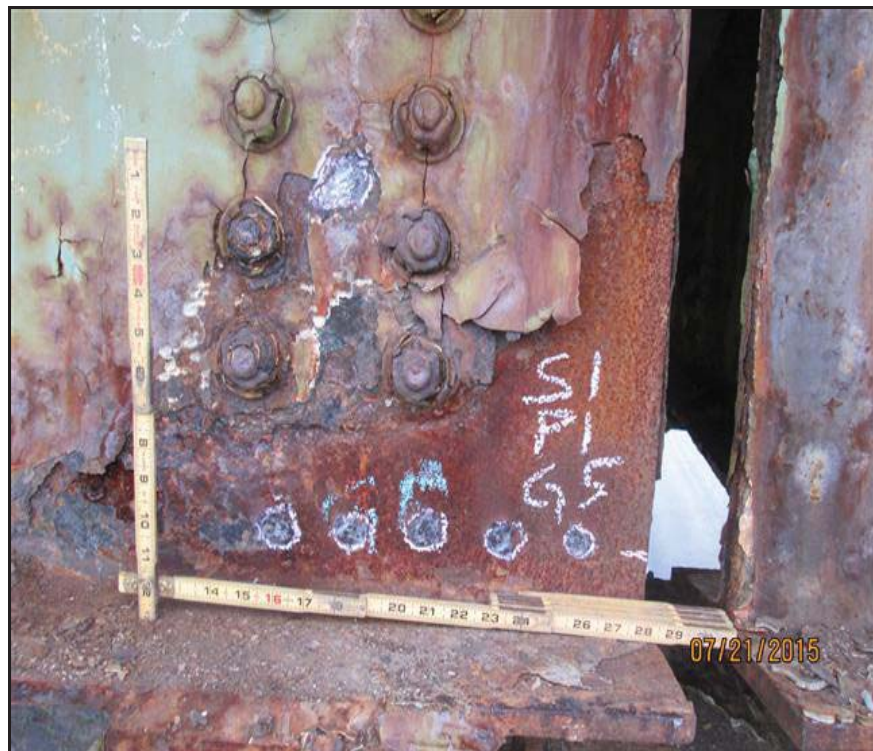
Location:	Photo Name:	Photo #:
Span 1, Girder G5 at Pier 1	262.01-350-28-01-15S1G5P1.JPG	15

Form:	Item:	Item Desc:	Span:	Rate:
350	28	Primary Members	1	5
350	30	Paint	1	4

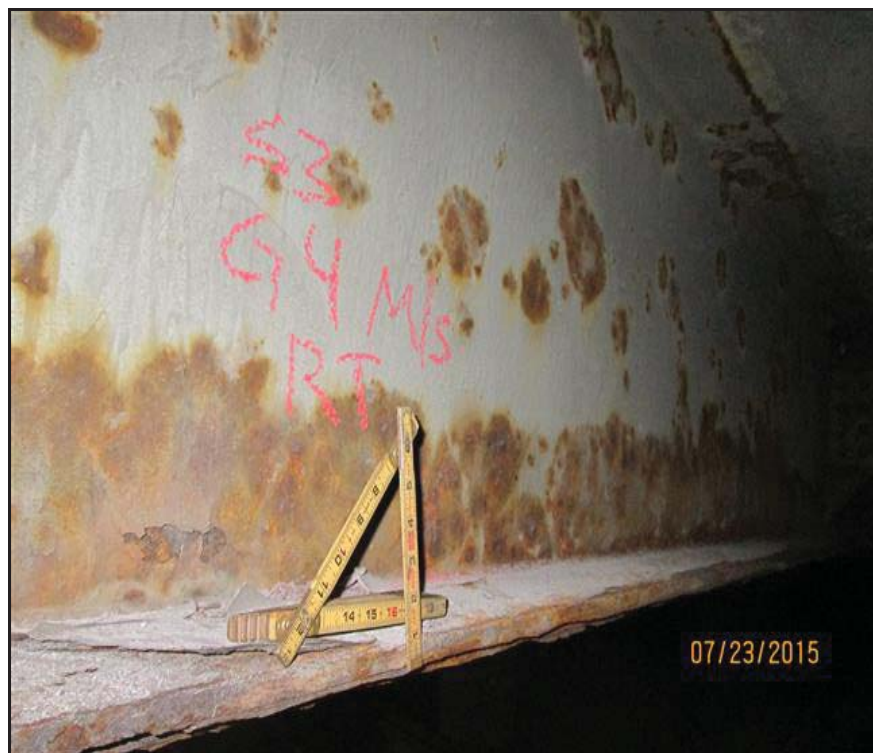
Location:	Photo Name:	Photo #:
Span 3, Girder G4 from Right at Midspan (Typical for All 5 Girders)	262.01-350-28-04-15S3G4MS.JPG	19

Form:	Item:	Item Desc:	Span:	Rate:
350	28	Primary Members	3	5
350	30	Paint	3	3

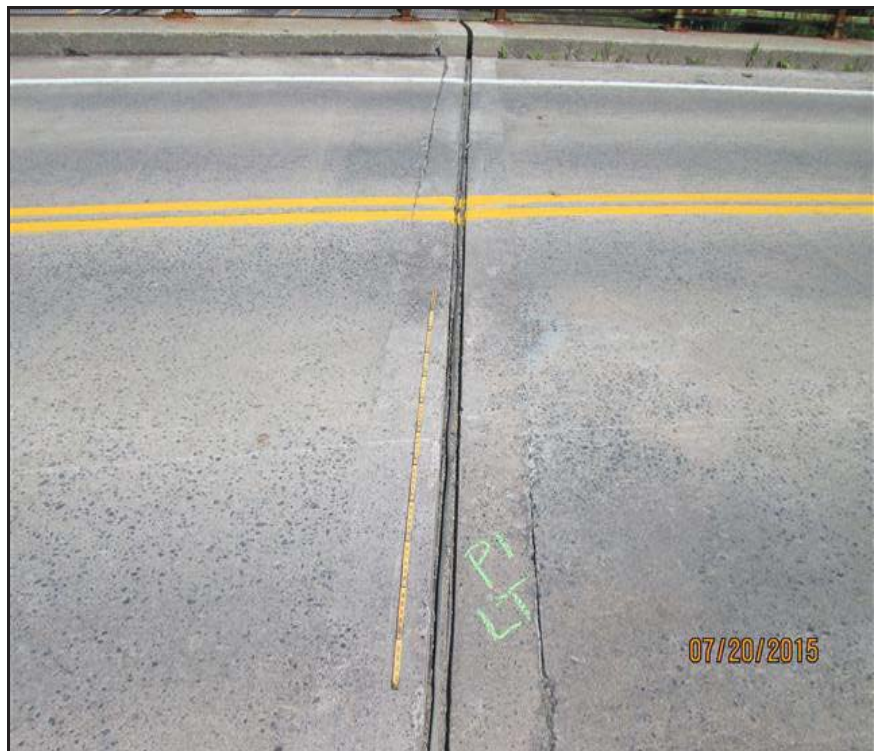
Location:	Photo Name:	Photo #:
Pier 1 Joint from Left	262.01-350-31-00-15JointL.JPG	21

Form:	Item:	Item Desc:	Span:	Rate:
350	31	Joints	1	4

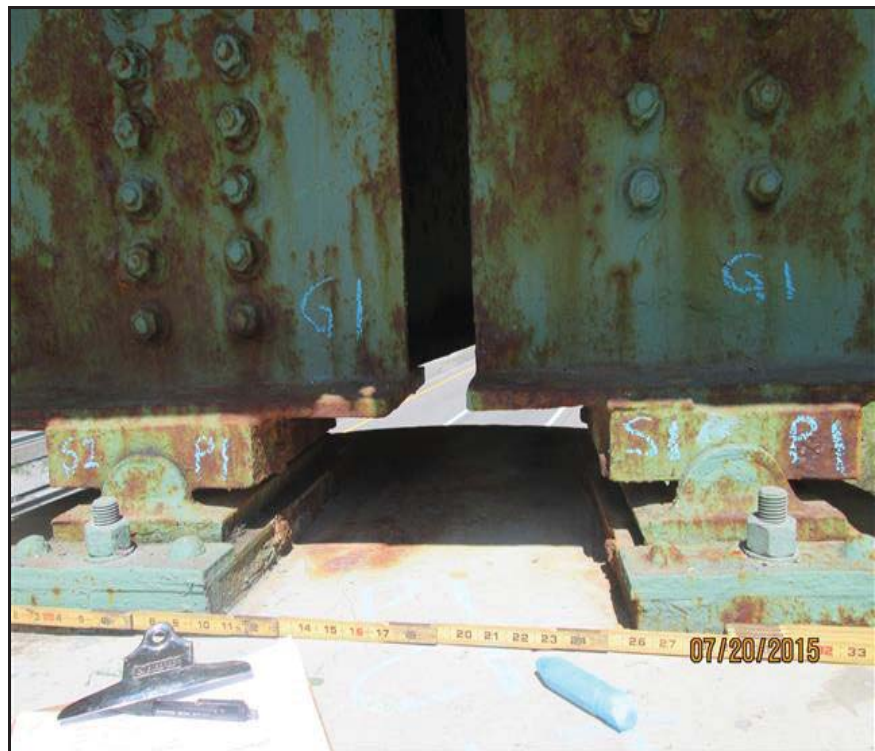
Location:	Photo Name:	Photo #:
Pier 1, Bearings under Girders G1	262.01-350-33-01-15BrgsG1.JPG	25

Form:	Item:	Item Desc:	Span:	Rate:
350	33	Bearings, Anchor Bolts, Pads	1	3

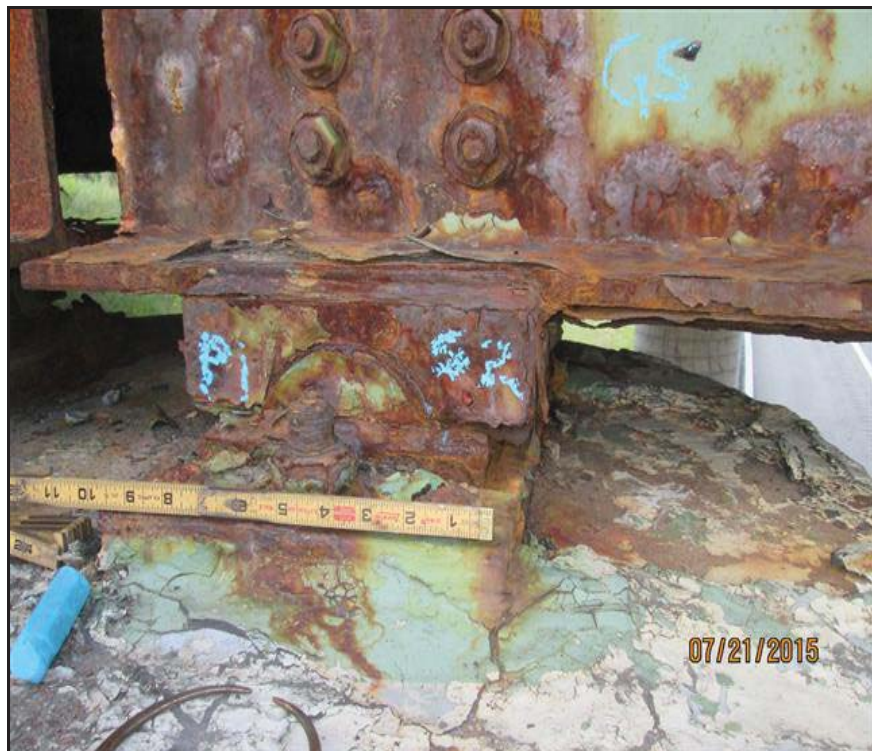
Location:	Photo Name:	Photo #:
Pier 1, Span 2 Bearing under Girder G5	262.01-350-33-01-15Sp2G5R.JPG	27

Form:	Item:	Item Desc:	Span:	Rate:
350	33	Bearings, Anchor Bolts, Pads	1	3

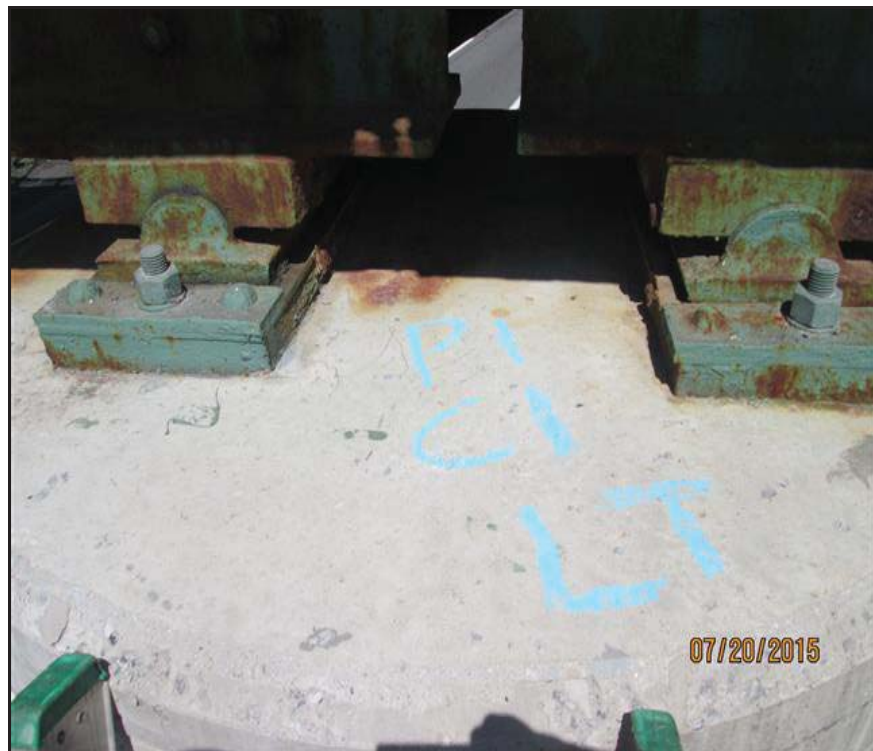
Location:	Photo Name:	Photo #:
Pier 1, Pedestal beneath Girders G1	262.01-350-34-01-15P1Ped1.JPG	31

Form:	Item:	Item Desc:	Span:	Rate:
350	34	Pedestals	1	5

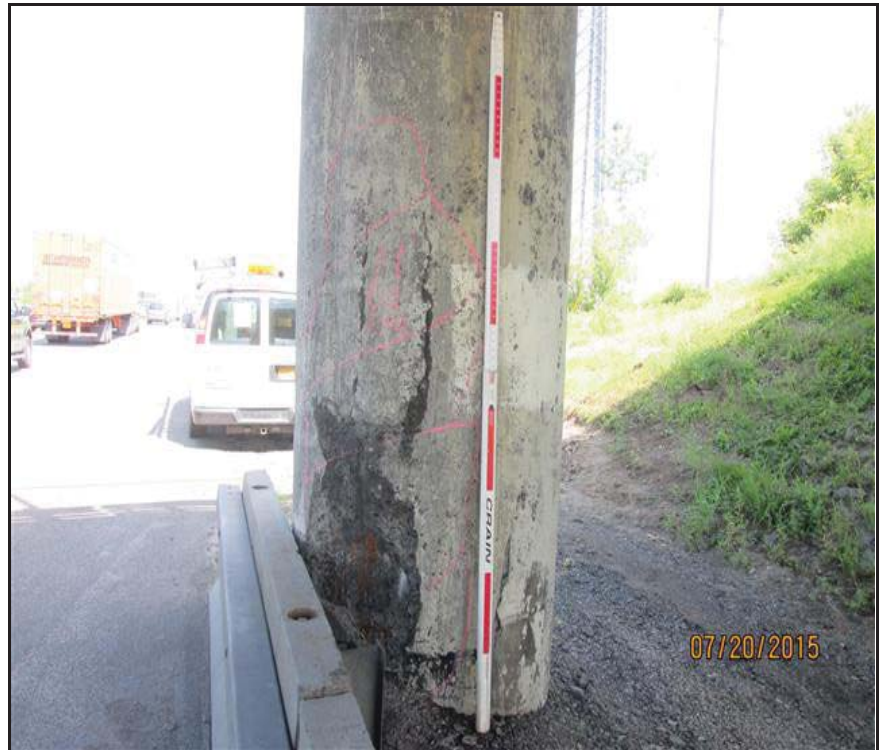
Location:	Photo Name:	Photo #:
Pier 1, Left Column	262.01-350-38-00-15P1Col1.JPG	35

The previously severely deteriorated portion of the Pier 1 Left Column has been completely replaced.

Form:	Item:	Item Desc:	Span:	Rate:
350	38	Pier Columns	1	4
