## FINAL DESIGN REPORT

Bridge Project  
NYSTA D214386  
PIN S52886 B690.1  
MP 240.48 BIN: 5512980  
Judd Rd. (C.R. 840) over I-90  
Oneida County  
Town of Whitestown

This project proposes to replace the existing bridge carrying Judd Rd. over I-90 (I-90) EB & WB (BIN 5512980) located at MP 240.48 in the Town of Whitestown, Oneida County, New York.

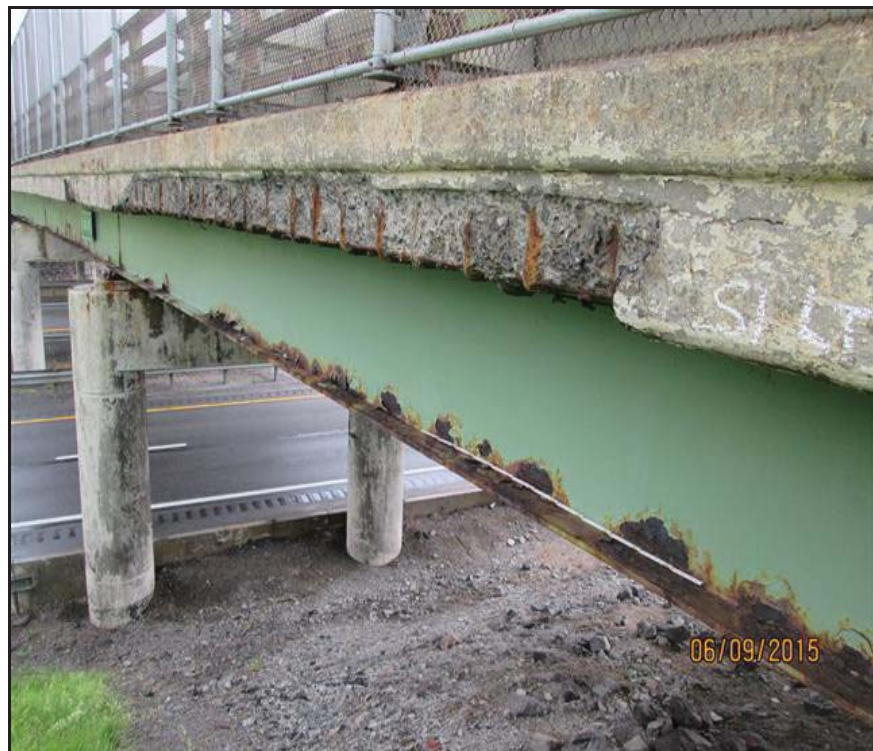
- 26' Long x 12" High x 3" Deep bottom corner spall with exposed reinforcement.

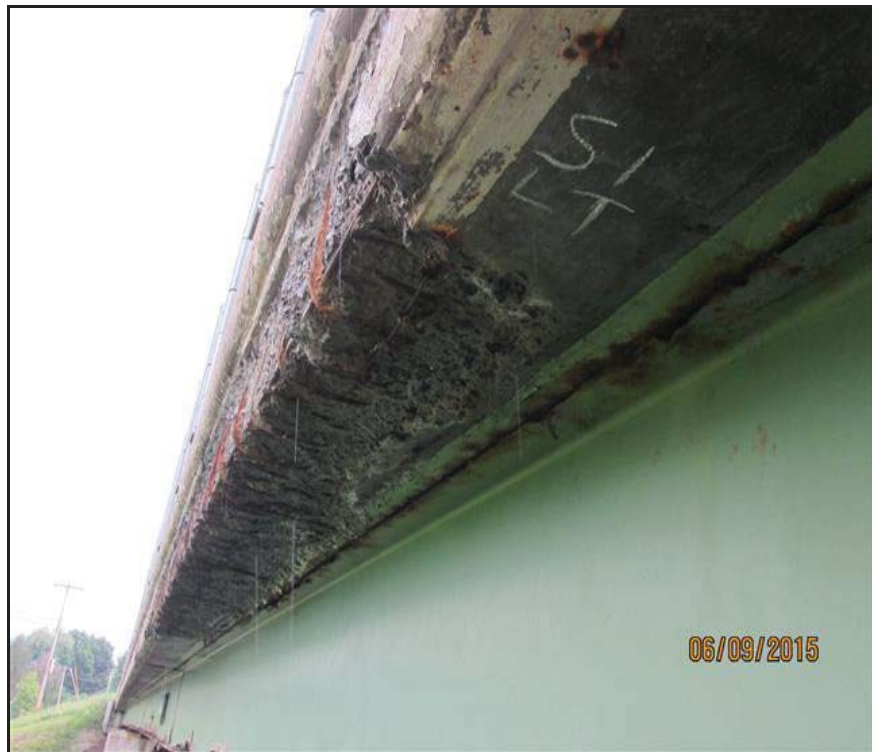
- 26' Long x 12" Wide x 3" Deep spall with exposed rebar.

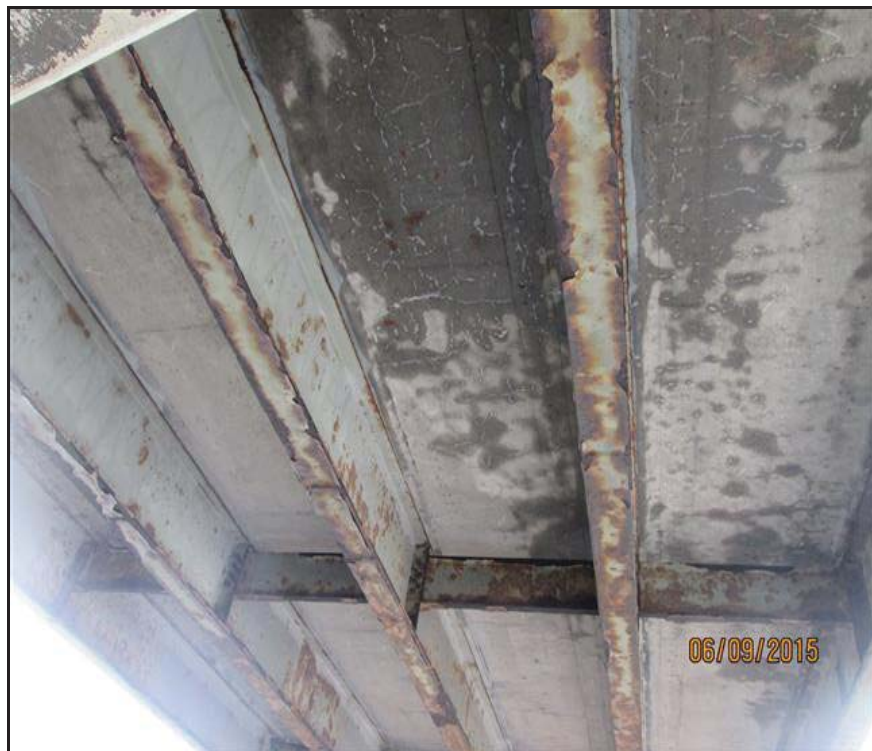
Location:	Photo Name:	Photo #:
Span 2, Deck in Girder Bays 3 & 4	240.48-350-27-02-15DeckS2.JPG	18

- Moderate dampness and Mapcracking with efflorescence and minor rust staining.

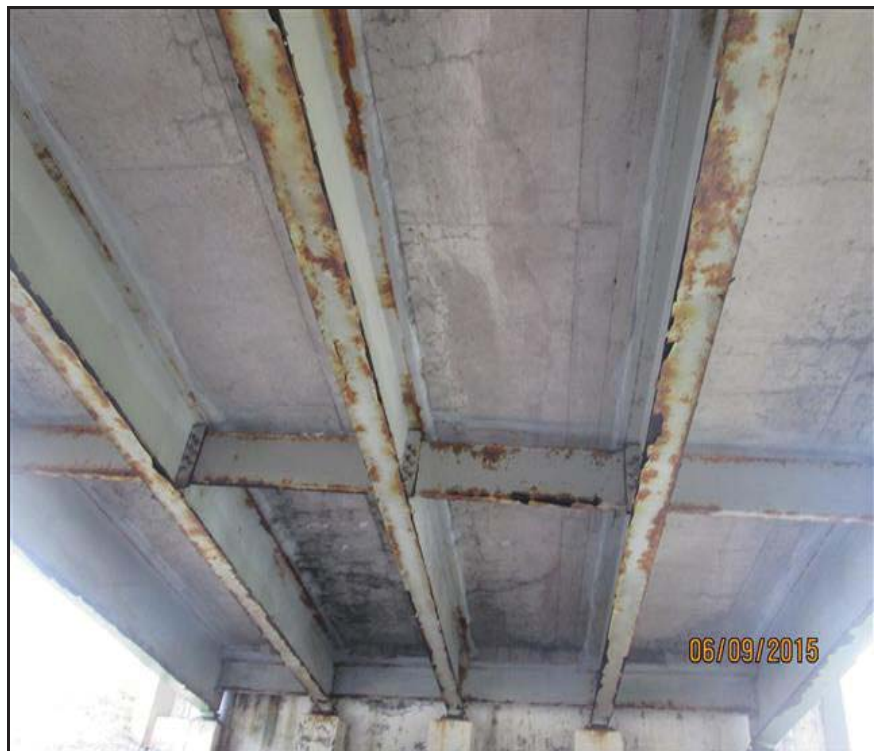
Location:	Photo Name:	Photo #:
Span 4 from Pier 3	240.48-350-27-04-15DeckS4.JPG	20

Description(s):
- Fine mapcracking with moderate dampness and efflorescence in the End half of the span.

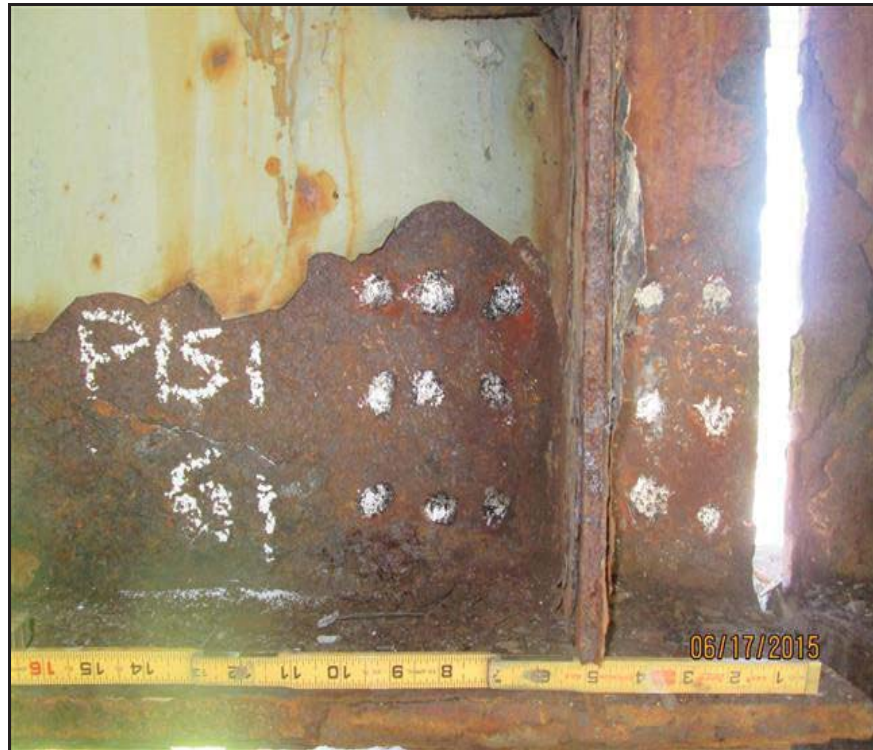
Description(s):
- Complete paint failure has resulted in minor corrosion, with up to 22% section loss in the critical section over the bearing.

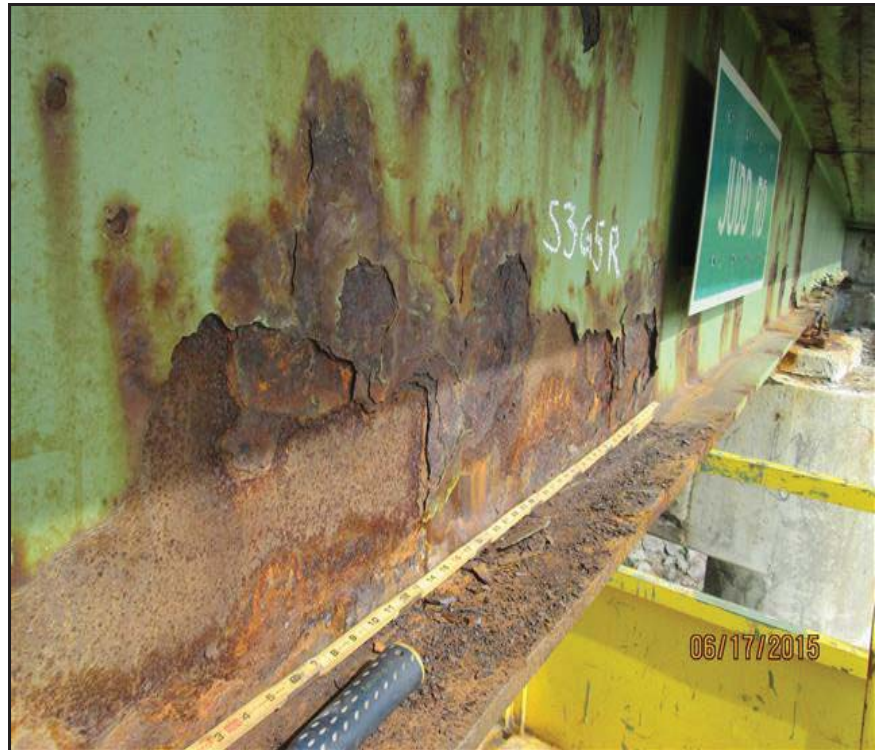
Description(s):
- Complete paint failure has resulted in moderate corrosion, with isolated areas of up to 45% web section loss.

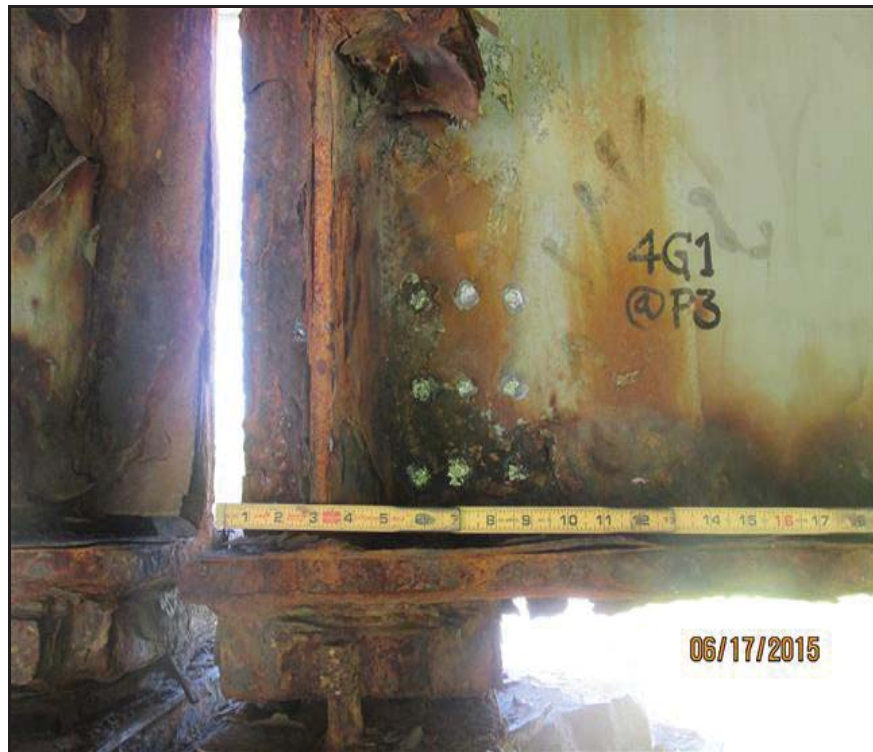
Description(s):
- Complete paint failure has resulted in minor corrosion, with up to 19% section loss in the critical section over the bearing.

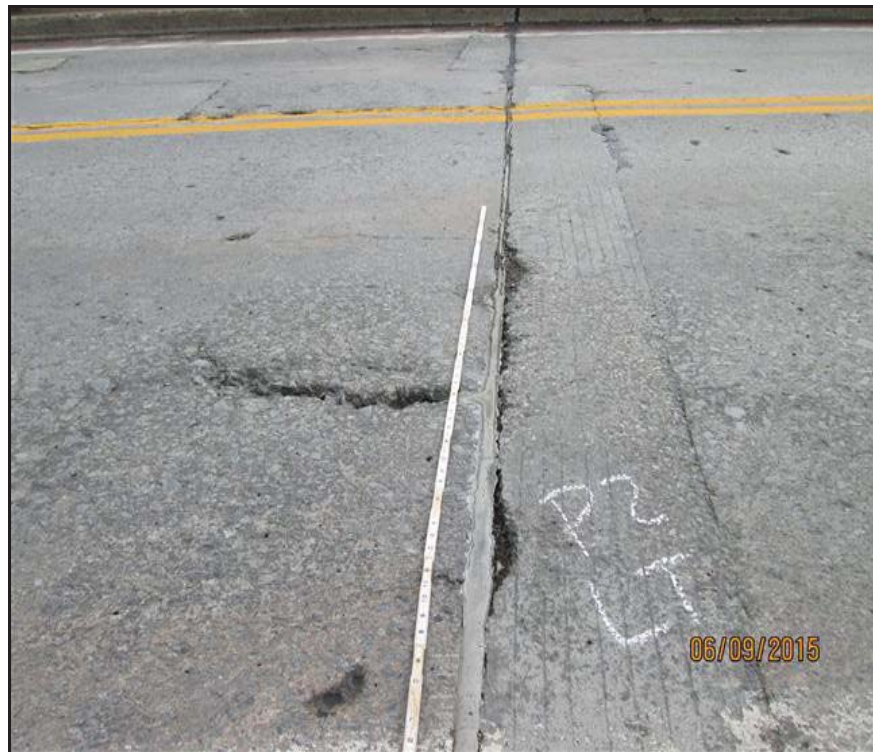
- Joint sealant is debonded due to 2" Wide x 1" Deep spalling along the edge of the Span 2 wearing surface.

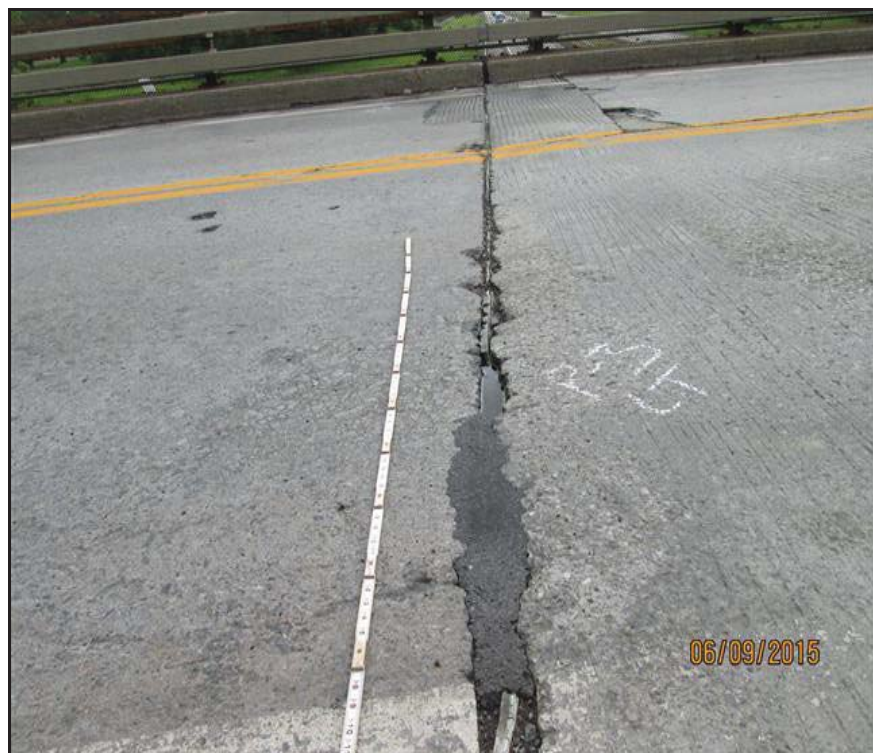
<b>Location:</b>	<b>Photo Name:</b>	<b>Photo #:</b>
Pier 3 Joint from Left	240.48-350-31-03-15Joint3.JPG	28

- 2" wide strip of 1.5" deep edge spalling. The Joint gap is filled with rigid foam board and asphalt, with no visible sealant present.

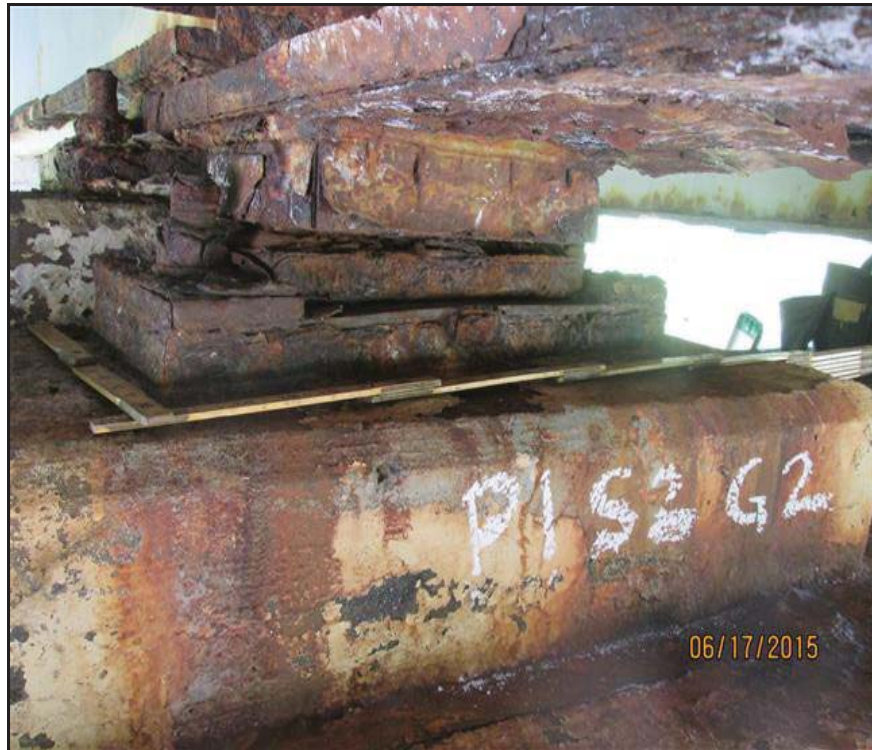
- Expansion Bearing surfaces exhibit heavy rust scale. The bronze sliding surface is bowed upward in the middle by 1/4" thick pack rust, which may restrict thermal movement.

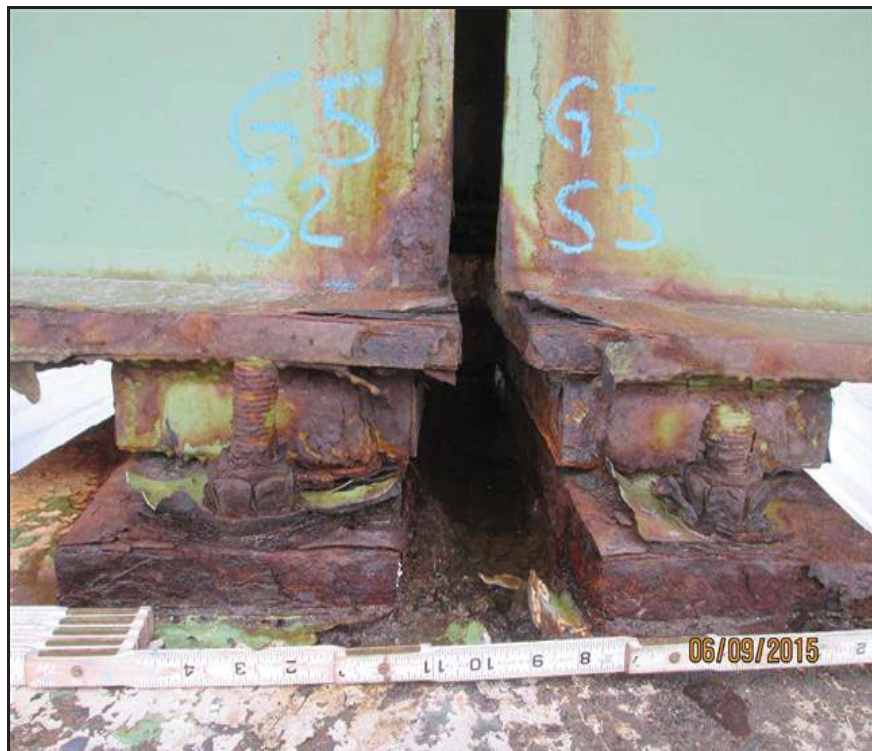
Location:	Photo Name:	Photo #:
Pier 2, Bearings under Girder G5	240.48-350-33-02-15Brg5P2.JPG	30

- Fixed Bearing surfaces exhibit heavy rust scale with thick pack rust under the sole plates, which may restrict proper movement.

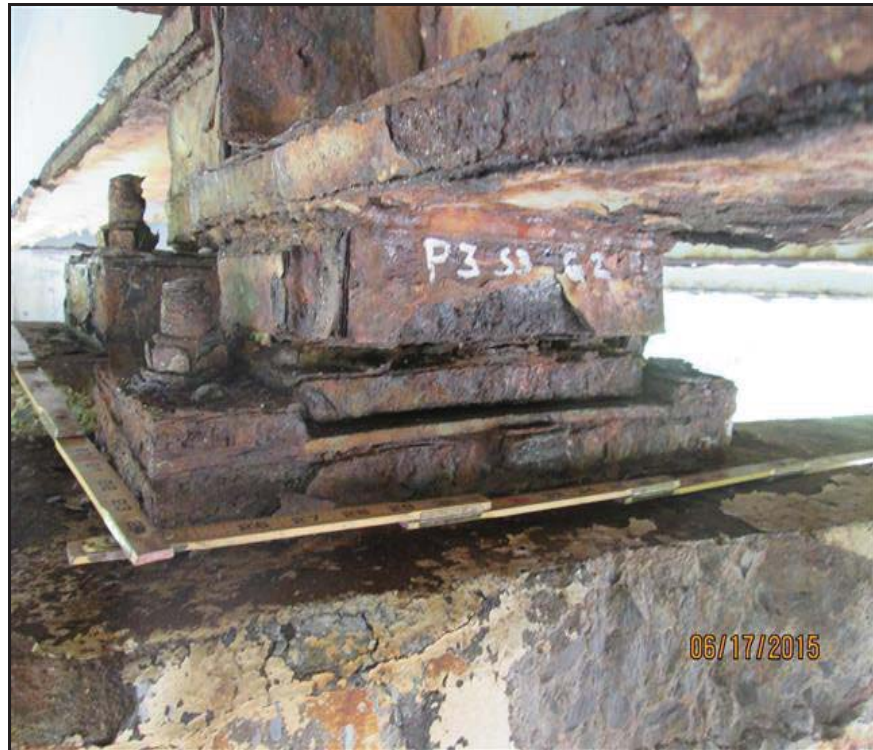
- Expansion Bearing surfaces exhibit heavy rust scale. The bronze sliding surface is bowed upward in the middle by 1/4" thick pack rust, which may restrict thermal movement.

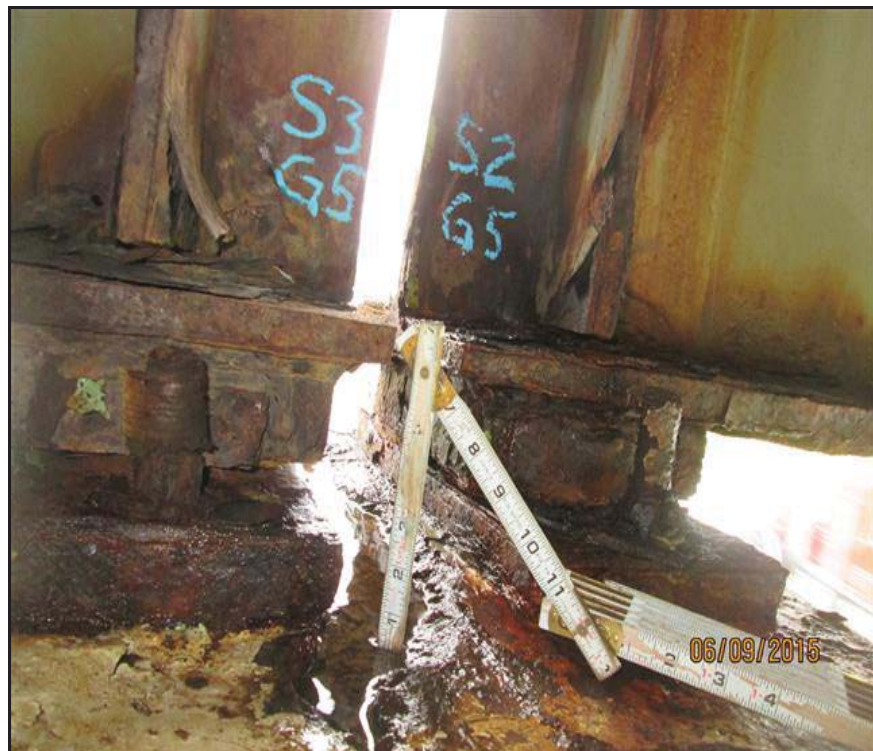
Location:	Photo Name:	Photo #:
Pier 2 Pedestal under Girder G5	240.48-350-34-02-15Ped5P2.JPG	32

- 24" W x up 3" D spall between the masonry plates which undermines the Begin edge of the Span 3 masonry plate by up to 1/4". Loss of contact area is less than 3%. The Span 3 Bearing is not undermined.

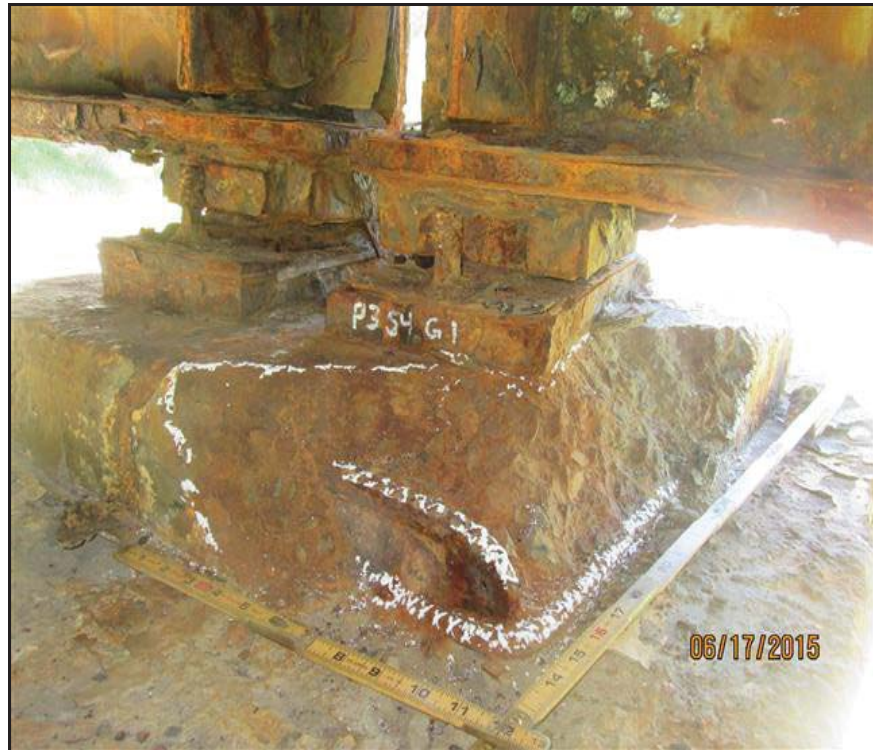
- 5" H x 3" D corner spall affecting a length of 14" along the Right and 18" along the End face. Spalling extends up to, but not under the masonry plate and exposes 2 debonded bars.

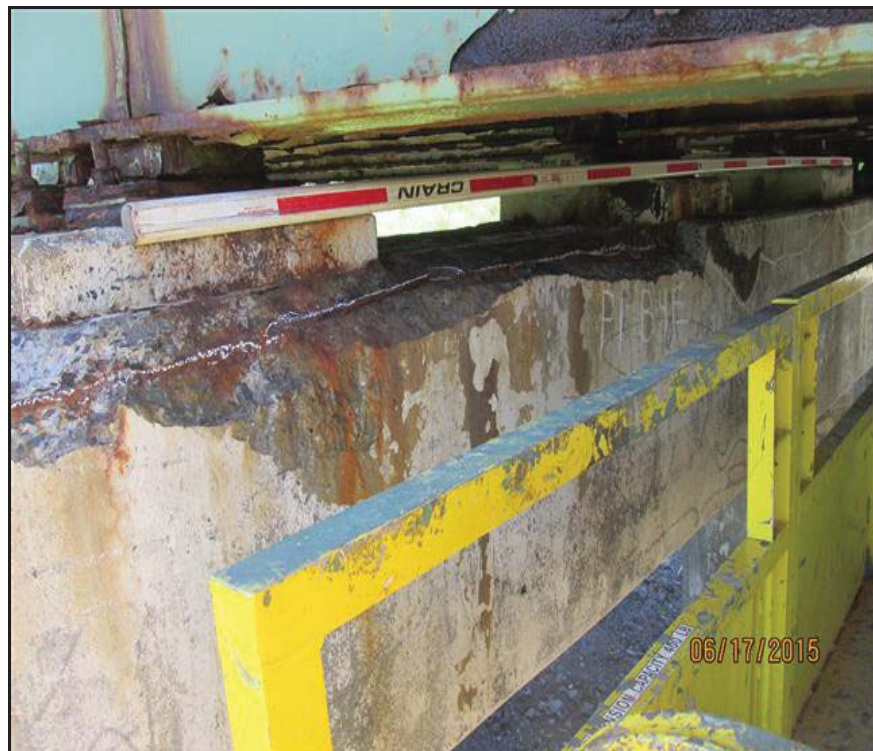
Location:	Photo Name:	Photo #:
Pier 1 Cap Beam from End Right	240.48-350-35-01-15Cap1ER.JPG	34

- 8' L x 8" H x 2.5" D top corner spall with exposed rebar, extending from the Right side of Pedestal 4 and beneath Pedestal 5. Spalling extends 12" into the Top of Cap in Bay 4.

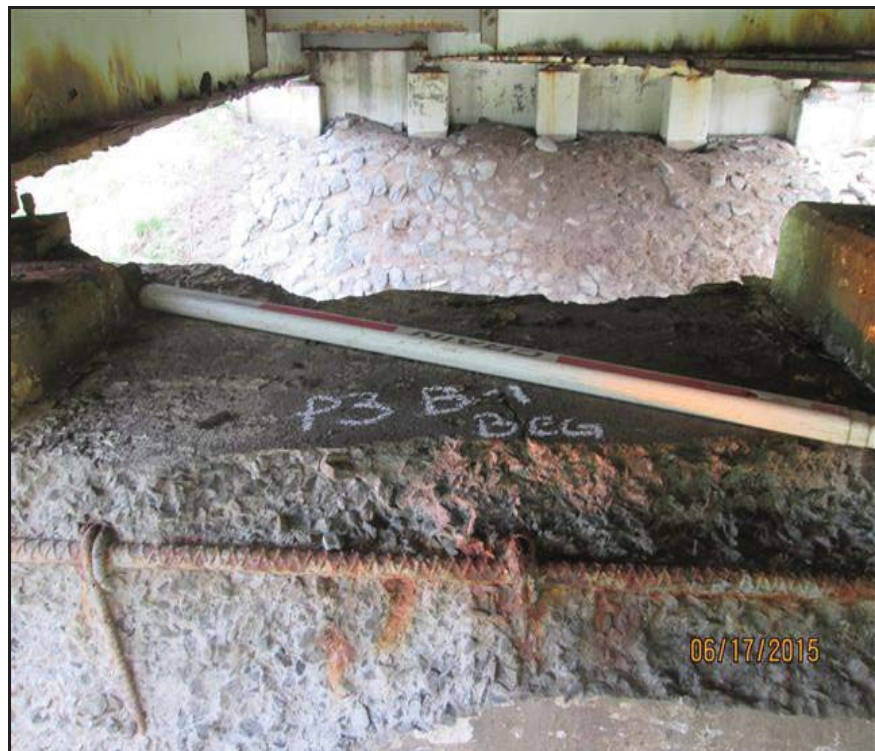
Description(s):
- 6" deep top corner spall extending 10" into the top surface and up to 18" down the vertical face. The top corner longitudinal bar is exposed and debonded.

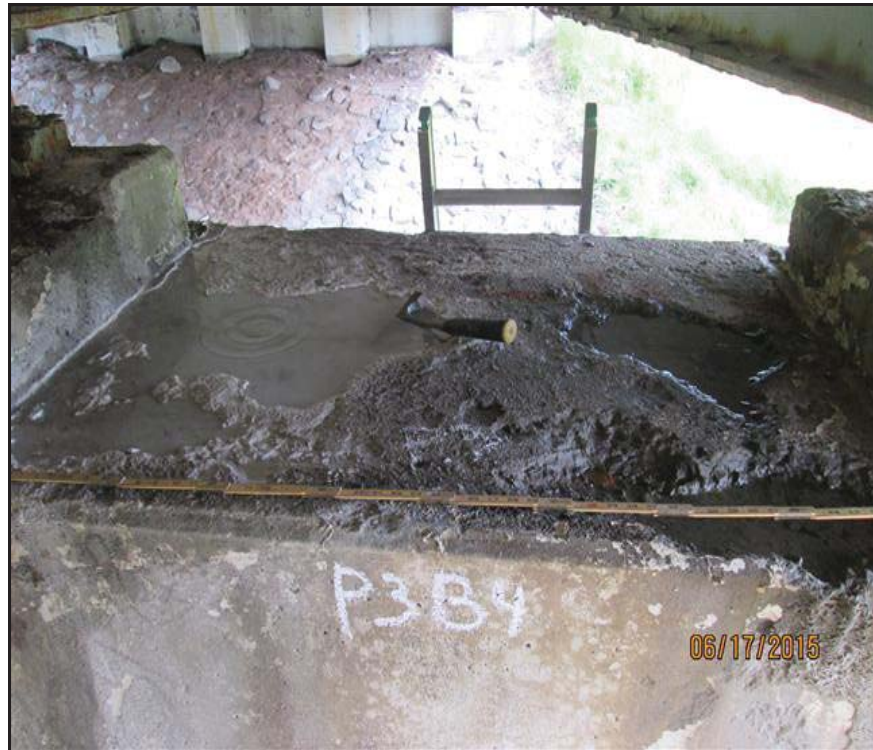
- 50% of the Bay's surface area is spalled up to 2.5". The affected areas allow active joint leakage to pond, promoting further deterioration.

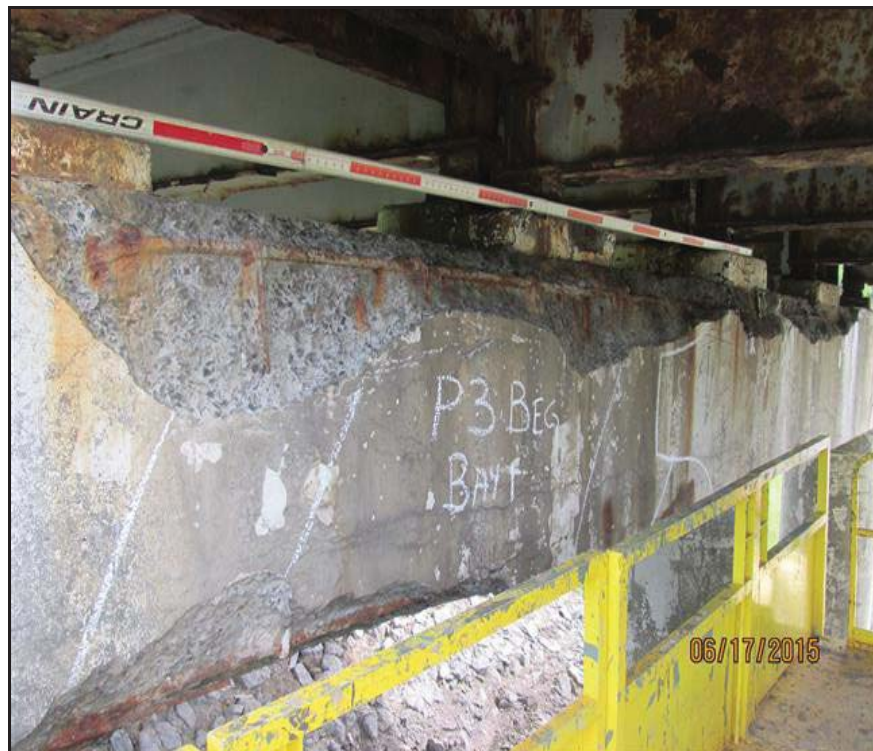
Location:	Photo Name:	Photo #:
Pier 3 Cap Beam from Begin Left	240.48-350-37-03-15Cap3BL.JPG	38

- 25' L x up to 18" H top corner spall extending from below G1 to the Right side of G4. Also, there is a 6' L x 4" D bottom corner spall below girder Bay 1. The top and bottom corner bars are debonded.

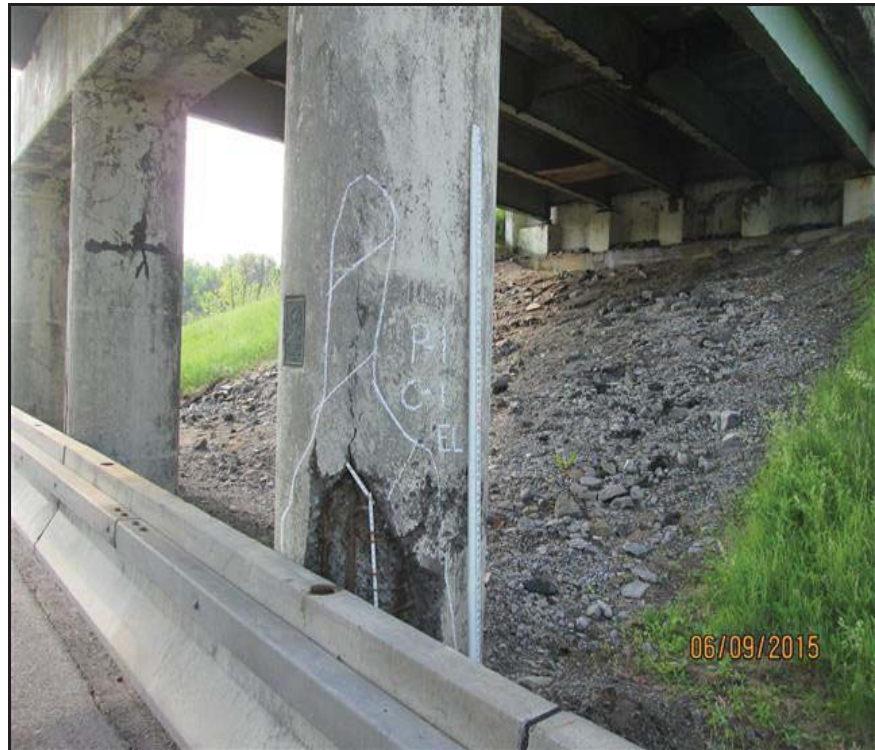
- 5.0' high x 2.8' wide x 4" deep spall with exposed and debonded reinforcement. Yellow Structural Flag 15-041.

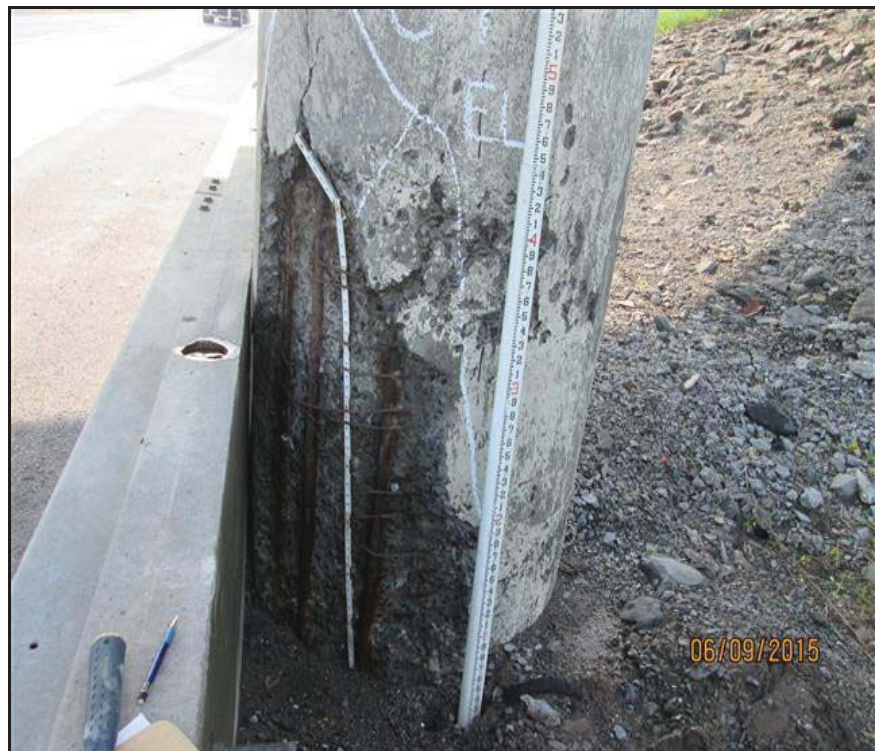
Location:	Photo Name:	Photo #:
Pier 1, Column 1 from Left	240.48-350-38-02-15P1C1EL.JPG	40

- Two vertical bars are debonded over a height of 3.5', and the 18 exposed spiral ties are broken. Yellow Structural Flag 15-041.

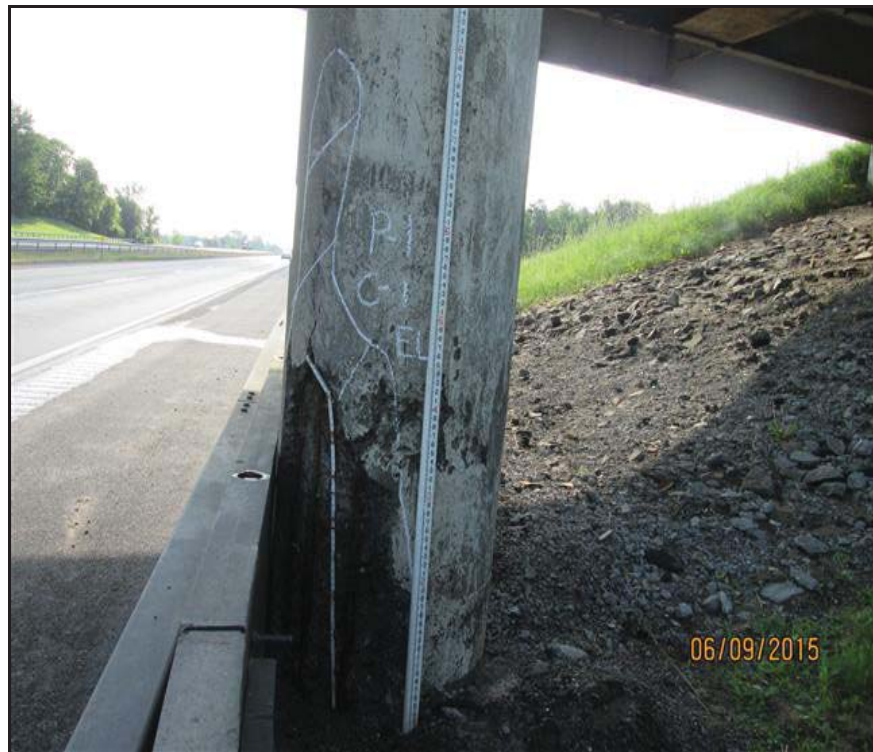
- The 5.0' high spall extends 1' below the surrounding ground line. Yellow Structural Flag 15-041.

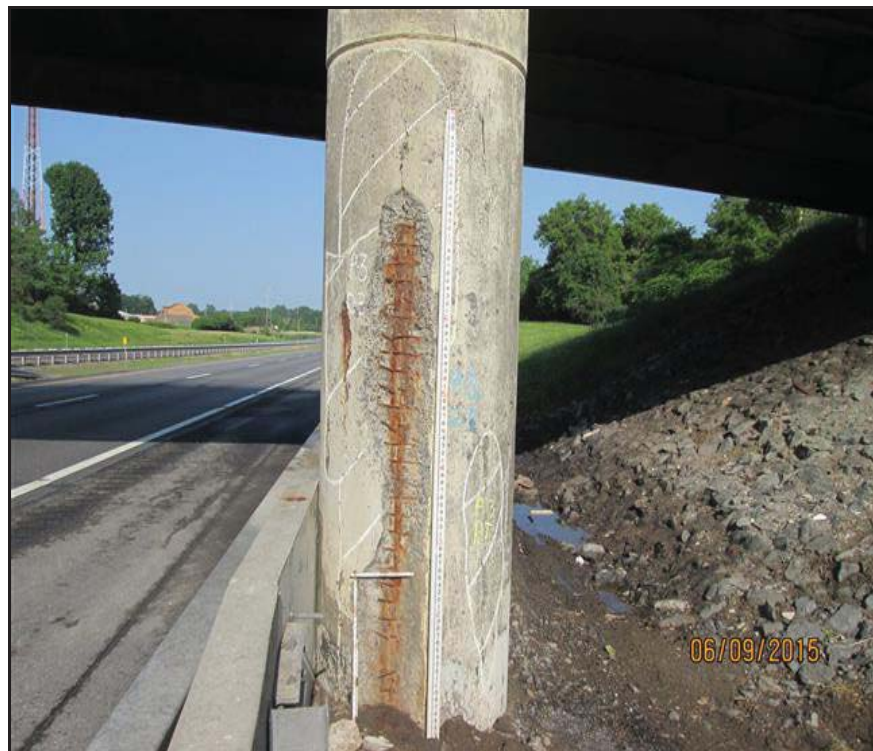
Location:	Photo Name:	Photo #:
Pier 3, Column 3 from Right	240.48-350-38-04-15P3C3Rt.JPG	42

- 7.5' H x up to 1' W x 2" D spall with one exposed vertical bar and 30 exposed spiral ties, 13 of which are broken.

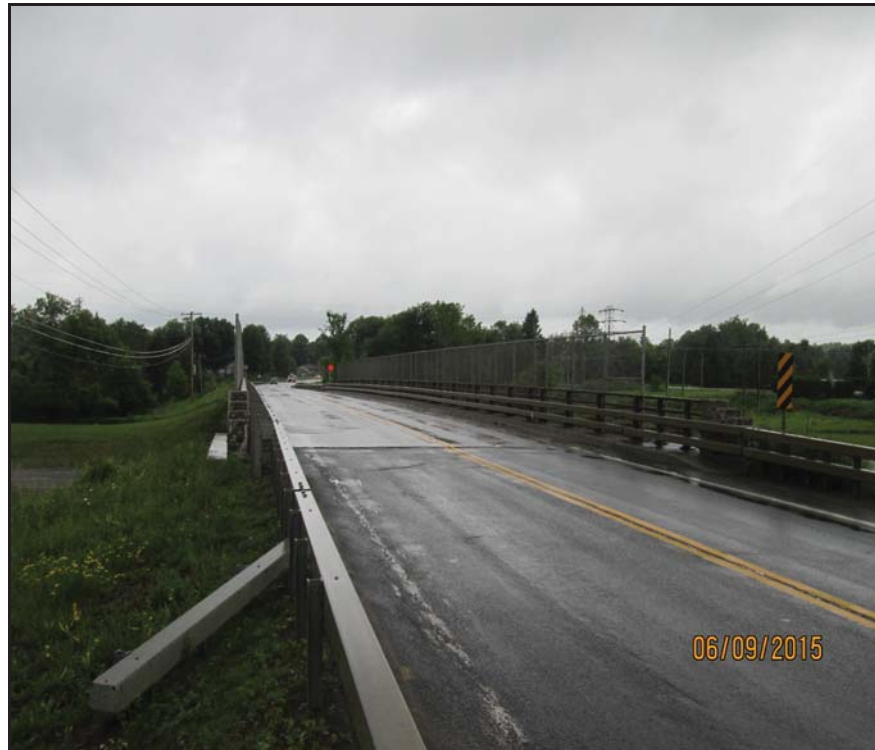
- The Horizontal Clearance Marker at the Left approach quadrant is missing.
