New York State Thruway Authority

General Large Culvert Inspection Report

Inspection Date: October 25, 2023

MP: 417.63 **CIN:** 41763011XX **Region:** 05 - Buffalo
Feature Carried: 90IX **County:** 3 - Erie
Feature Crossed: DRAINAGE DITCH **Political Unit:** Town of Cheektowaga
Orientation: 3 - East **Approximate Year Built:** 1952

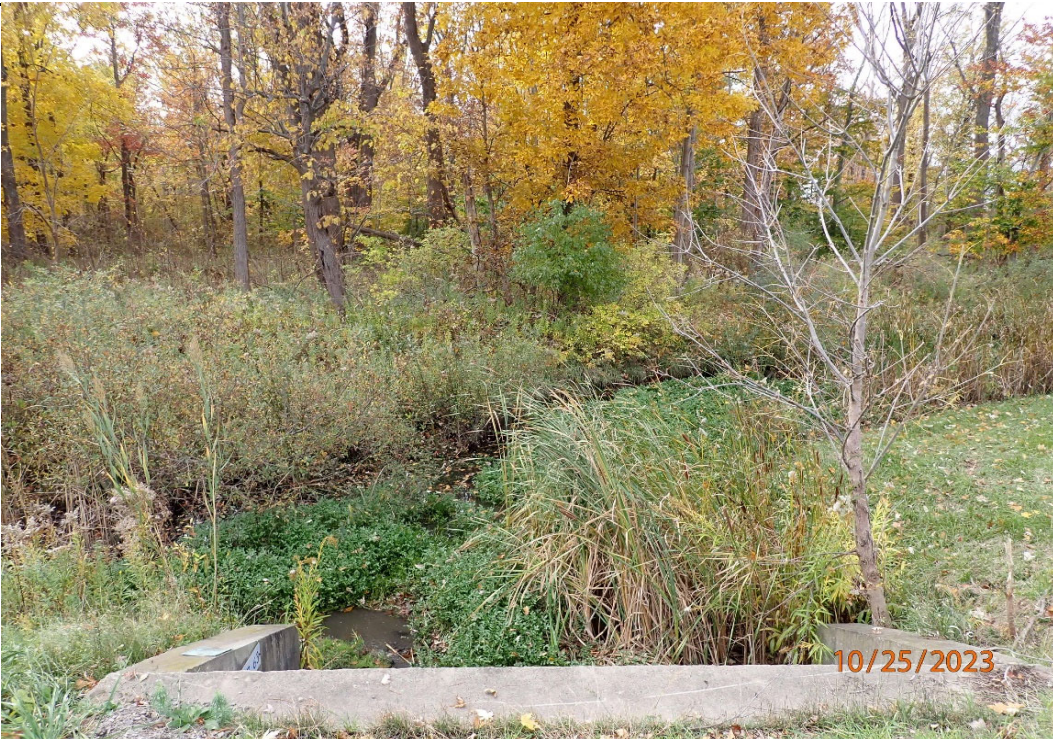
MP 417.63_CIN 41763011XX_FeatureCrossedRight

There is minor accumulation of vegetation at the culvert outlet (right side) in the begin half of the channel that slightly reduces the waterway opening.

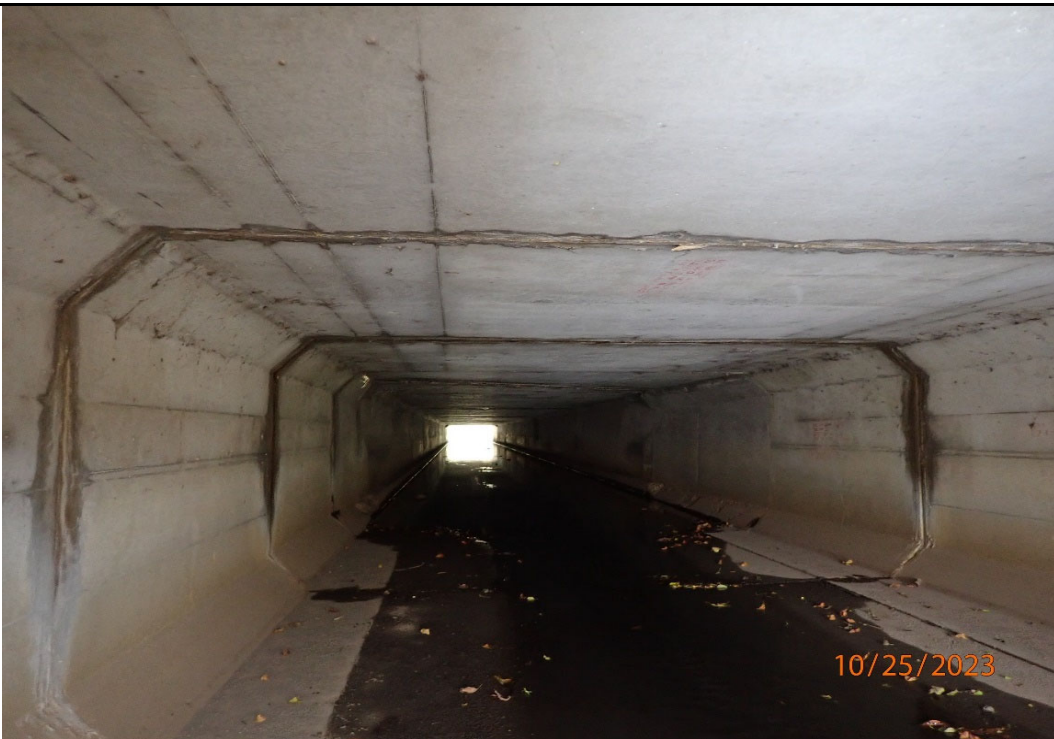
MP 417.63_CIN 41763011XX_CulvertInterior_PrecastExtension

Span 1: 241 - Reinforced Concrete Culvert Referenced Photo(s): 1, 2, 3, 4, 5, 6, 7 Referenced Sketch(es): None	TQ	CS-1	CS-2	CS-3	CS-4	CS-5
	244	93	124	27		
<p>PRECAST EXTENSIONS At the left and right side of the original culvert, there are (4) precast concrete box culvert units and (1) precast concrete end section (assessed under Element 241) installed under TAB 98-23. The precast units are in good condition, except for minor dampness at joints, 4 LF x 2 sides = 8 LF CS-2.</p> <p>CLOSURE POURS There are closure pours at the transition from the original cast in place concrete culvert to the precast concrete extensions. The closure pours are generally in good condition, CS-1.</p> <p>ORIGINAL CAST-IN-PLACE CUVLERT The original culvert is generally in good to fair condition with areas of minor cracking, delamination, dampness, and isolated efflorescence, 75% (116 LF) CS-2. There is more severe deterioration at the following locations:</p> <p>LT FASCIA (Photo 1) - There is minor leakage and rust-staining at the cold joint with the closure pour. There are 1' to 2' wide delaminations along the cold joint and a 1 SF and 3 SF spall with exposed/corroded rebar, 2 LF CS-3.</p> <p>CJ 1 (Photo 2) - Damp with minor leakage and rust staining. Left side of joint exhibits a 3' wide x 8' long delaminated area with a 2 SF x 1"D spall. Right side of joint is spalled 1' to 2.5' wide x 6' long x 1"D with (3) exposed/corroded rebar and delaminated concrete adjacent, 5 LF CS-3.</p> <p>CJ 2 (Photos 3 & 4) - 6' wide x full span length x up to 2.5"D spall with (8) exposed/corroded longitudinal bars (up to 50% section loss). (4) of the (8) bars are debonded 3' to 4' long. Concrete adjacent to the spall is damp and delaminated. 6 LF CS-3.</p> <p>CJ 3 (Photo 5) - Left side of joint exhibits a 4' wide x 9' long x up to 2.5"D spall with (3) exposed longitudinal bars (up to 10% section loss). Concrete adjacent to the spall is damp and delaminated. Right side of the joint is damp and delaminated up to 2' wide. 6 LF CS-3</p> <p>2' RT of CJ 3: 2' wide x 4' long x 2" deep area of honeycombing with partially exposed rebar, 2 LF CS-3.</p> <p>CJ 4 (Photo 6) - Left side of joint exhibits a 2' wide x 6' long x 2" deep spall with (2) exposed/corroded rebar. Right side of joint exhibits a 3' wide x full length area of heavy dampness, mapcracking and moderate efflorescence. At the bottom of the begin stem there is a 1 SF x 4"D spall. 5 LF CS-3.</p> <p>RT FASCIA (Photo 7) - Leakage and rust staining at the cold joint with the closure pour, 1 LF CS-3.</p>
